The information in this document were prepared by Jim Godward and Jim Epting.

As originally diagnosed by Jim Godward, the Vehicle Data Unit (VDU) installed in the 1999-2001 Freightliner chassis has significant manufacturing quality control issues. The issues have lead to erratic performance and some frustrating instrument cluster problems, though non of the problems are known to have caused a shut-down or need for road service. This note addresses one of the instrument cluster issues, false low air pressure warnings on both the warning light and pressure gauge. (In fact, the Freightliner representative at the 2006 Quartzite Newmar Rally indicated that the vehicle would run and drive without an operating VDU, but with no instrument panel gauge operation. This is untested by the writer.)

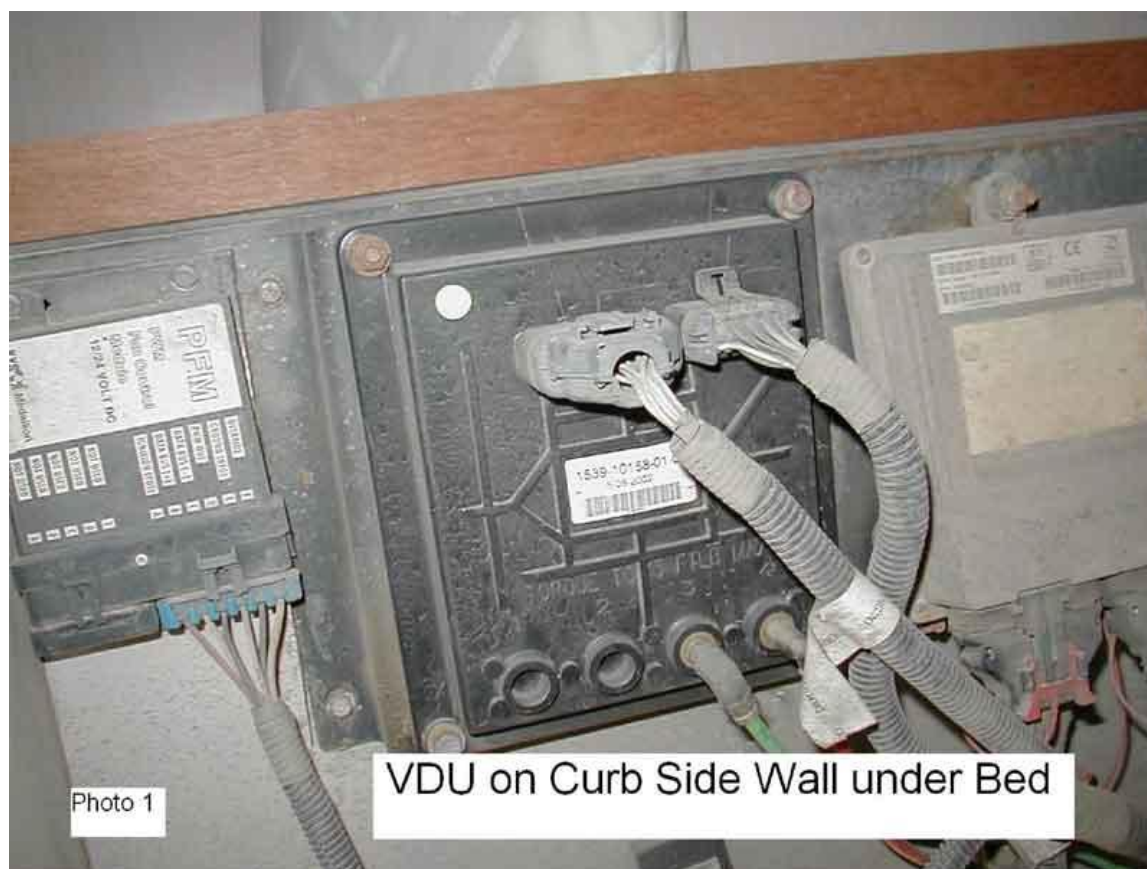
The VDU is a small black box which gathers and conditions various vehicle data destined to be displayed on the drivers instrument panel. This data is multiplexed onto a single digital bus, and passed to the instrument cluster, where it is de-multiplexed and displayed by the various individual instruments. In the 1999-2001 coaches, the box is attached to the curbside vertical engine bay wall, accessible by lifting the under-bed engine hatch. The box is approximately six by seven inches, less mounting flange, and one inch thick. It is attached by four small bolts in the corners, with rubber shock mounts surrounding each mounting bolt. The VDU has two multi-wire quick disconnect plugs and two small air lines of ¼ inch diameter attached. The airlines are color coded red and green and are apparently routed to the front and rear air brake reservoirs. The VDU is easily identified by looking for the color coded air hoses. Photo 1 below show the VDU mounted in under the bed in the engine compartment. The mounting bolts, quick release plugs, and the air lines are clearly visible.

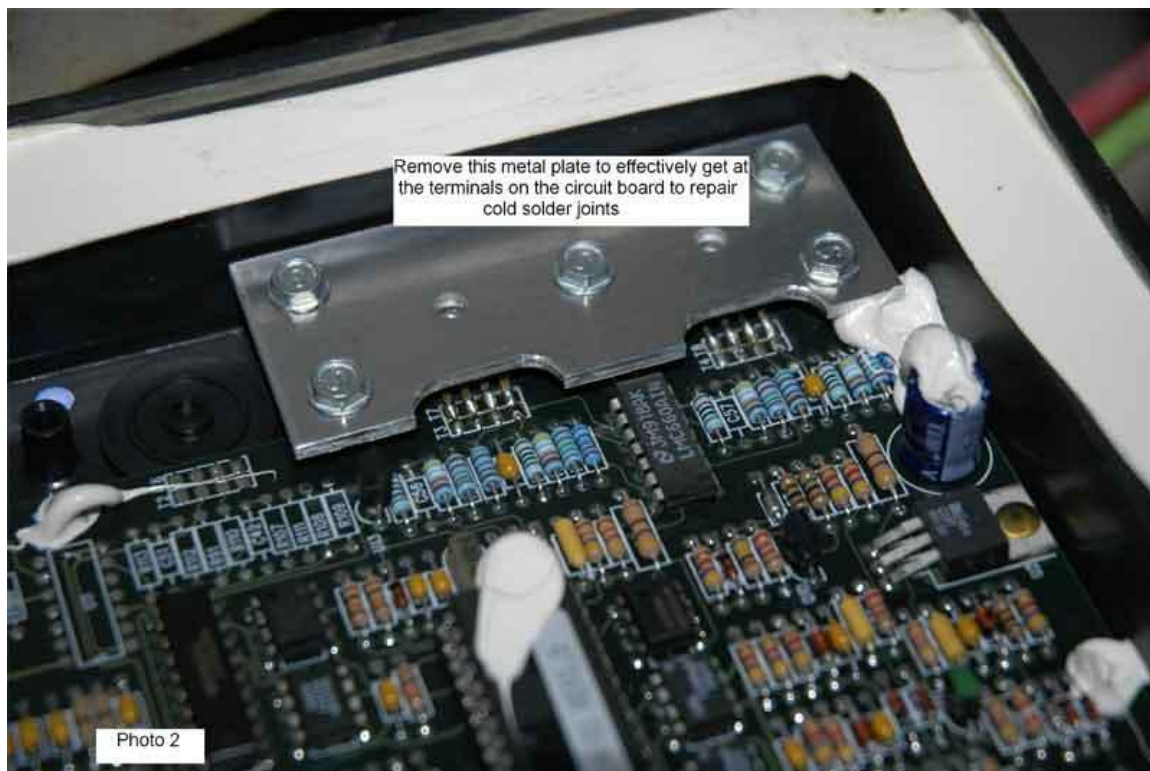
The primary quality control problems are with cold solder joints on the air pressure sensors, which become immediately clear when the unit is opened. Upon opening the VDU one will observe that the internals of the VDU consist primarily of a single printed circuit board and two attached brake pressure sensors. The air pressure sensors are covered by the small screw mounted aluminum plate which should be removed for repairs, shown in Photo 2.

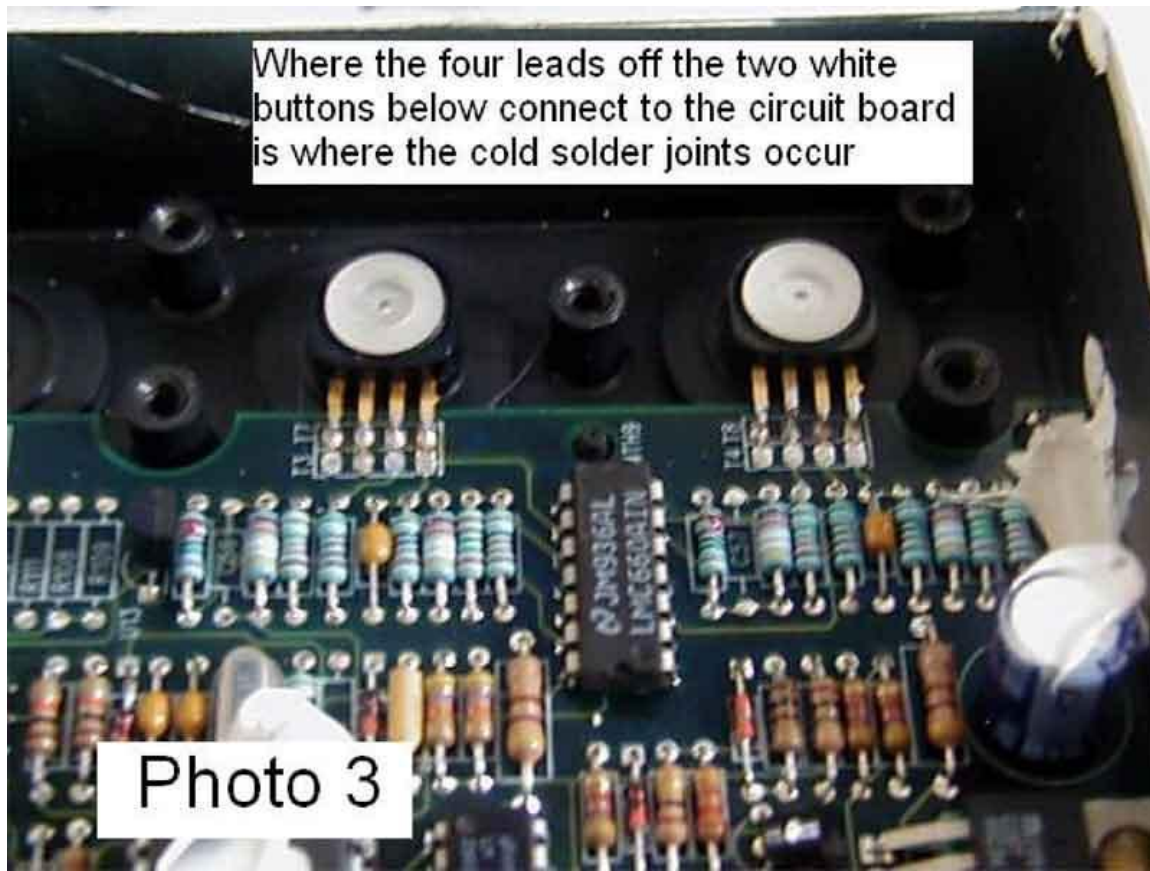
The primary soldering problem seems to be with the four attachment leads that each of the two brake sensors have on the printed circuit board. The connections to the air pressure sensors are just visible in the "notches" of the aluminum cover. (See picture below with cover removed) In both the Godward and the Epting cases, the solder joints were "cold." (Cold joints are characterized by a dull, grainy, rough appearance. Good joints are characterized by a bright, shiny, smooth appearance which "flows" onto the subject material.) All eight of the attachment leads (See Photo 3) had obvious cold joints, and there were visible cracks in some. This is an easy fix for someone with soldering experience, even without if careful.

The conductors and component leads on the VDU are quite small, though certainly larger than the current microcircuit level. These components cannot tolerate a lot of soldering heat, so a small iron is needed. Repairs are clearly within the realm of possibility, with a small pencil tip soldering iron and some care. I purchased a 40 watt pencil tip iron and a bit of fine resin core solder at Radio Shack. Just apply the tip of the soldering iron to each of the eight joints for a few seconds, and apply a very small drop of fine, resin core solder. After using the soldering iron, I now think that a 30 watt iron would have been even better, but one wants to get a good joint and not produce another cold joint. The entire operation took no more than an hour, once all the planning and preparations were made. If one has no soldering skills, or experience, then it would perhaps be better to find a friend who does.

When finished, the VDU must be resealed to avoid moisture and road spray. The original sealant is a tough, somewhat pliable material of undetermined origin. Mr. Godward, and aerospace electronics expert, advises the use of a small amount of butyl rubber sealant to reseal the unit. If this is unavailable, an epoxy would seem to work well. Mr. Godward advises against silicon since it releases a potentially destructive acid as it cures. Reinstallation is straight forward, but care must be exercised to avoid over tightening the four shock mount bolts. The shock mounts should not be compressed since this might distort the case, or cause excess vibration. The elastic locking nuts will prevent the nuts from backing off. The air hoses will lock in place when pressed back into the pressure fittings. Reconnect the chassis battery and test the repair.
