March 10 2008

As most of you are aware, it all started with "Quest for SS Frame". Back in Sept 2006 we have purchased a well used 1973 26' Argosy. After bringing it home to Pennsylvania, close inspection revealed that the frame needed serious repairs. At first, we have considered sandblasting and replacing sections of rotted frame [shown in the picture under the new one]. After some quick calculations we decided that it would be cheaper for us to build a new SS frame. This would eliminate cost of sandblasting priming and painting for ever. Having most of needed SS material in stock, we first tore down and scrapped the interior which was to be replaced anyway. We removed the empty shell and left it on blocks in the storage yard. In the end of December 2006 old frame was brought into the shop and work begun on new Stainless Steel frame. All work in the winter of 2006 was done on after business hours basis. We could only afford to tie up one 12'X35" bay because our business had to remain operational.

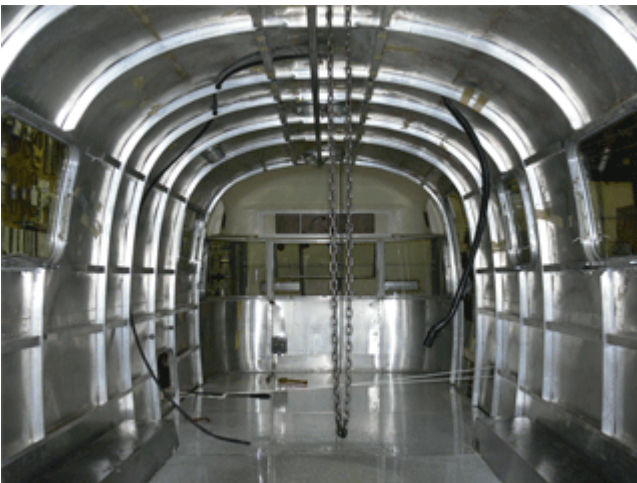
Most of the original fiberglass insulation was compacted down where over 50% of the total wall area was not insulated at all. Stripped out clean shell was then lowered onto the installed floor and fastened with ¼" SS lag bolts to the outrigger plates and the frame at each end of the shell.

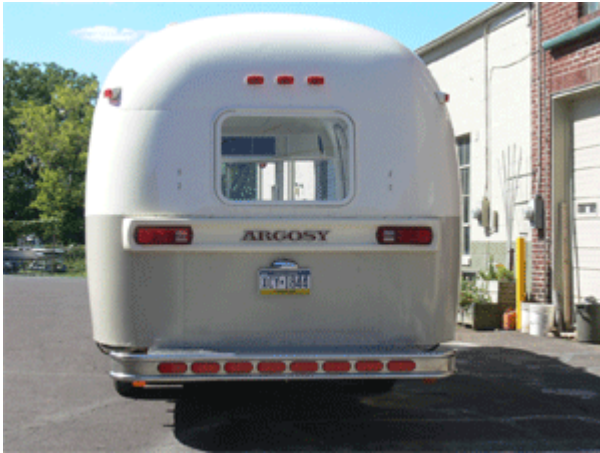
The original light panel at the beltline was cracked into many pieces. It was repaired with DEVCON and Kevlar Cloth. It took quite a few hours to reshape the face of it to a presentable

condition. Top side of the light bar was sealed onto the shell during the installation with 5200 at top and sides of the panel. Bottom was left open so it can drain.

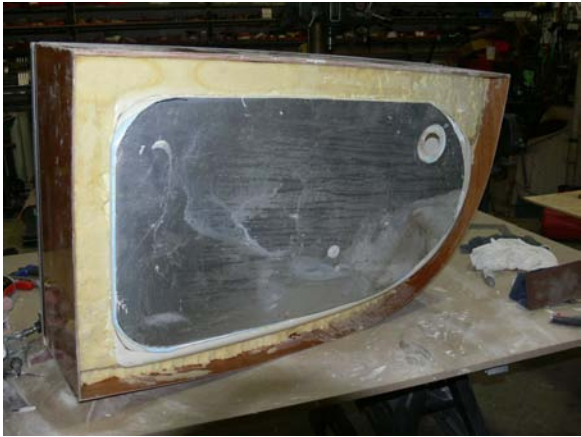
Bath tub had few cracks in it. Those were repaired with DEVCON and Kevlar cloth from the backside. The tub was then encased in a 3MM plywood form on the wall side, and a 10MM varnished face panel which is visible when tub is in place. Plywood case was made to fit the tub space exactly and at proper angles to the wall. Void area between the form and the tub was gradually filled with rigid Closed Cell pour urethane foam layer by layer. Urethane foam generates plenty of heat as it cures, and it can melt the plastic tub while curing. This is why caution must be taken when pouring the foam. Tapered foam wedge was glued on the underside of the tub, so that the drain is at the lowest end of the tub. The wedge than was covered with aluminum 0.025" as a protective plate. Tub was then sent out to be professionally recoated with acrylic coating. Cost \$275.00. Prior to having it recoated I have cut and trimmed top edges with

aluminum C trim on the backside, and H trim on the face side connecting the tub and the face plate.

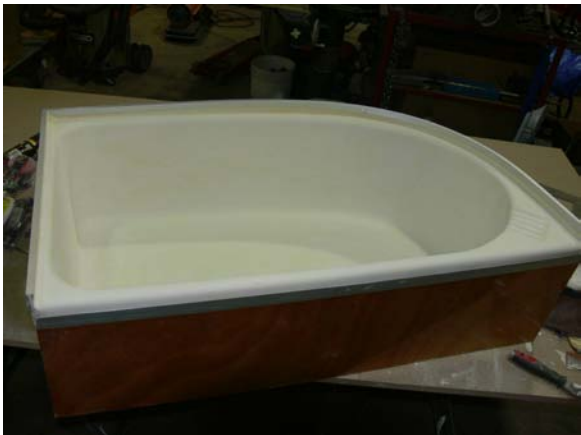
Tub seen with aluminum base plate

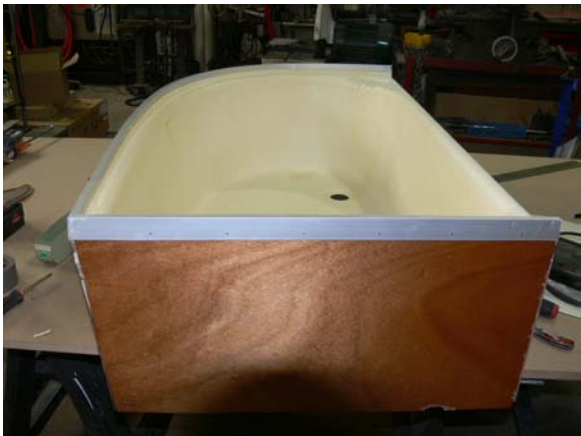
Face panel with aluminum H trim joining it to the tub.
