AIRSTREAM SERVICE BULLETIN # 146

SHELL TO CHASSIS SEPERATION

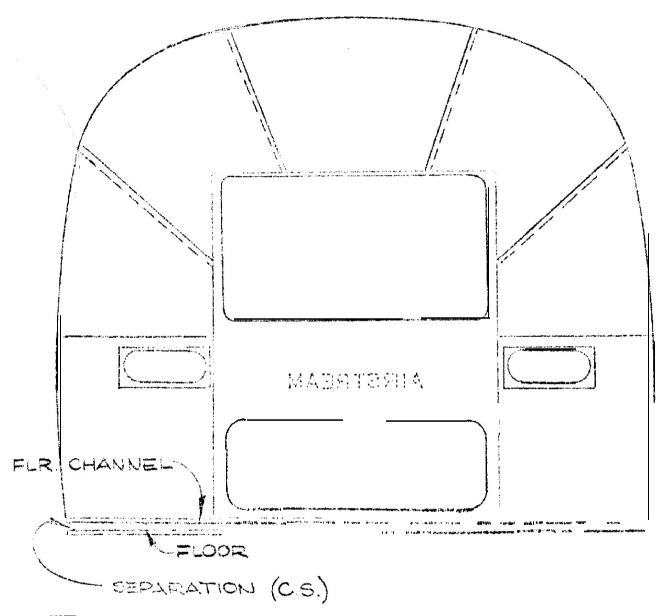
Frame separation at the rear of the trailer is indicated by the chassis of the trailer dropping away from the shell or body.

- To correct 1969 1970 1971 1972 Models -
- (1) Remove rub rail from rear of trailer.
- (2) Cut 3" square hole directly above main frame, starting at bottom of rear sheet. (See figure # 1B) <u>Be sure not to cut floor channel.</u>

- (3) Remove rivets from sewer hose carrier pan bottom, (using a # 30 drill) and remove pan from trailer.
- (4) Place floor jacks under the main frame at the rear of the trailer and jack frame up until it is back in corrected position.

- (5) Jack frame up to correct position. From underside of trailer, drill. a 3/8" hole through the main frame floor and floor channel into the area between walls of the trailer.
