Original Vertical Shock Position (standard in 1963)

NEW AXLE

Airstream recommended
Horizontal Shock Position
(standard after 1969)

New vs Old axles

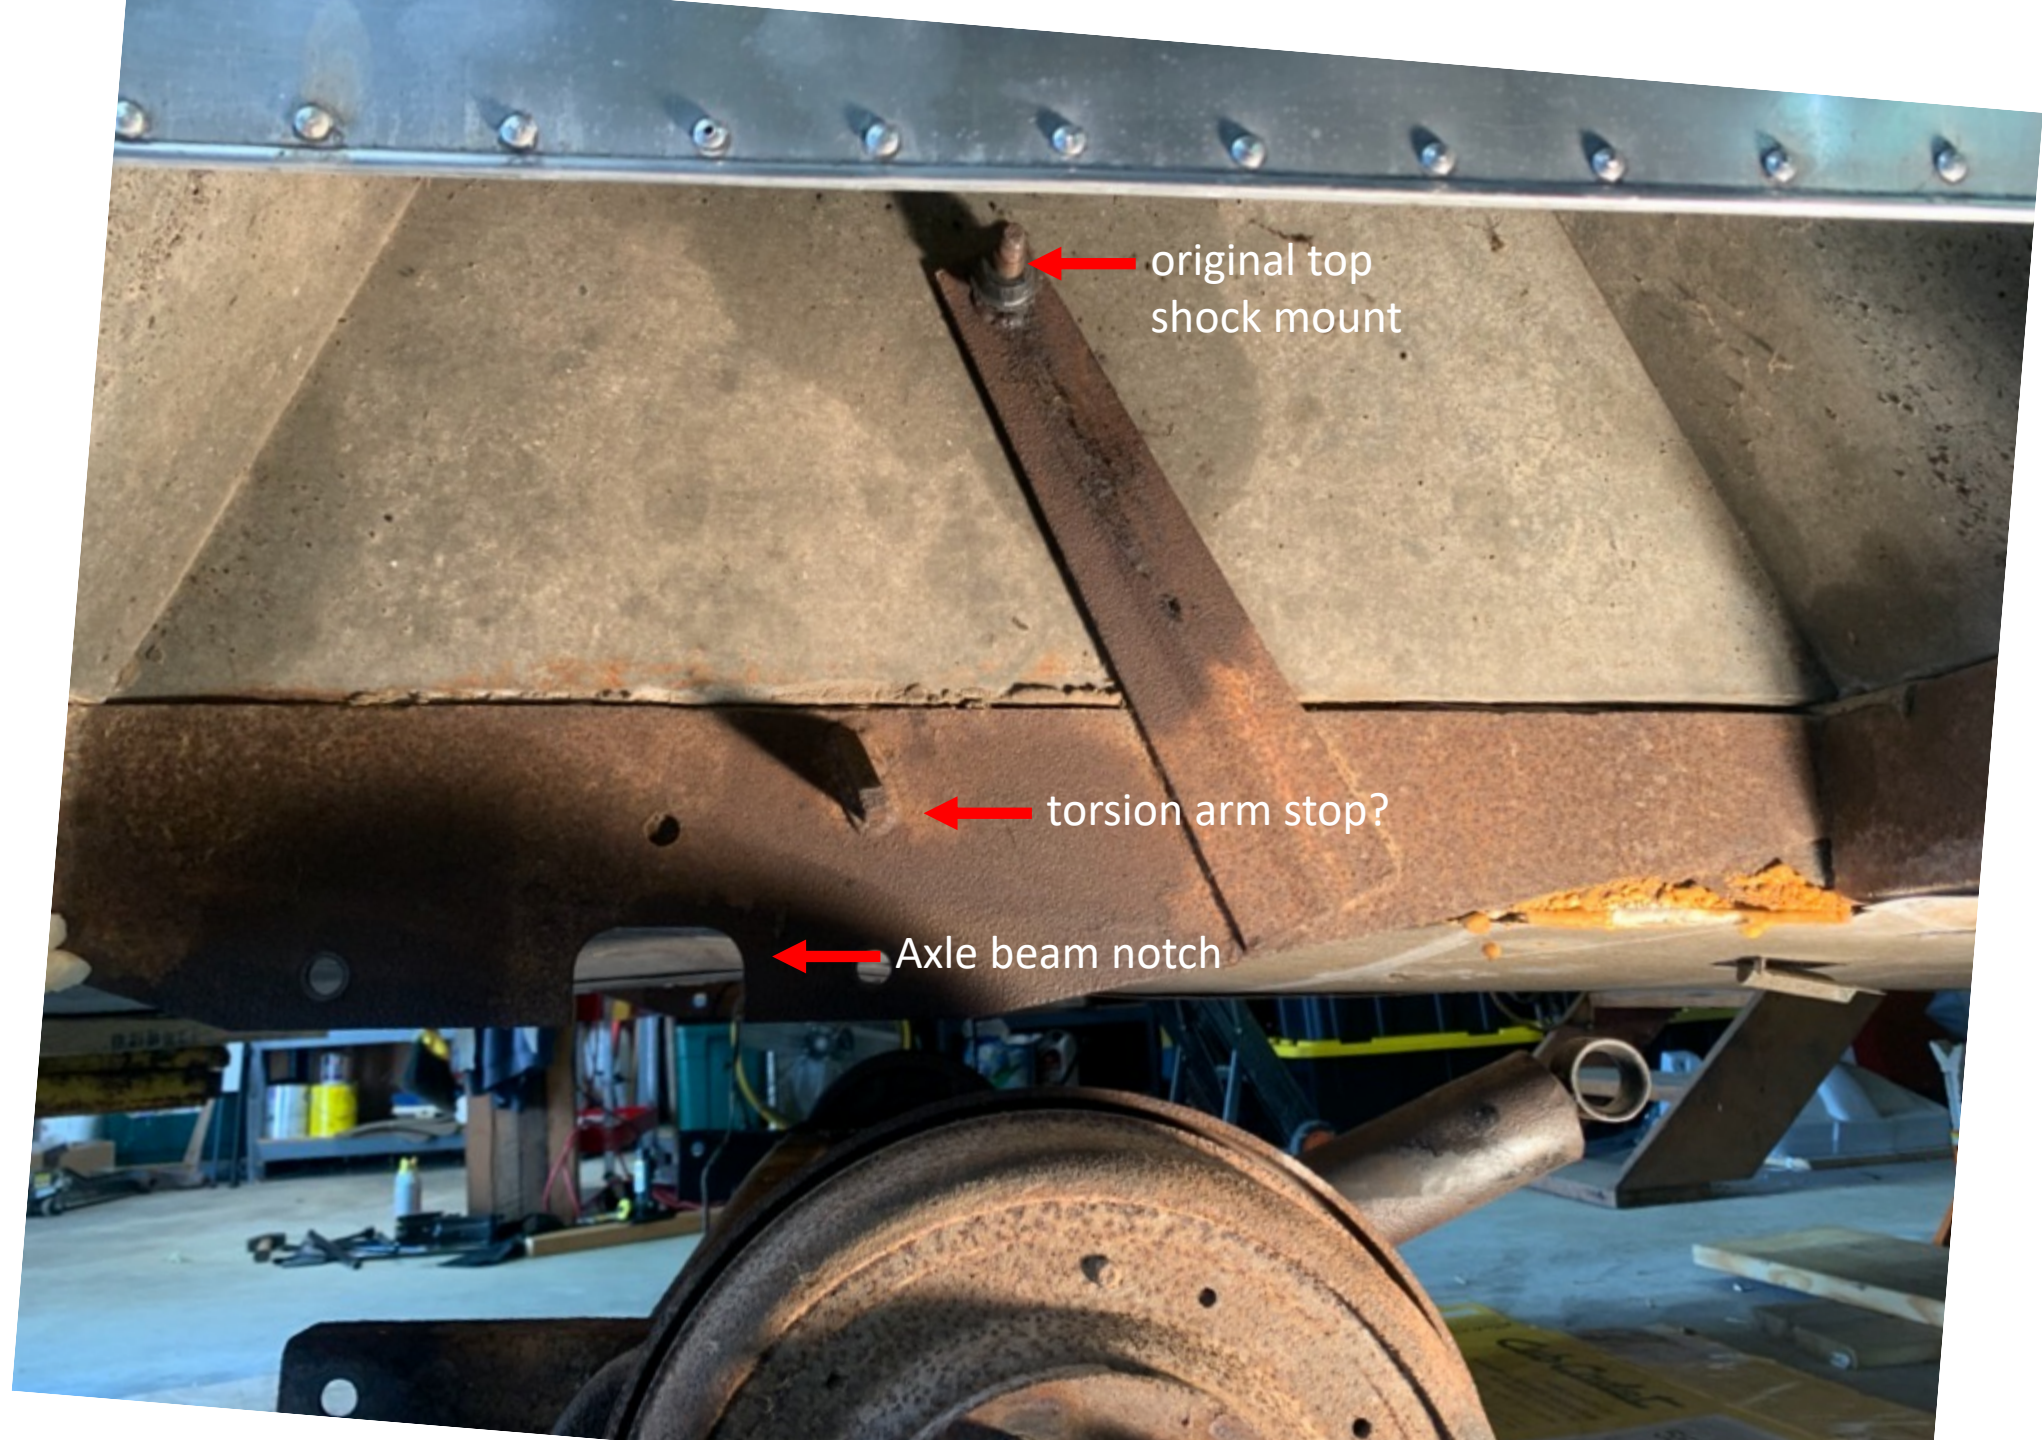
original top
shock mount

torsion arm stop?

Axle beam notch

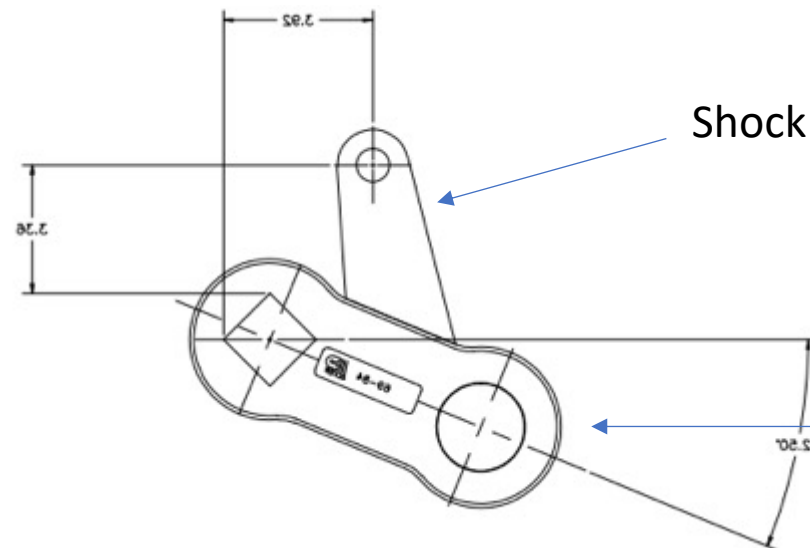
Shock Bracket

Torsion arm (front view)

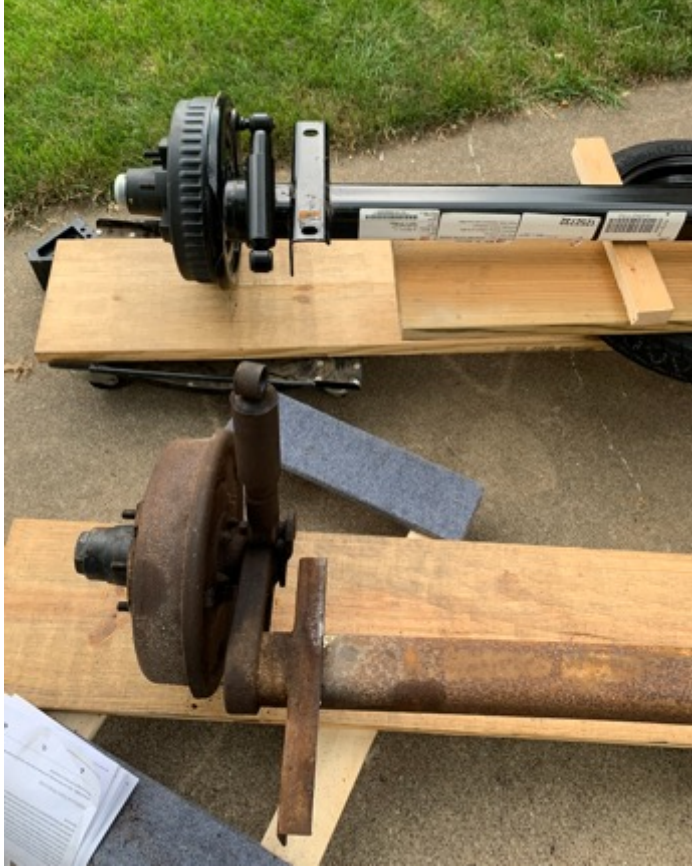
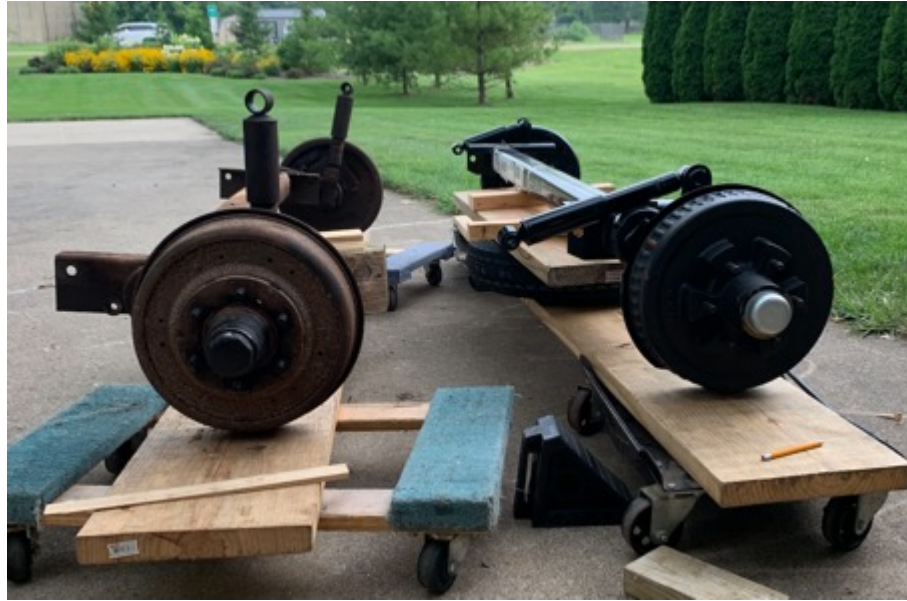
- Mounting positions of shock brackets (inside vs outside and center mounted vs. axle side mount)
- New shock mount position hits torsion arm stop on frame so new shocks cannot be installed without cutting it off and/or moving it

- New manufacturer and 1963 v 2021 tech
- length of torsion arm (6" old v. 7" new center to center)
- gap between wheel and axle is different axle length is different

- significant alterations needed to configure new axle like old and there are some key differences that cannot be modified however engineer says "take them both to a welder and tell him to make the new one look like the old one" I have concerns about the accuracy of these modifications and cost. We are not even 100% yet which modifications can be made without interfering with fit.

- Airstream shocks designed for laydown position it is unknown if they can be used in vertical position or if they must be replaced with vertical automotive shocks

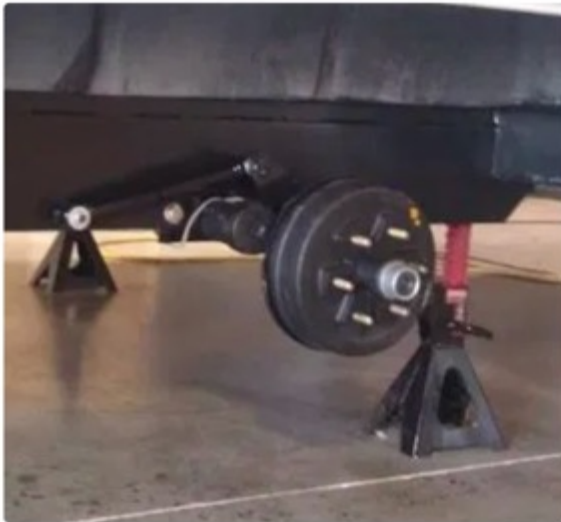
- *Trailers built before 1969* may also need to modify the shock mount on their trailer chassis. In 1969 Airstream changed from a vertical shock to a horizontal shock orientation (pictured below) more like 45 degrees. This allowed for a much smaller wheel well and in turn added more room to the interior of the Airstream. In order for new shocks to install correctly for older Airstream models, the vertical shock mount needs to be moved. The vertical shock mount is a 6-8 inch piece of metal on the chassis that is located above the axle mounting cutout up in the wheel well. This piece needs to be cut in half and welded to a more acceptable location as shown in the picture below.

IMPORTANT: Before relocating the shock mounts on older Airstreams, it is important to plan where they will be re-welded.

Measure from the center of the shock bracket stud on the axle to the center of the shock bracket stud on the chassis. The distance can be no more than 14.5" and no less than 9.5" between the two shock studs. Anything more or less will not accept the shocks. Ideal distance between 2 studs is 13-13.5" apart to allow for complete shock compression and rebound dampening.

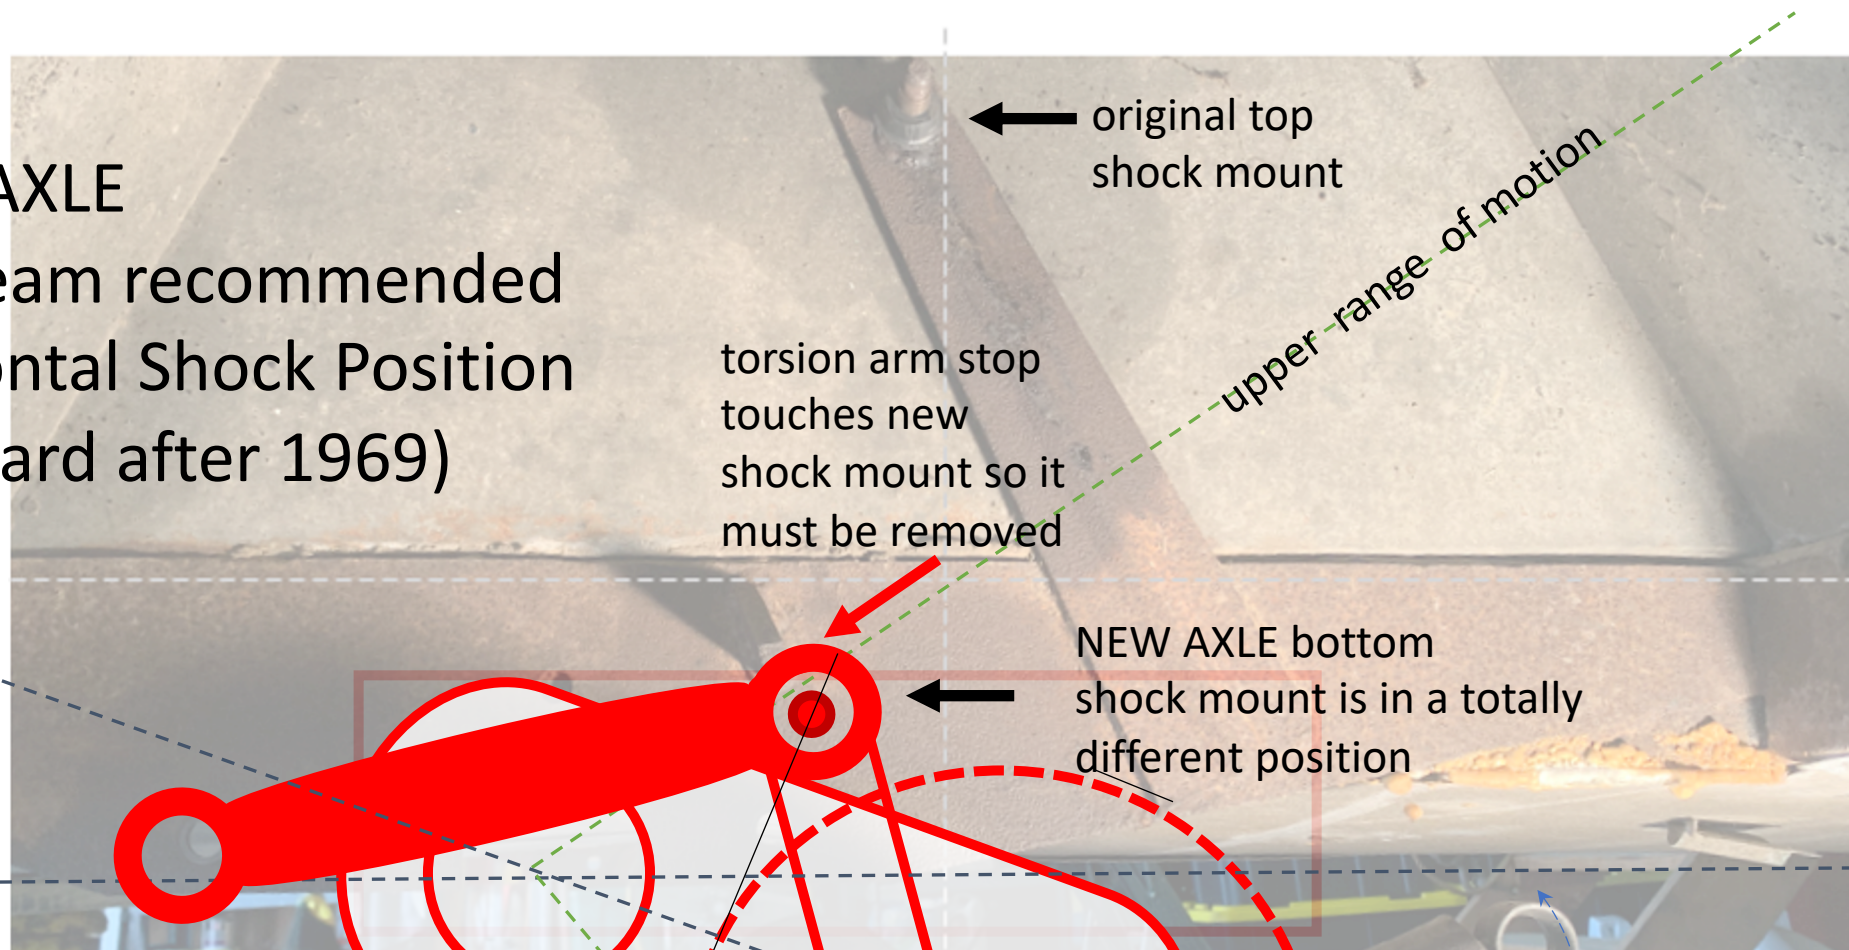
Airstream recommended
Horizontal Shock Position
(standard after 1969)

-22.5 degrees

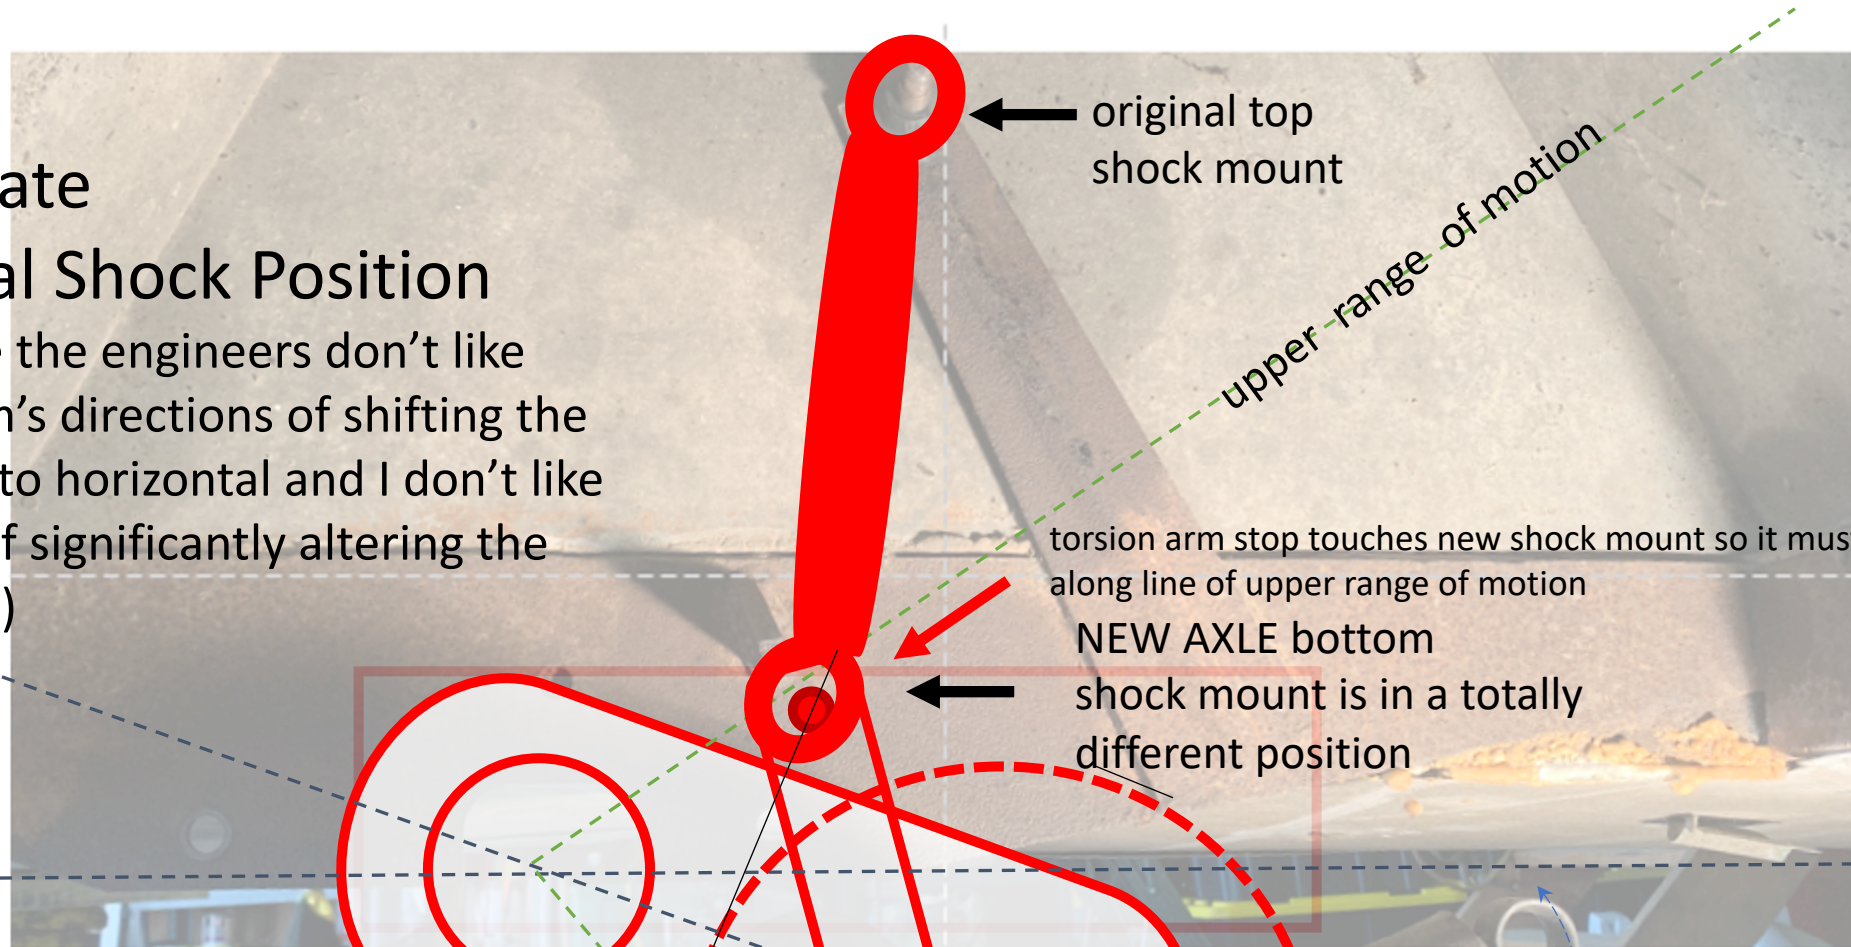
Vertical Shock Position

(because the engineers don't like airstream's directions of shifting the position to horizontal and I don't like the ide of significantly altering the new axle)

-22.5 degrees

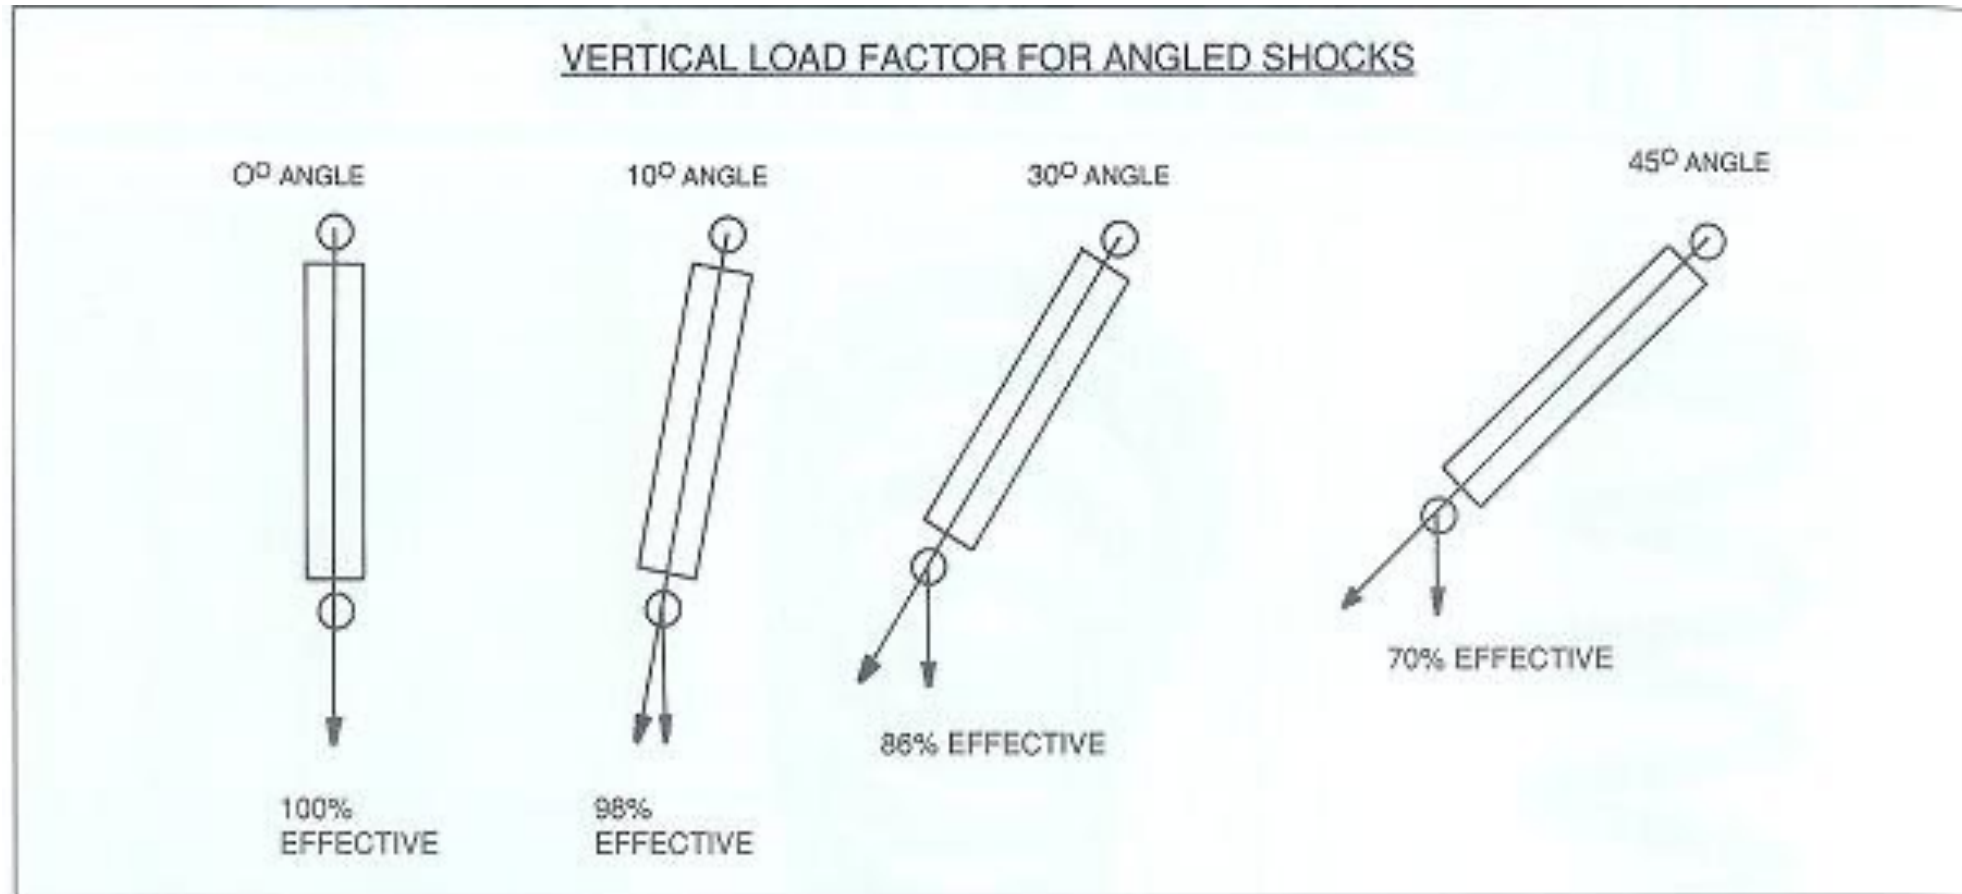
Figure 5-7. Shocks are most effective when they are mounted perpendicular to the direction of travel. Slight variations are permissible, but anything over 30 degrees will result in a loss of shock effectiveness.
