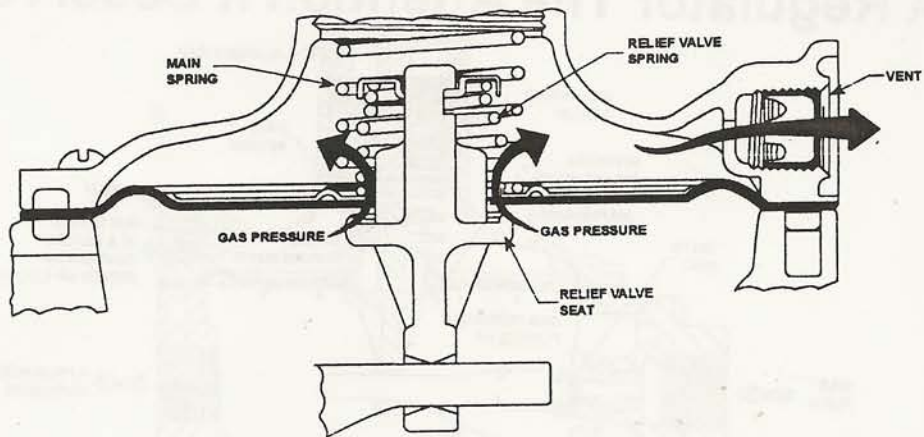
**Figure 2.** Internal relief valve being opened by excessive gas pressure.

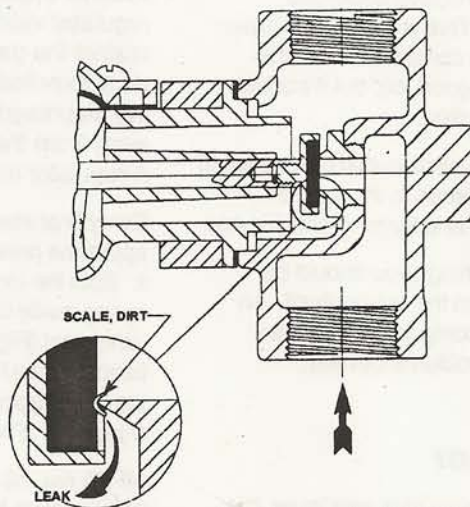
**Figure 5.** Gas leakage caused by chips preventing the disc from seating tightly enough against the orifice.
