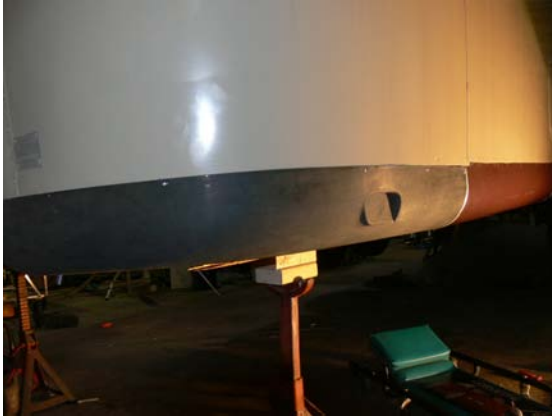
The new plastic banana wraps had to be fitted to length and ends were tapered in thickness, in order to insert them into the joining trim molding which has 0.080" slot.

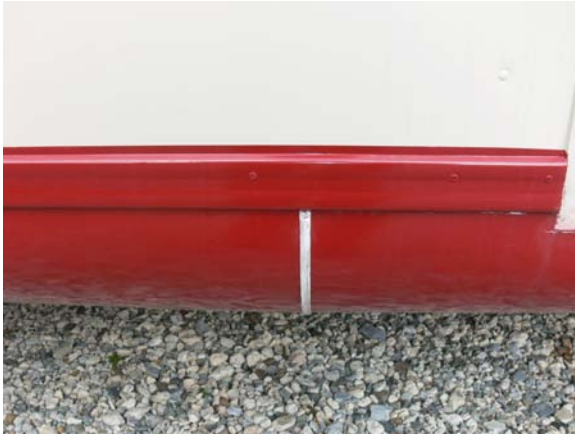
Front aluminum panel of the belly wrap was inserted over the top edge of the banana wrap to prevent the water from the road from being forced into the belly pan during towing.

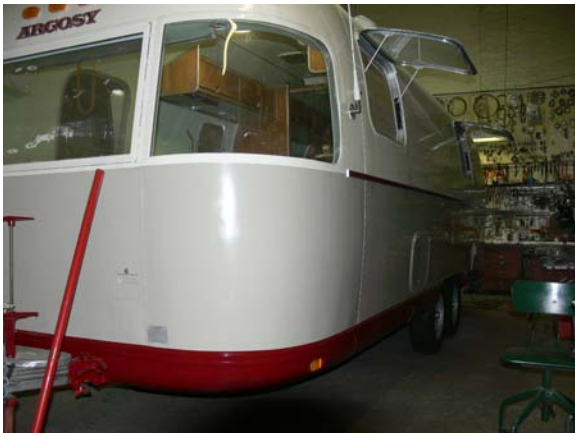
The belly pan wrap joint is only 1/2" wide on the outside.
