First step, take out the old
Bowen.

Reroute gas line to back of RV-500. Plastic hose over copper line for protection

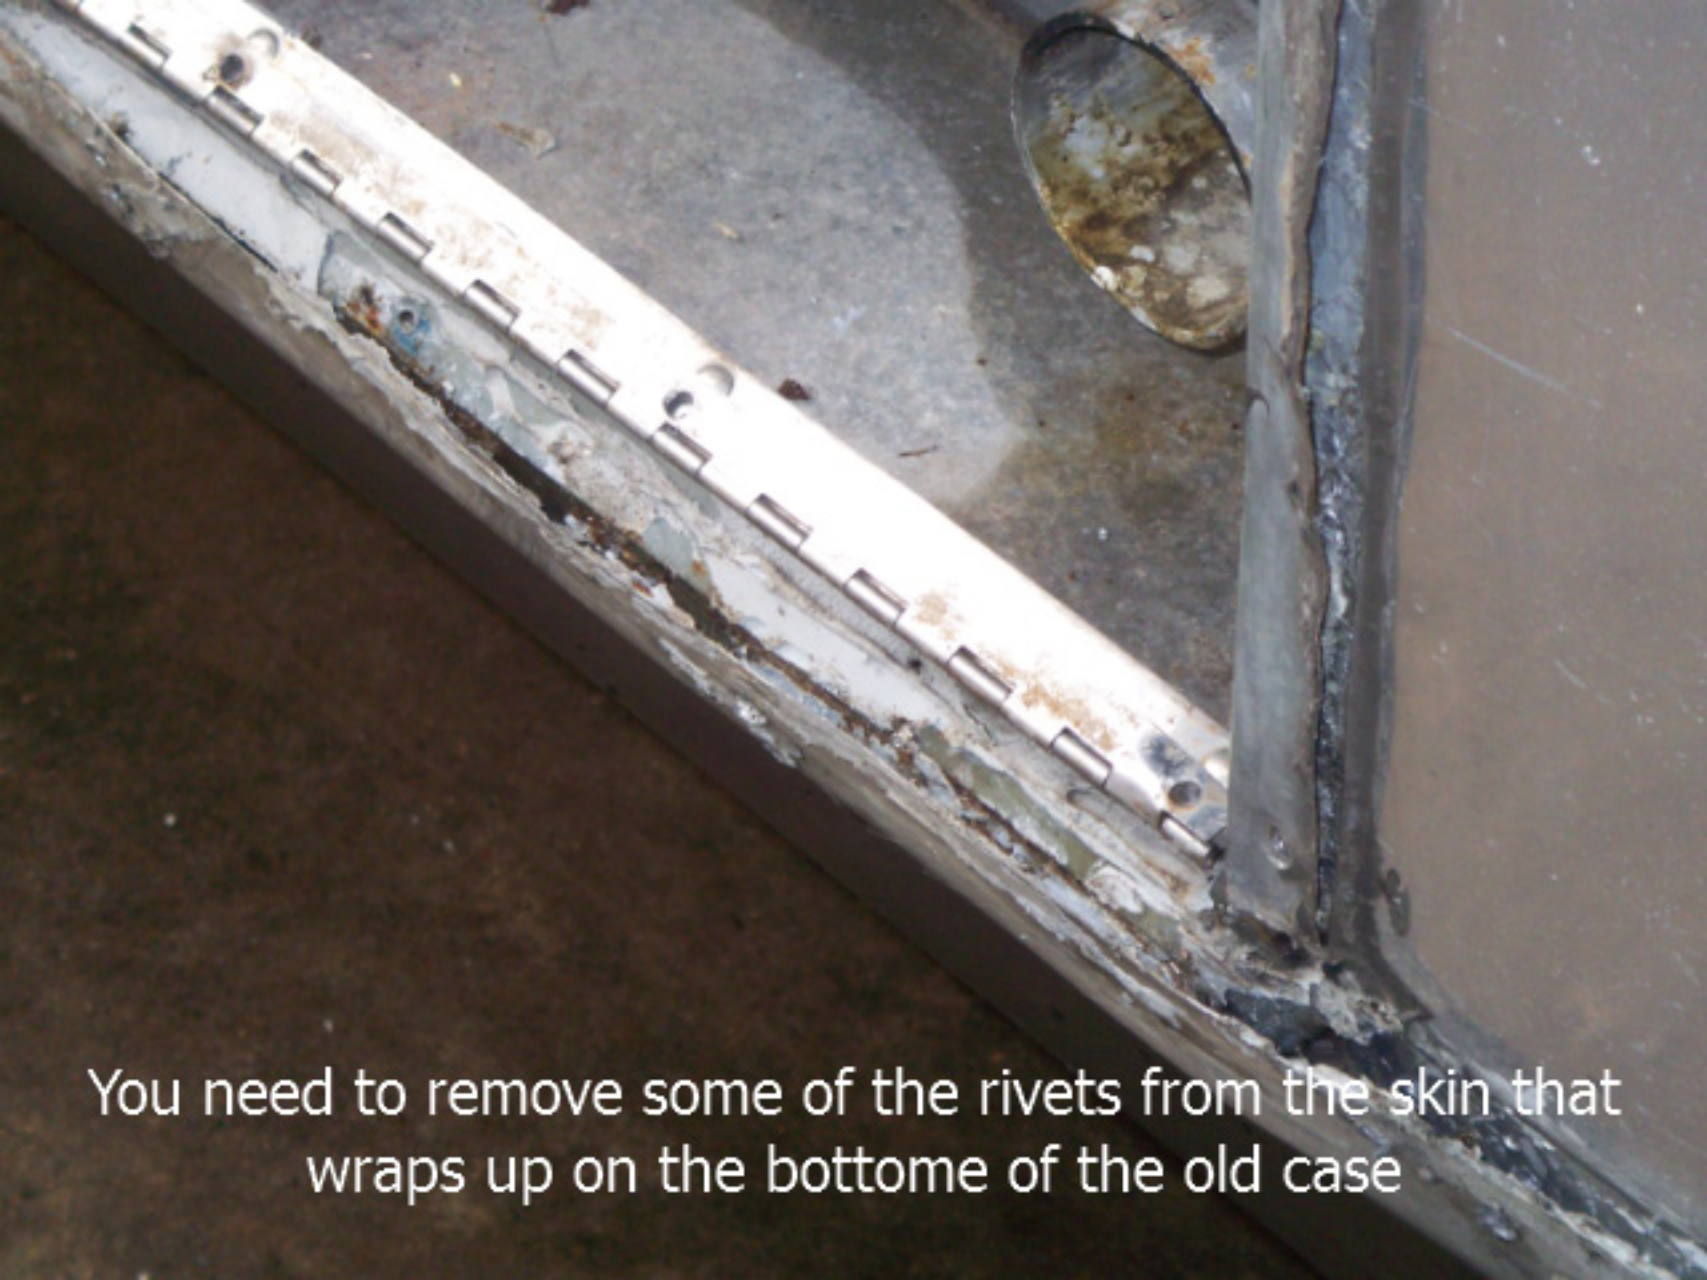
They must have built the trailer around the water heater

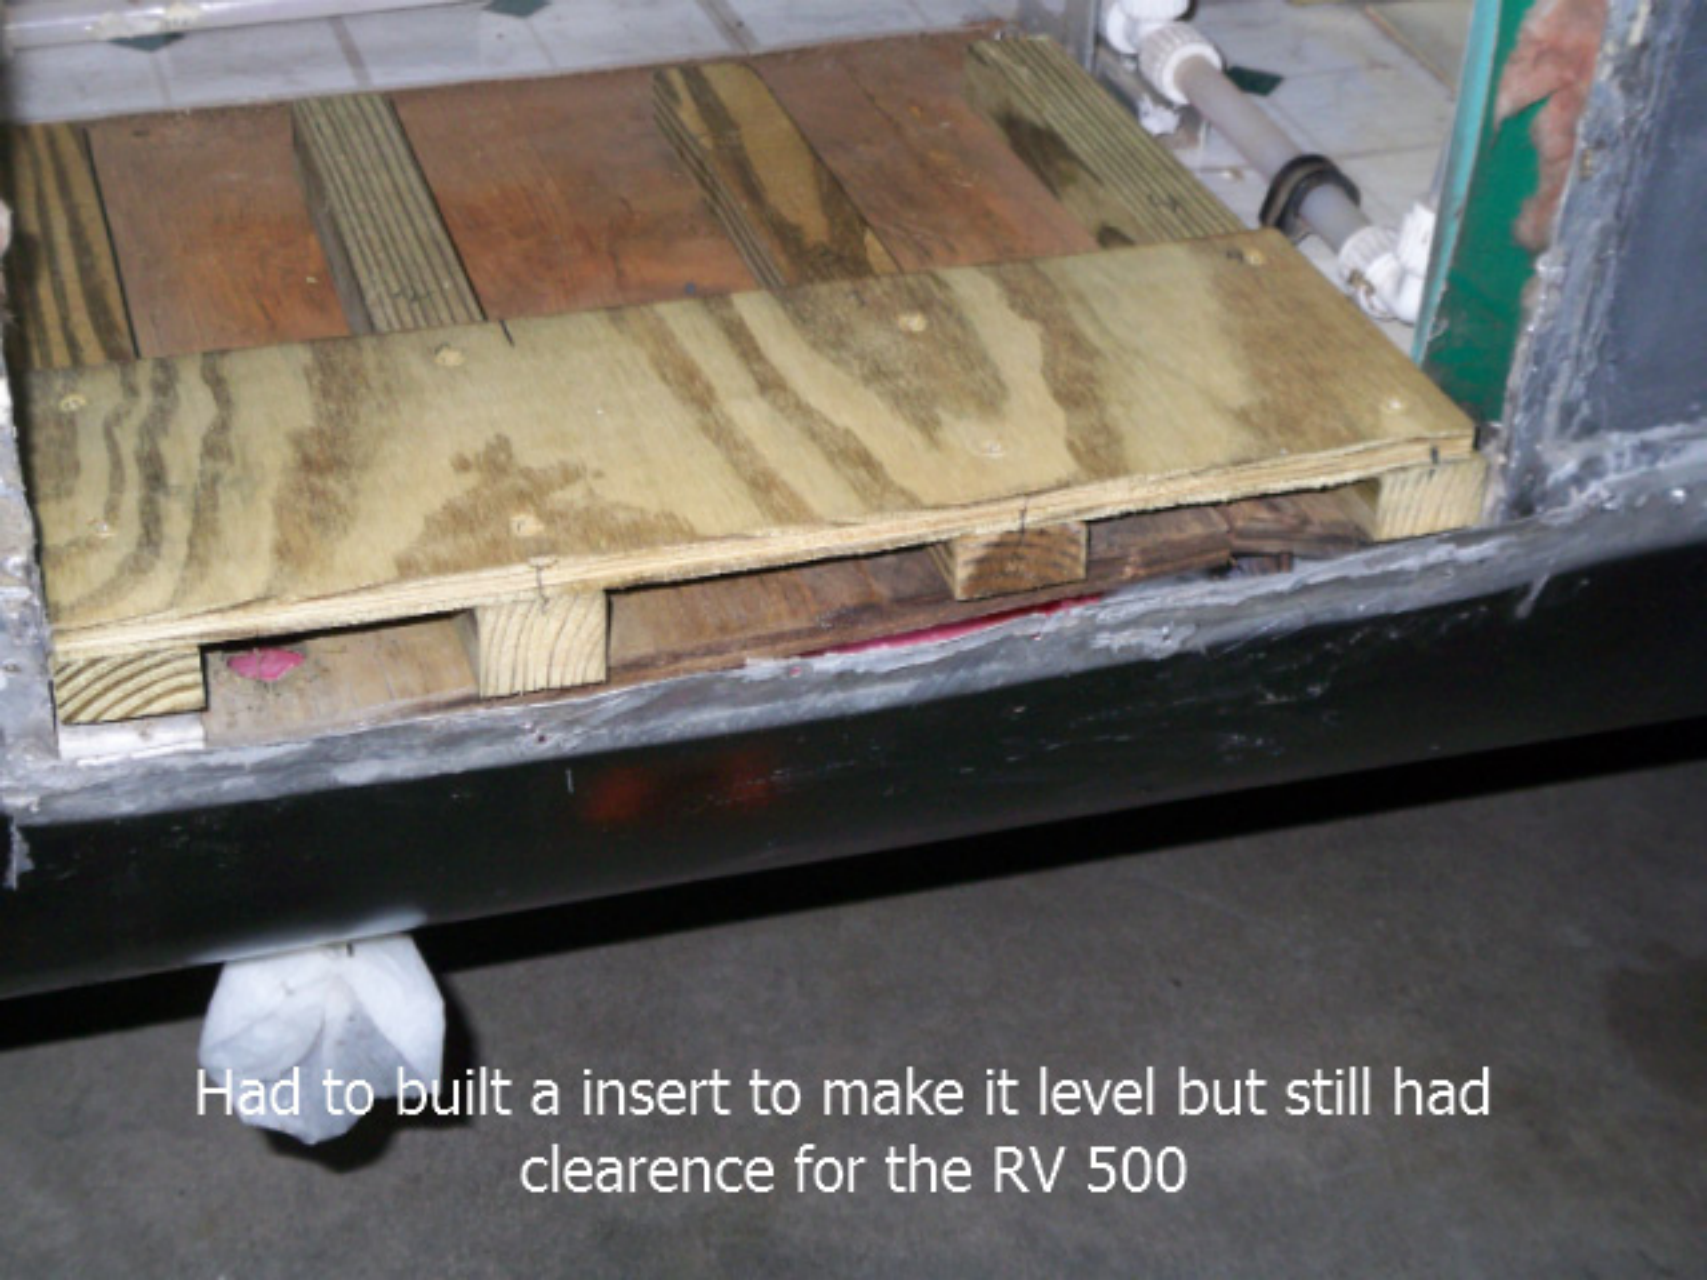
The floor is pushed up by outrigger. Looks like it has been that way for some time

Had to built a insert to make it level but still had
clearence for the RV 500

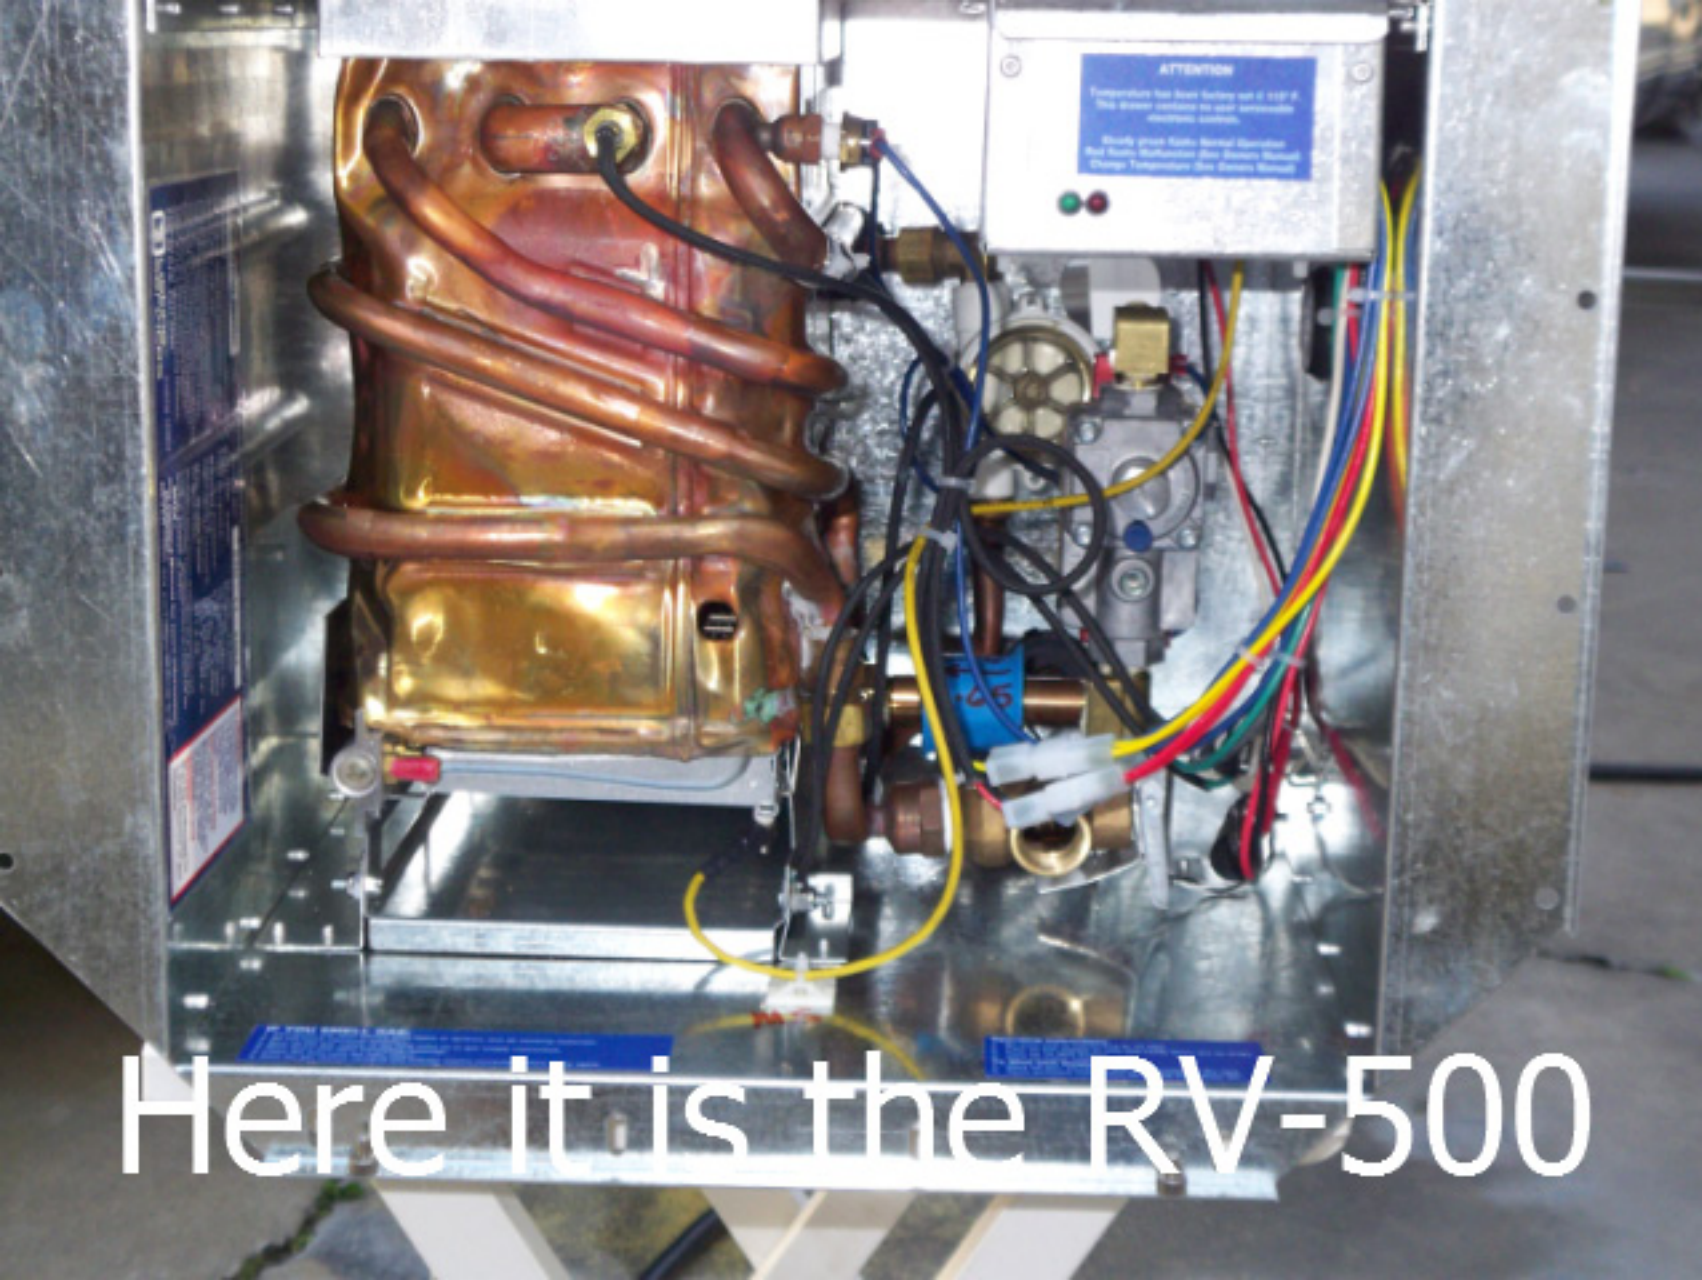
New gas line and
valve

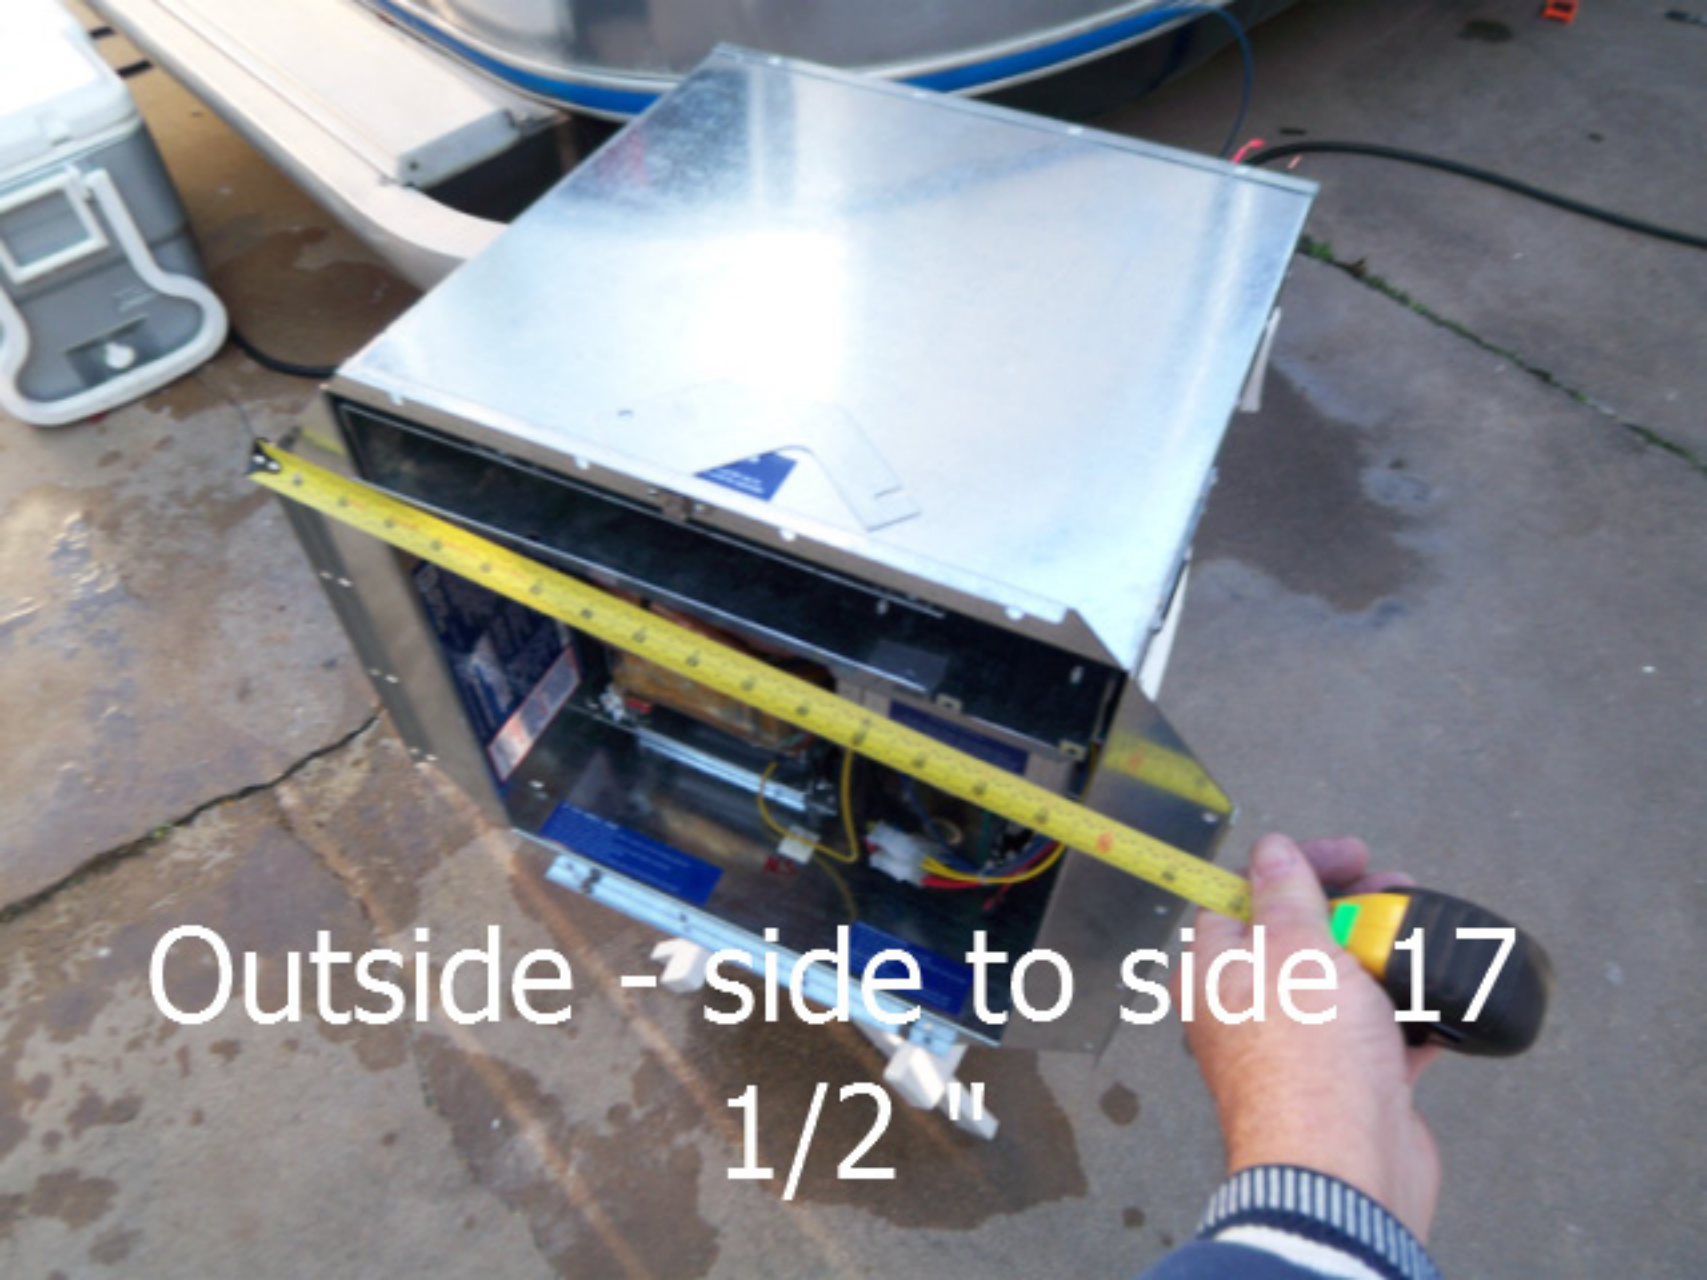
Top to bottom 16
1/2"

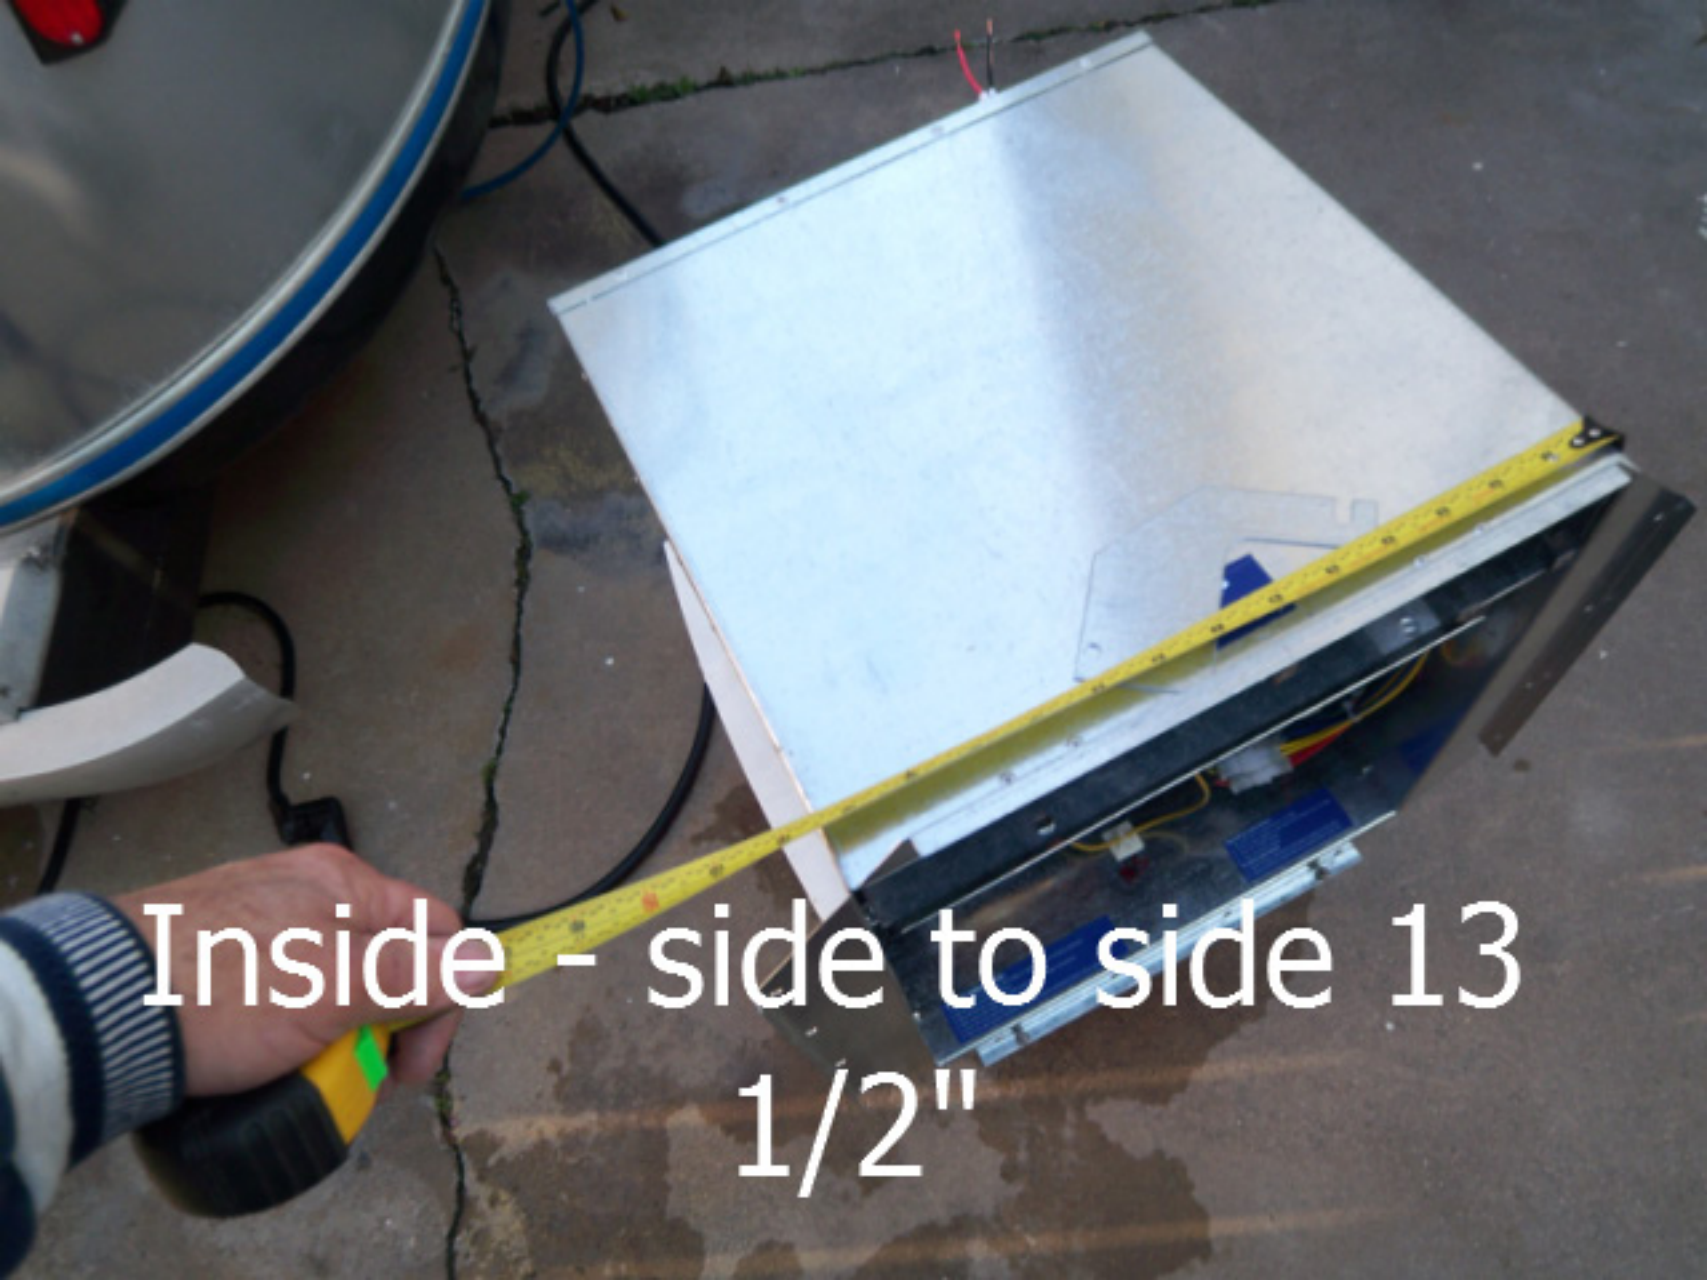
Outside - side to side 17
1/2"

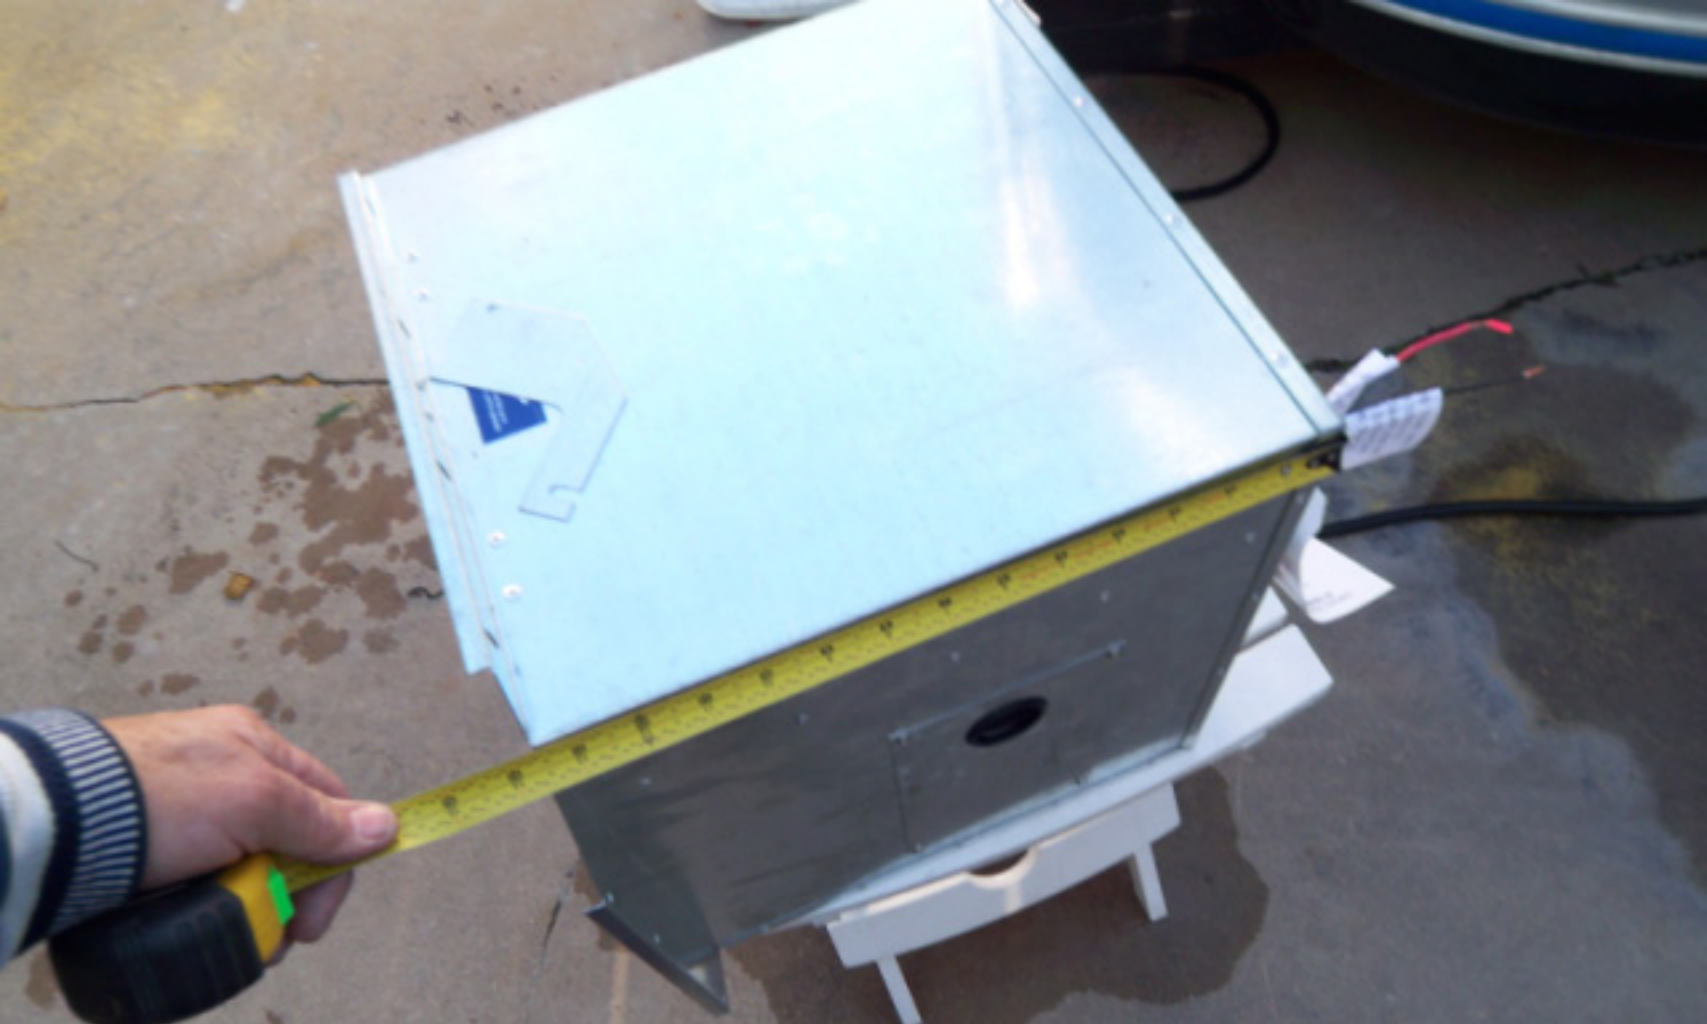
Inside - side to side 13
1/2"

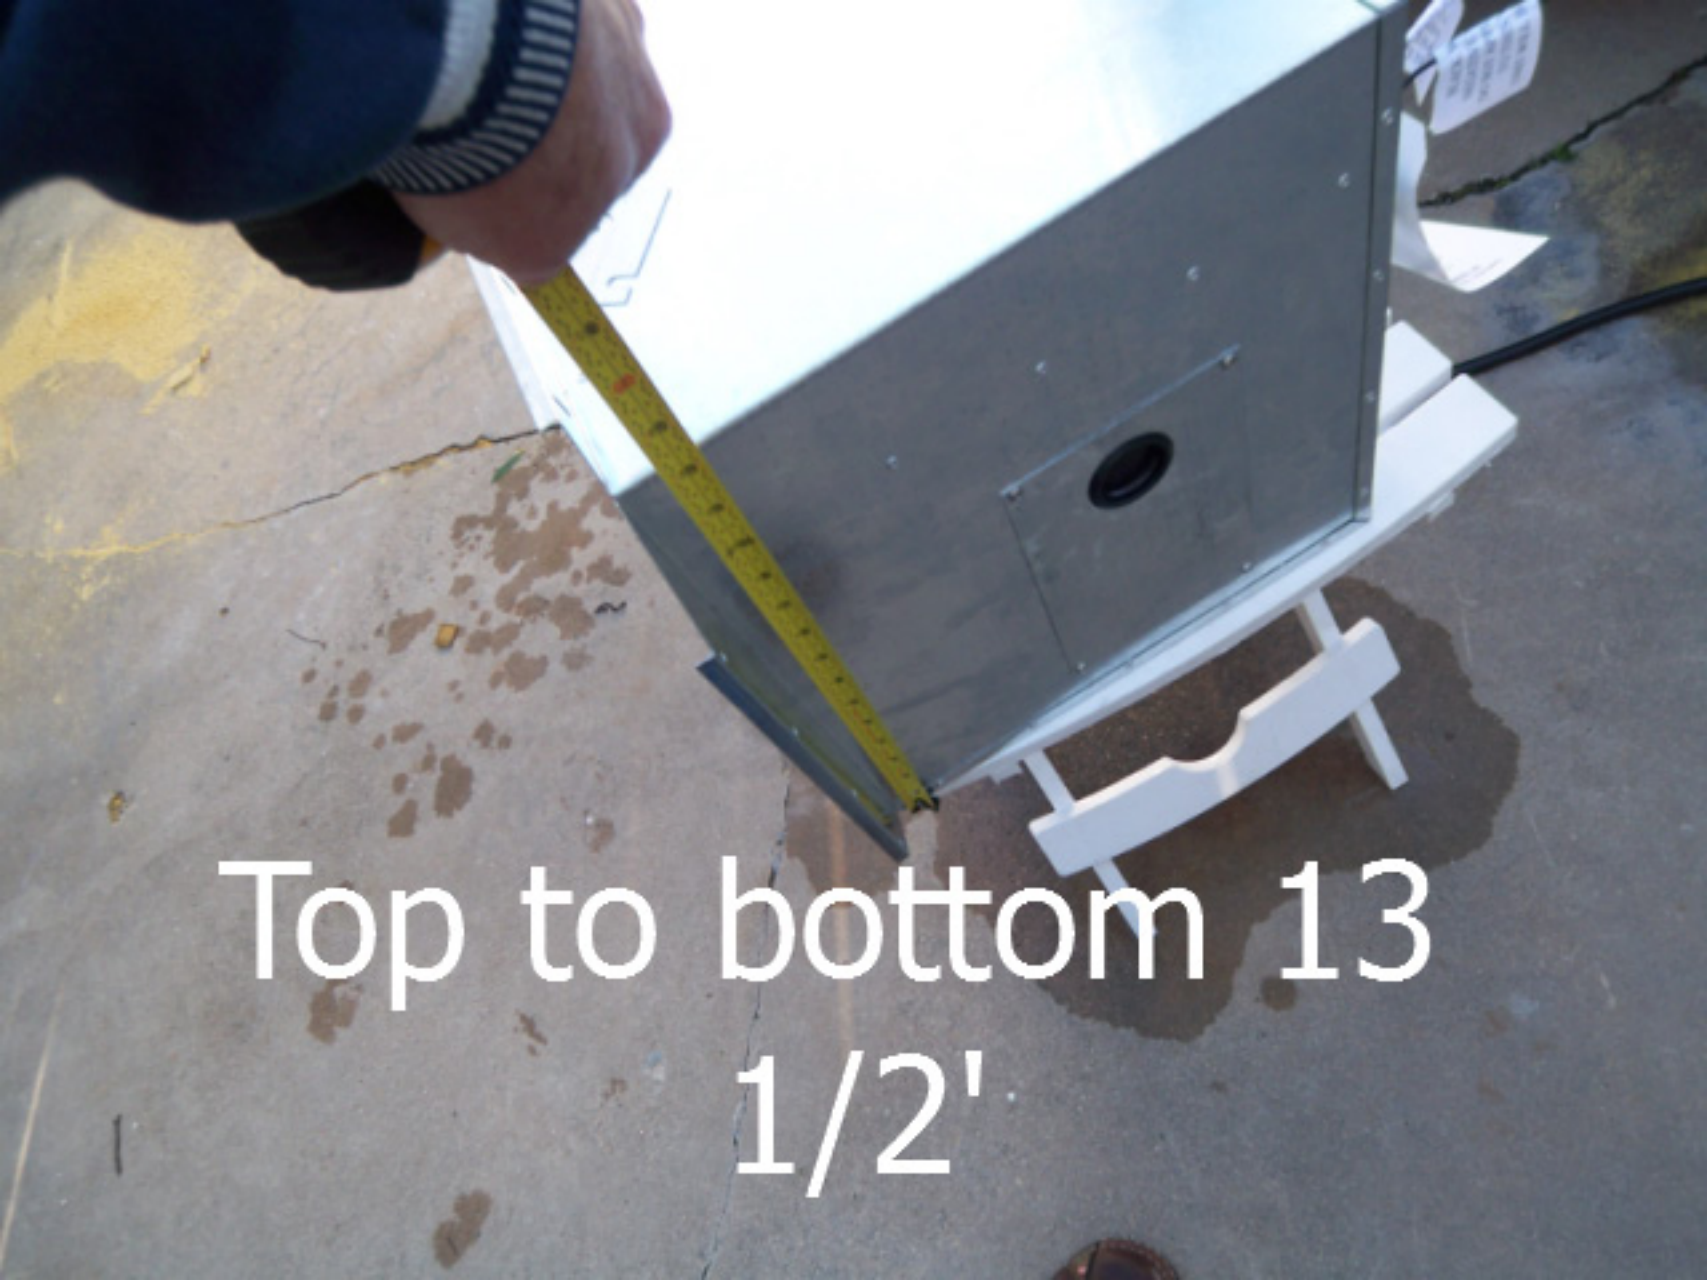
Front to Back 13 1/2'

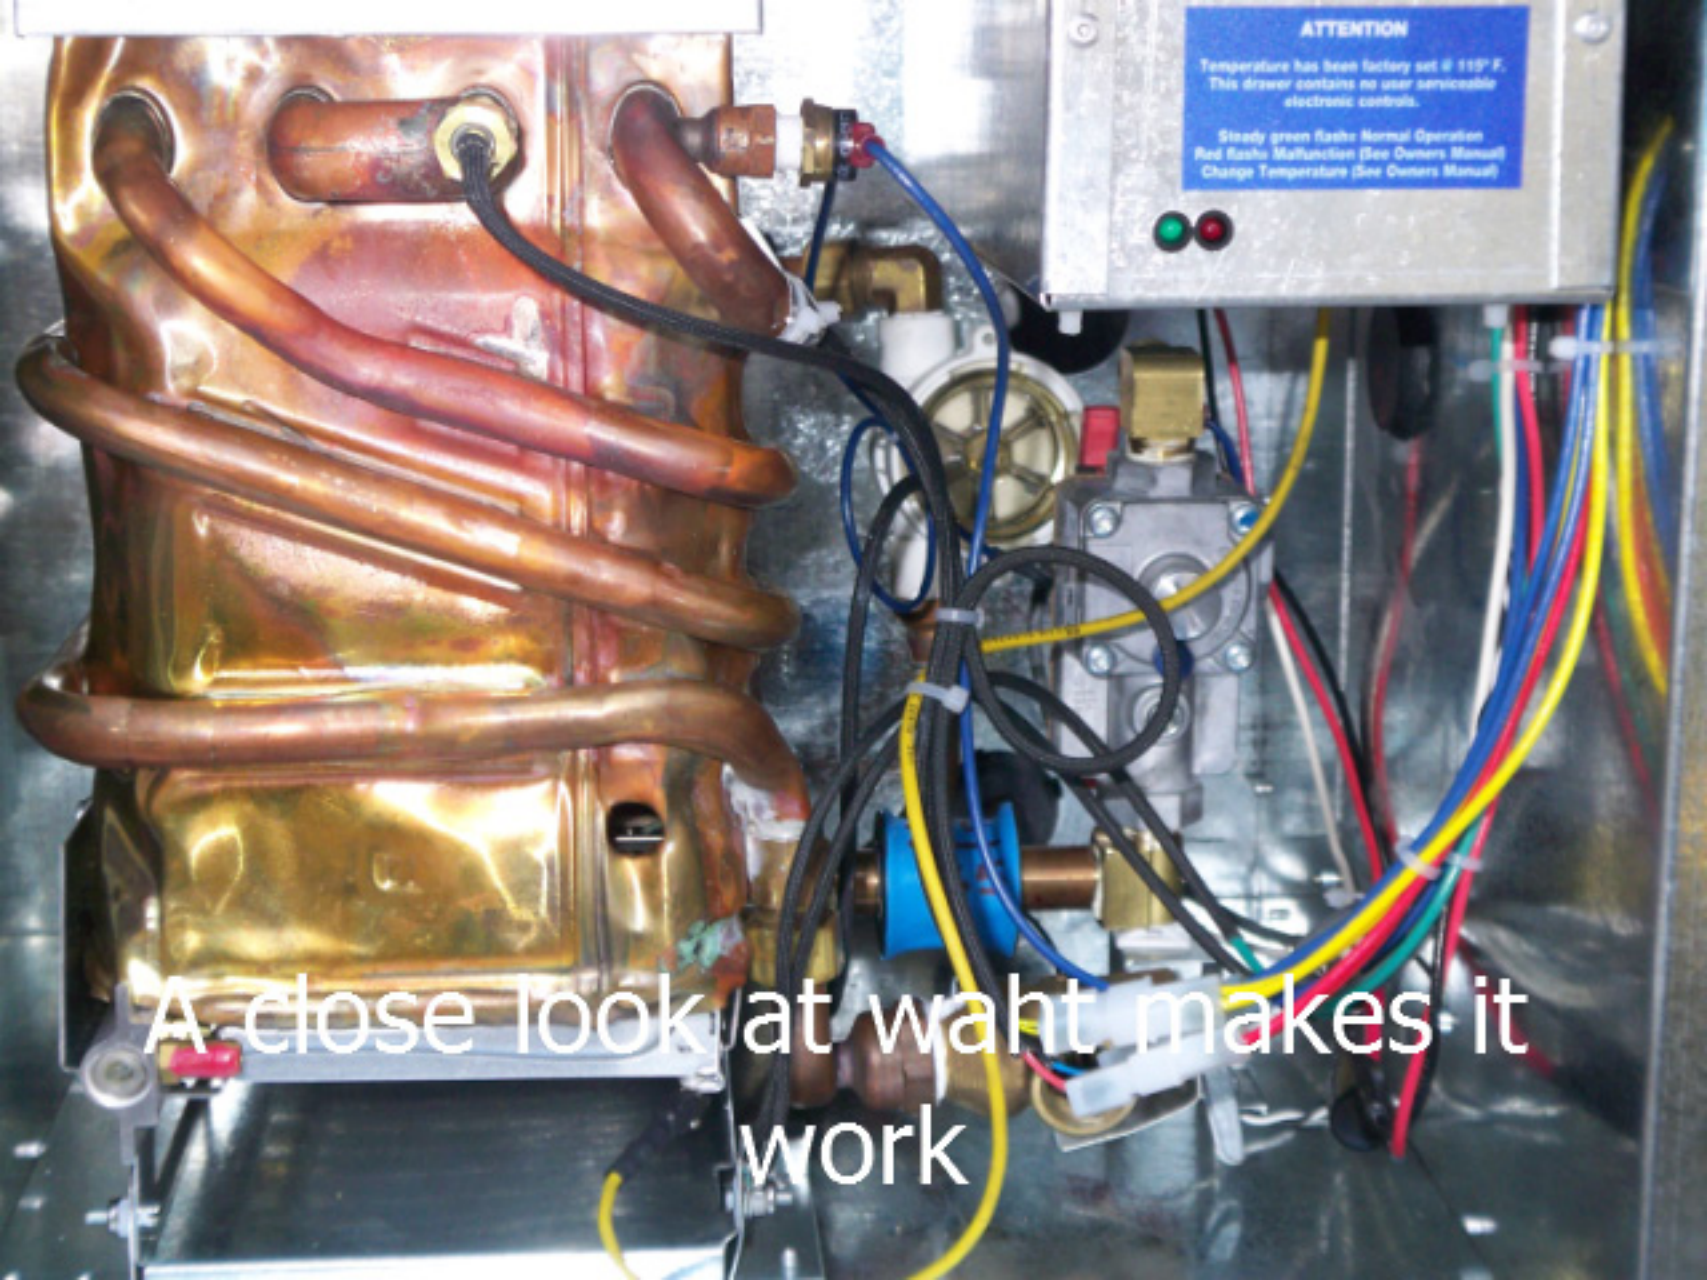
Back view Gas - clod water in - Hot water
out

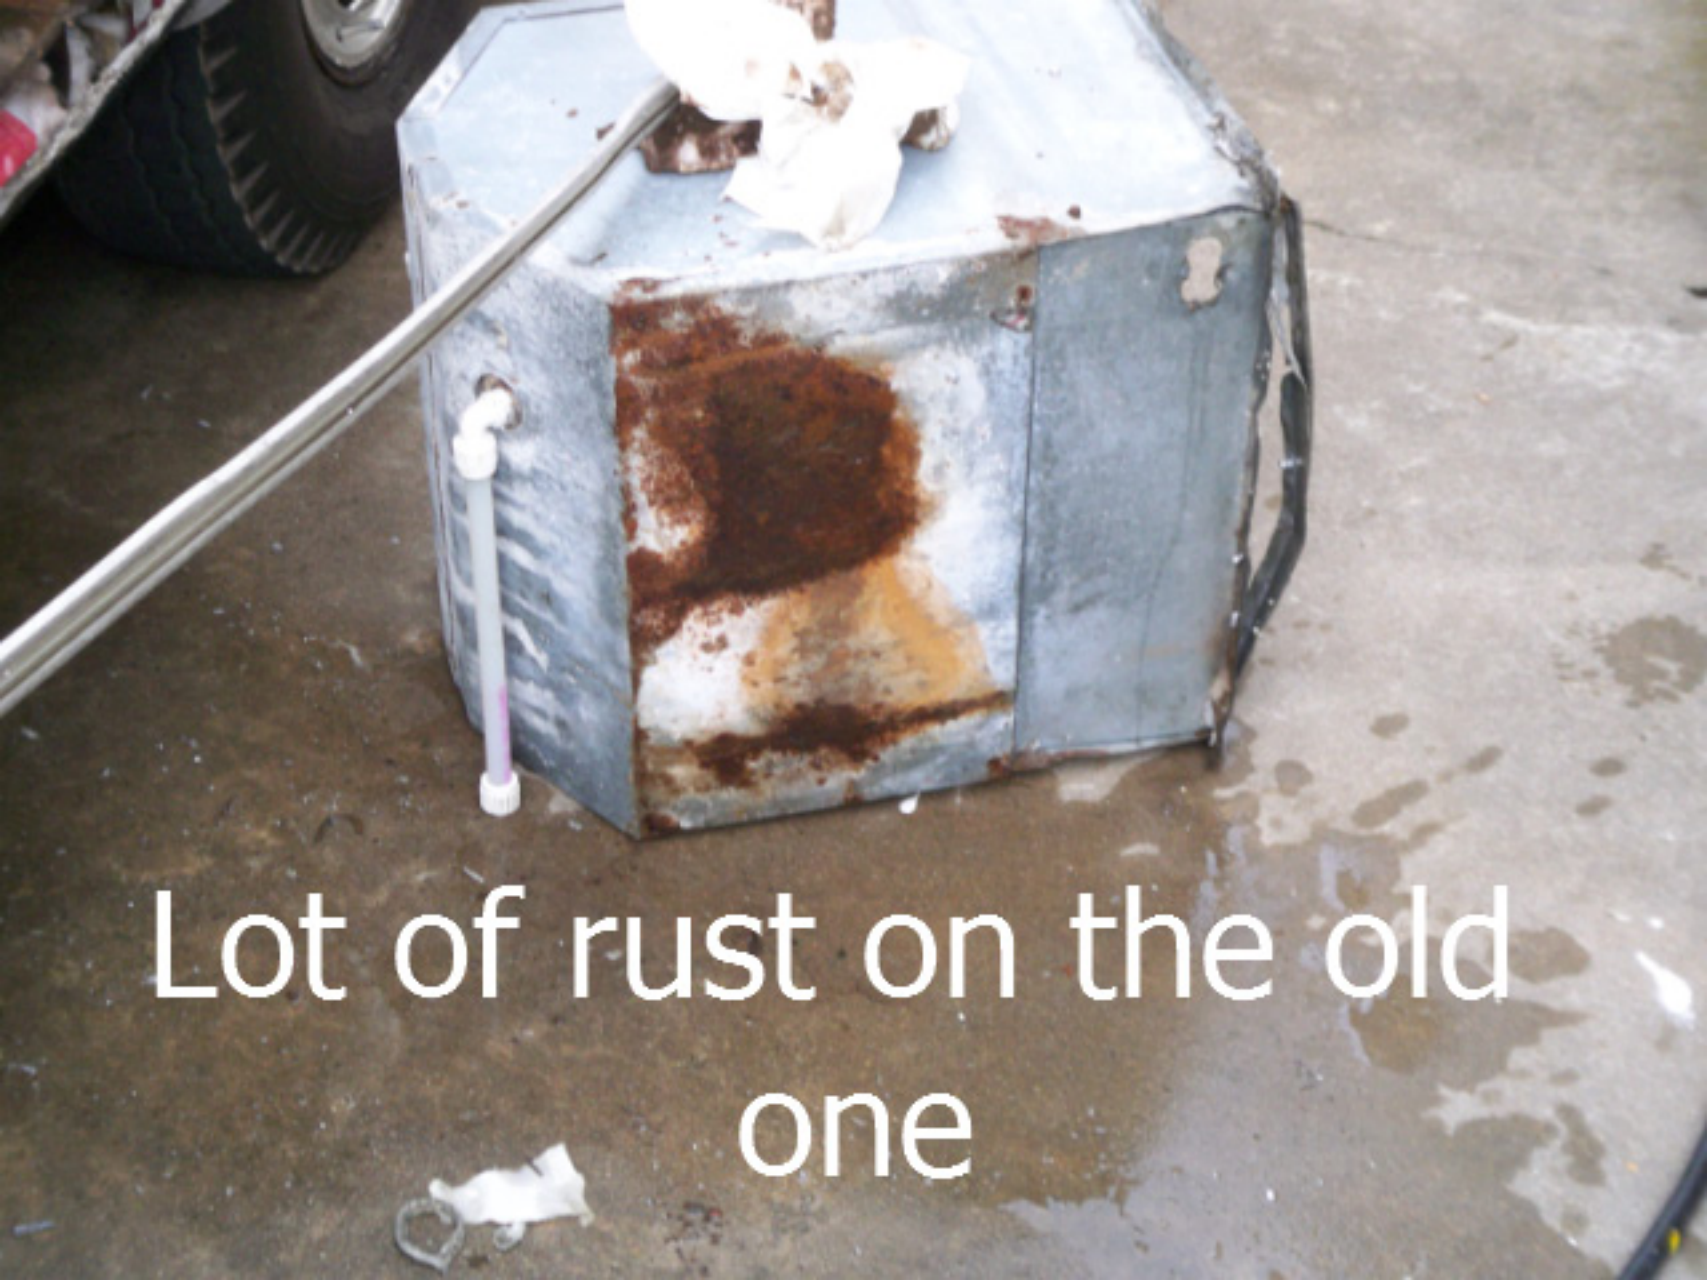
A close look at waht makes it work

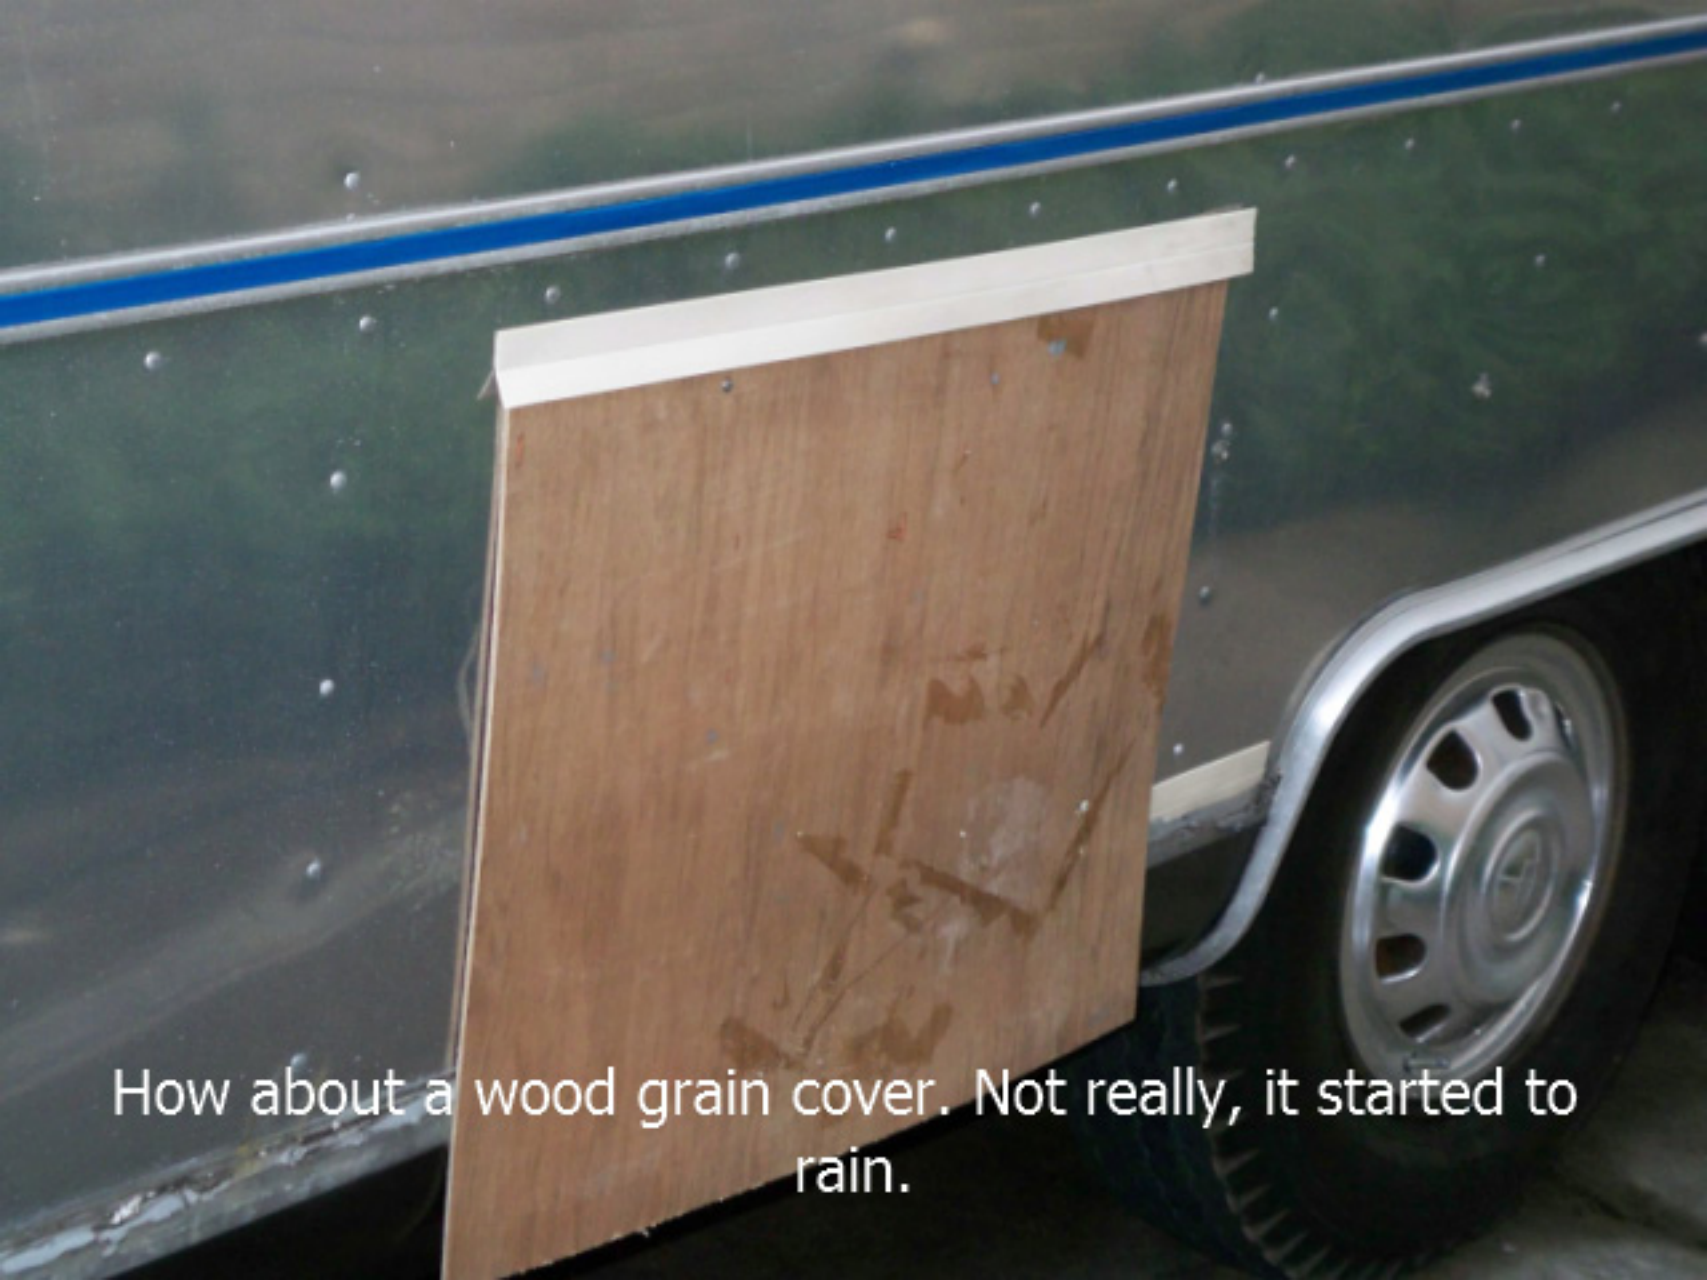
Lot of rust on the old
one

Anyone need a boat
anchor
