First step, take out the old
Bowen.

Reroute gas line to back of RV-500. Plastic hose over copper line for protection

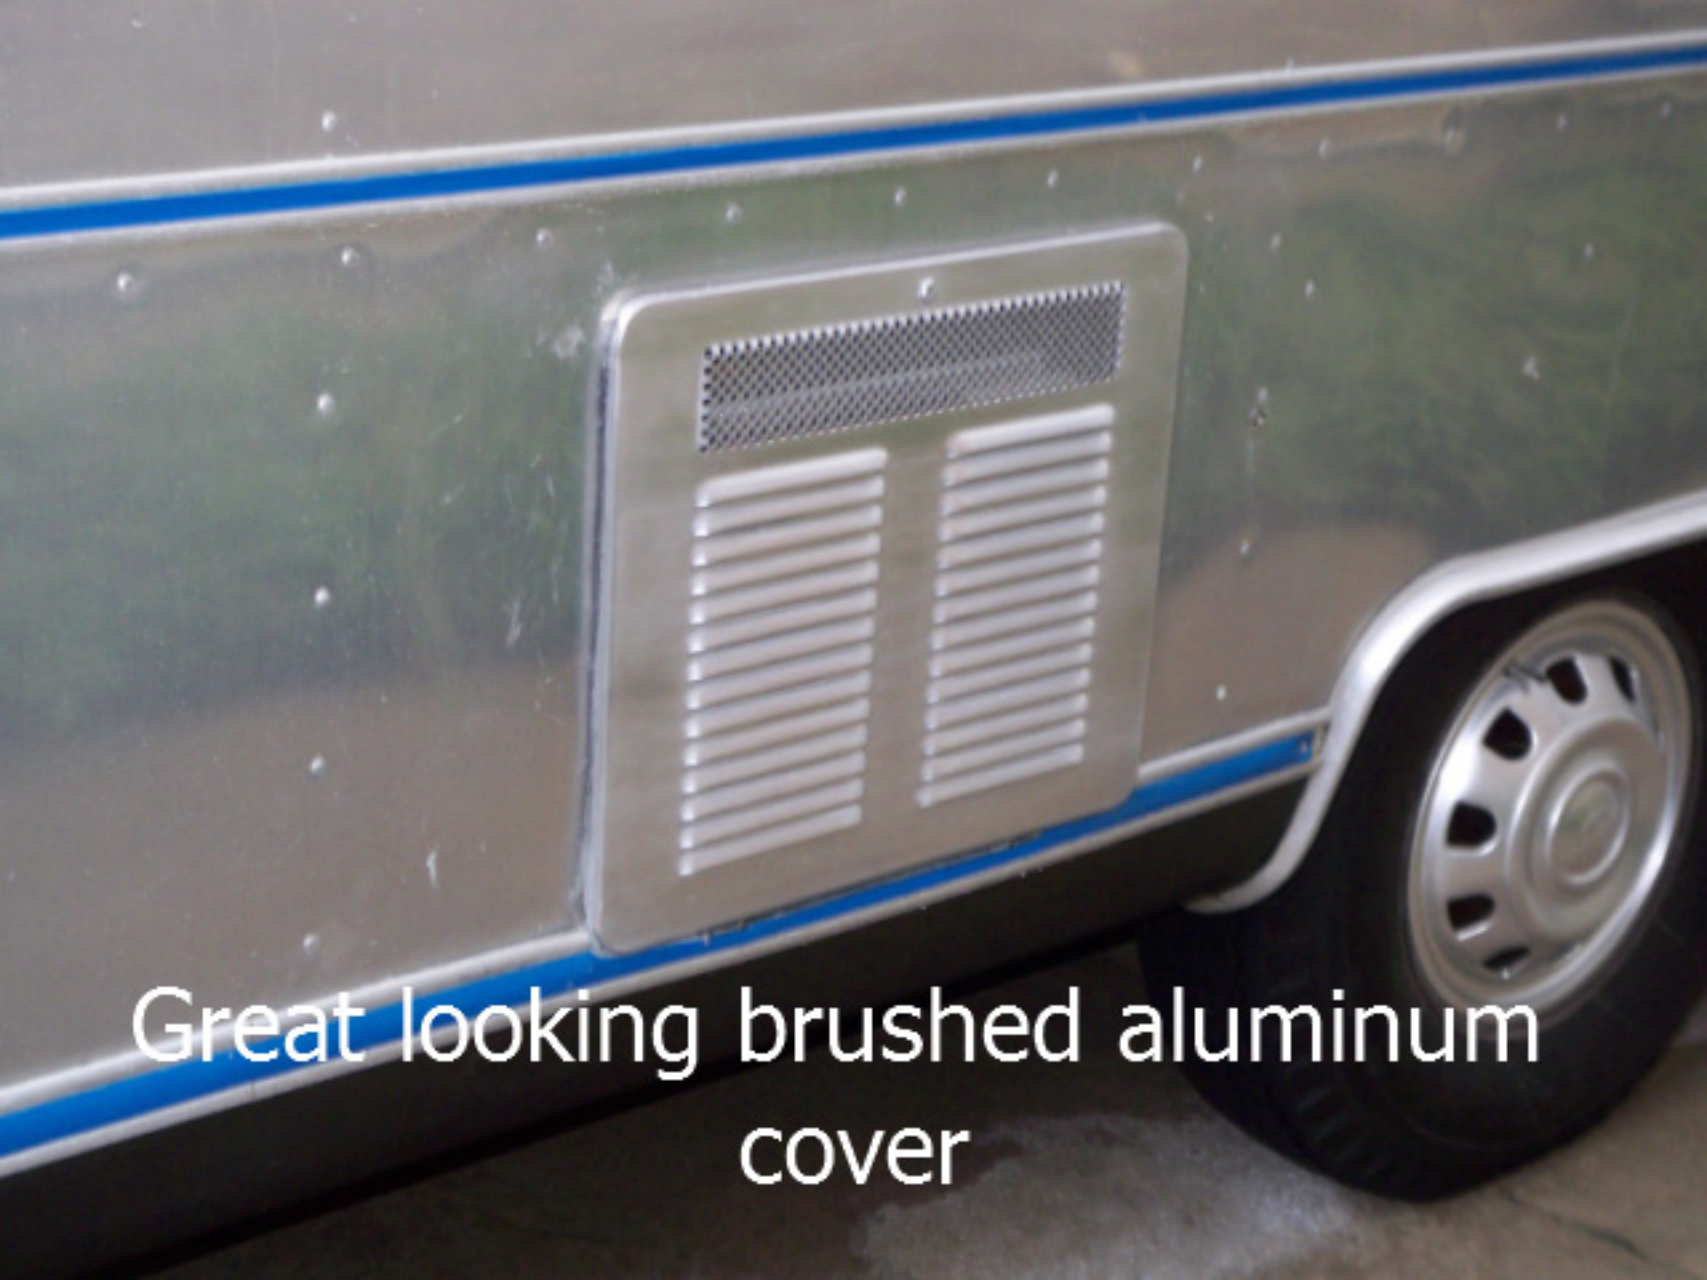
Installed and sealed. Note the modifications on the trim molding
