Gear Vendor Field Installation

April 3-15, 2007

Gear Vendor is basically an overdrive unit. One difference is, you can engage it while in any of the three regular gears, so it makes your rig a "6-speed." Installation by Camping World or a shop would cost about \$700.00, and I felt it was straightforward enough to tackle myself.

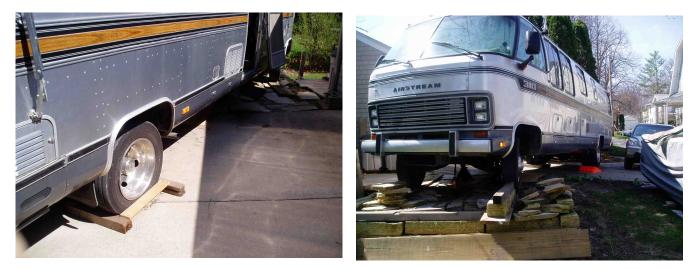
Step one was to block the curb side rear wheel and put the front end up on stands. Note the well lighted and spacious shop space, marred only by a lack of shade, since my tree has not leafed out yet.

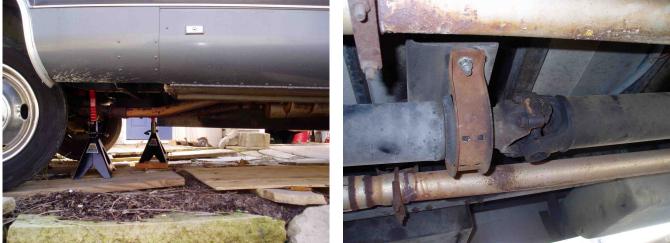
The hydraulic jack was adequate to bring the coach's front wheels off the ground so it could be supported by the two 12,000 pound stands (below left).

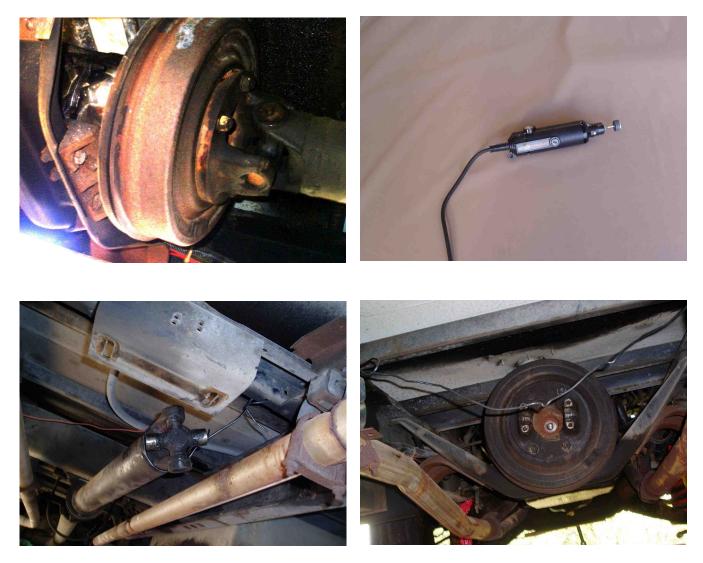
The next photo shows the carrier bearing between the first and second drive shafts. I partially dropped the carrier bracket and tied wire to the second shaft to keep it from dropping down.

A Dremel tool (pictured) was used to score marks on the components. This would be so that they could be oriented the same way on replacement. It turned out the drive line shop assumed each component would have been individually balanced. They didn't think it would be necessary to balance the drum and shaft together after shortening the shaft. So the marks really weren't of any use.

I removed the U bolts from the second drive shaft yolk (right side of the carrier bearing in the photo) and from the front combo brake drum/yolk at the transmission end.

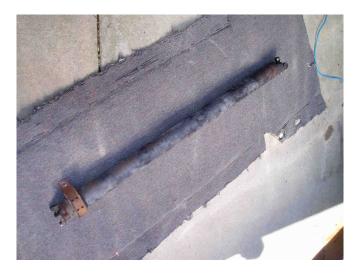
Above, left is the second drive shaft with the first drive shaft and carrier bearing assembly removed. At right is the parking brake drum with center bolt removed. It was, fortunately, fairly easy to pull the drum off the splined transmission shaft by prying carefully on two sides with a pair of large screw drivers.

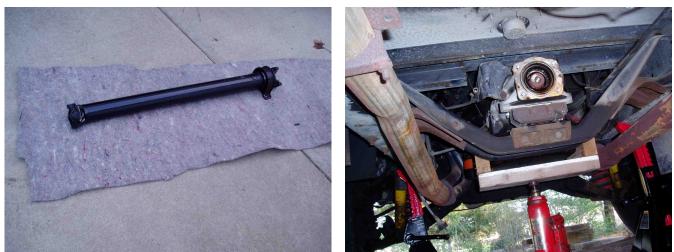
Above, the drive shaft is out on the ground, and the brake drum DOES FIT the Gear Vendor tail shaft. And the shortened shaft is back, prettier than new. Below right, I've removed the backing plate and

cable and the speedometer cable and the bolts holding the rubber transmission mount. The Talcott Automatic Transmission Jack is deployed. I then removed the tail assembly (six bolts), and the rubber transmission mount (two bolts).

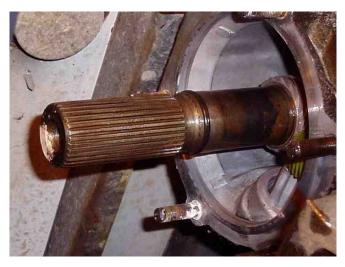
Now some bad news. the splined coupler of the GV input shaft does not want to slide on to the transmission tail shaft.

There was rust in the brake drum splines and the center bolt was maybe a little too easy to remove. And maybe it was a little too easy to pull the drum off the splined shaft, also. This tail shaft is kind of beat up. I could drive the coupler on, maybe it would go all the way on, maybe not.... I put in a call for help and sent GV a photo of the tail shaft...

GV is sending a new coupler and I am burnishing the shaft where the splines are mushroomed and distorted, mainly out towards the end. Here's the "before" picture....

I used a flat file and a rat tail file and emory paper to burnish the grooves and lands. In the process I nicked the coupler, so I sure am glad they are sending a new one. The 'rusty' color in the photo is actually reflection from the drop light, not rust.

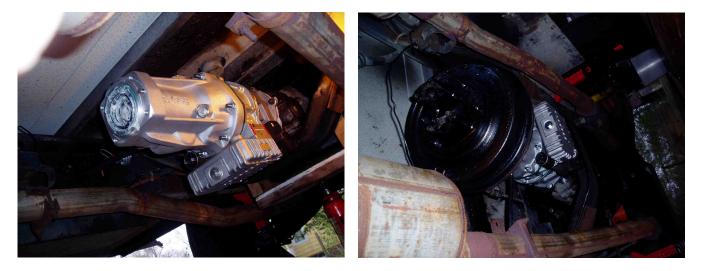
Here and in the following photos, the GV is in place and the brake re-installed.
