## Massive leaks and destruction

About a month ago I acquired a 1996 Airstream Cutter Motorhome. I paid vaguely below the lower end of book value. Before I bought it, I knocked and pounded on all the walls, looking for any soft spots. Everything seemed good. Here'st it looked like when I bought it:

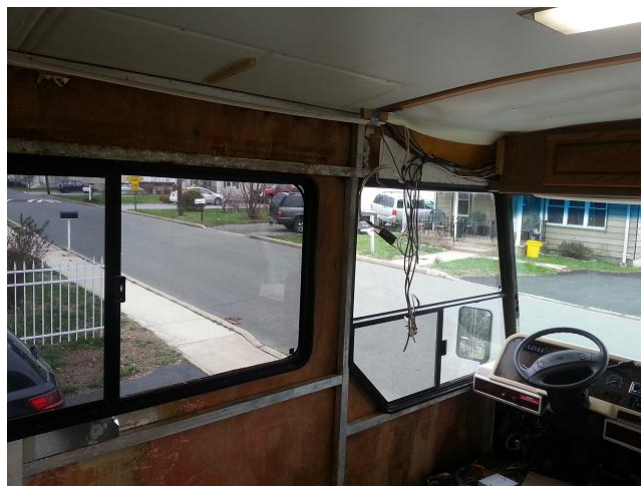
This is what it looks like now:

After I got it home--it ran beautifully, by the way--I removed the sofa, intending to replace it, and there, behind the sofa, I was able to pull the wall apart with my fingers. I've now pulled out all of the wood and foam on the driver's side all the way back to the beginning of the kitchen. The rot continues beyond the edge of the kitchen.

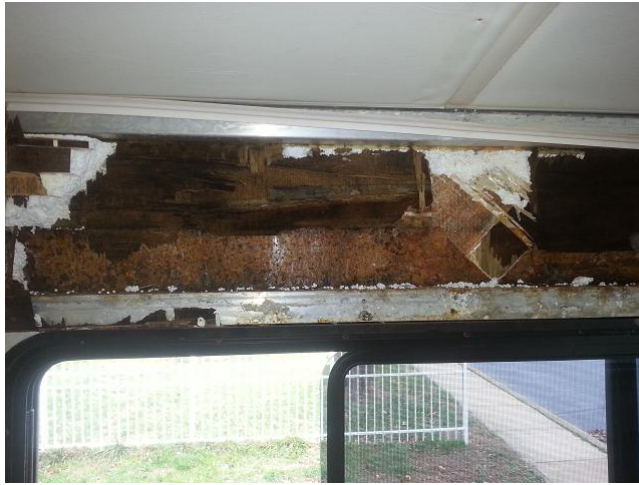
When I knock on the wall, it still sounds solid. But the wood between the outer fiberglass skin and the styrofoam insulation is so rotted it falls

apart in my fingers, as you can see below.

For anyone who doesn't know, the wall consists of: the outer, fiberglass skin, a thin layer of plywood (possibly luan), the aluminum frame an inch and a half thick with styrofoam between the frames, another layer of thin plywood, and the thin vinyl wallpaper.

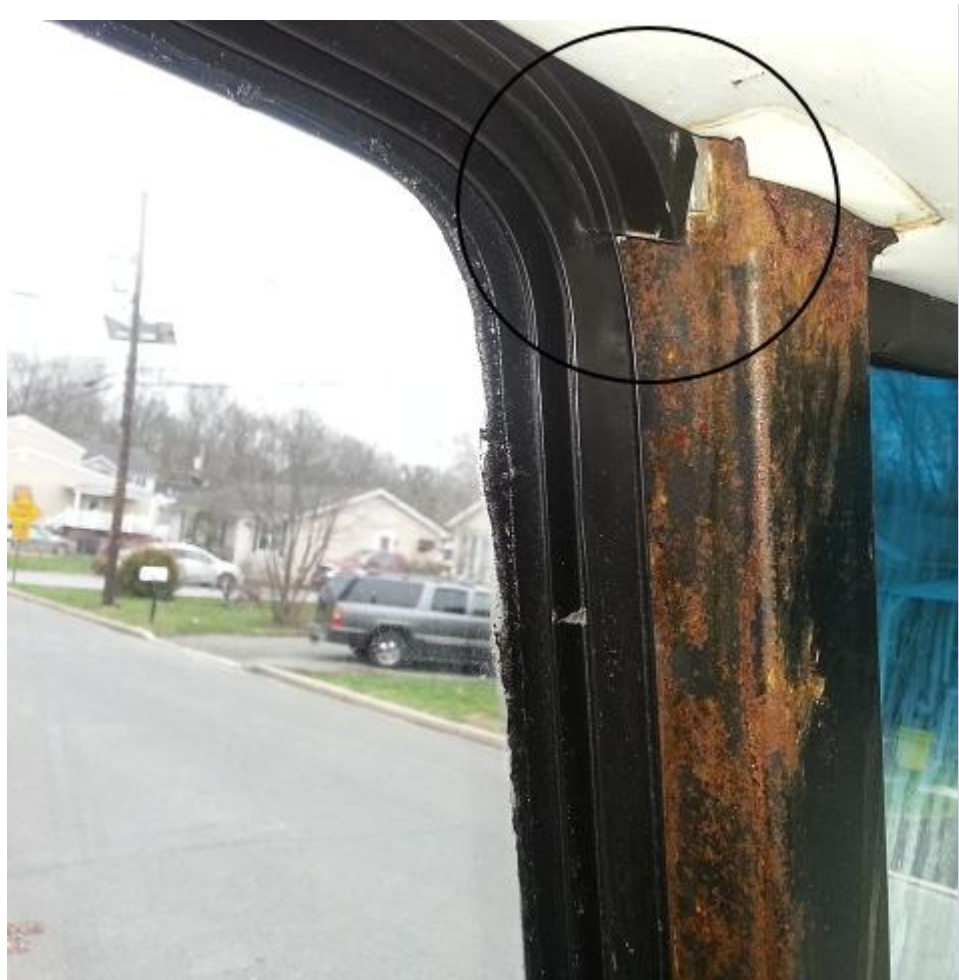
So I need to remove the windows. Actually, with the walls scooped out, the windows are only being held in by the caulk between the outer flange and the fiberglass. Removing most of the windows are pretty straight-forward: just remove the inner screws from the frames and the window should just pop out (except for removing the caulk, of course). The issue is the driver's side window. Airstream removed the inner flange of the window frame ...

... and I can't tell what is holding the window frame to the structural frame. Possibly some kind of adhesive? and/or screws that I can't see? Don't know. I'm hesitant to remove this as I'm not sure how to get it back together. Does anyone know?

First, I found how the front driver's side window is attached. It's so obvious to me now that I feel a little dumb. There are three screws through the inside of the window frame going into the structural frame. They're not too hard to reach, but it's a good guess that they'll snap off. I'll see soon enough.

In a previous post, I said I didn't know how the driver and passenger windows were attached to the steel corner frame. Turns out there were three screws inside the tracks of the window frame going forward into the steel frame. Don't know how I missed them; seems so obvious now. I was afraid they would be rusted and would just snap off, but they all came out cleanly.

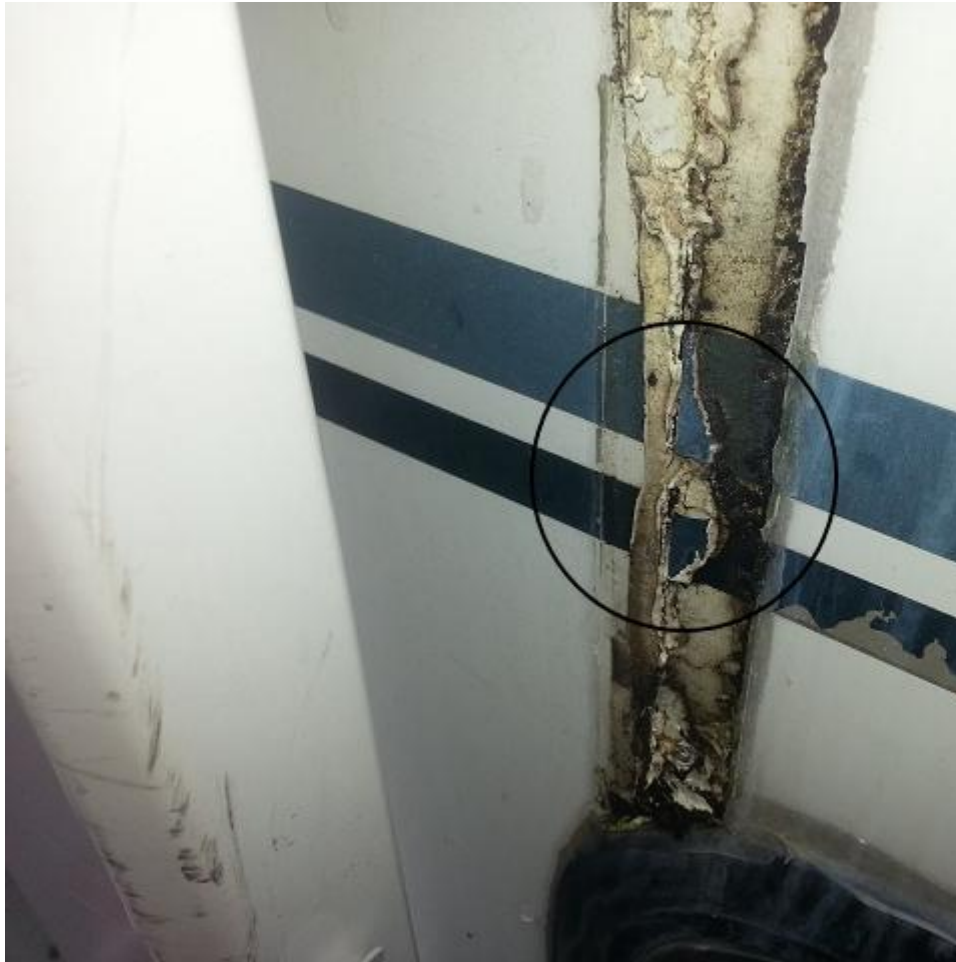
The other issue is all of the leaks. It's been raining quite a bit here lately (New Jersey), on and off, and with the walls gone, it's been easy to see the water inside. I stopped most of it that was coming in from behind the molding strip between the two windows where the fiberglass from the cab joins the fiberglass from the body. There was nothing but a thin bead of caulk covering the joint. And as you can see, the joint isn't even entirely covered.

That seam is open and had never been closed properly (Criminal almost.). Probably leaking from day one. This is on both the driver and passenger sides. I covered this temporarily with tape. (The window frames are covered just as a precaution since I've disturbed them so much. They didn't seem to be leaking at all.)

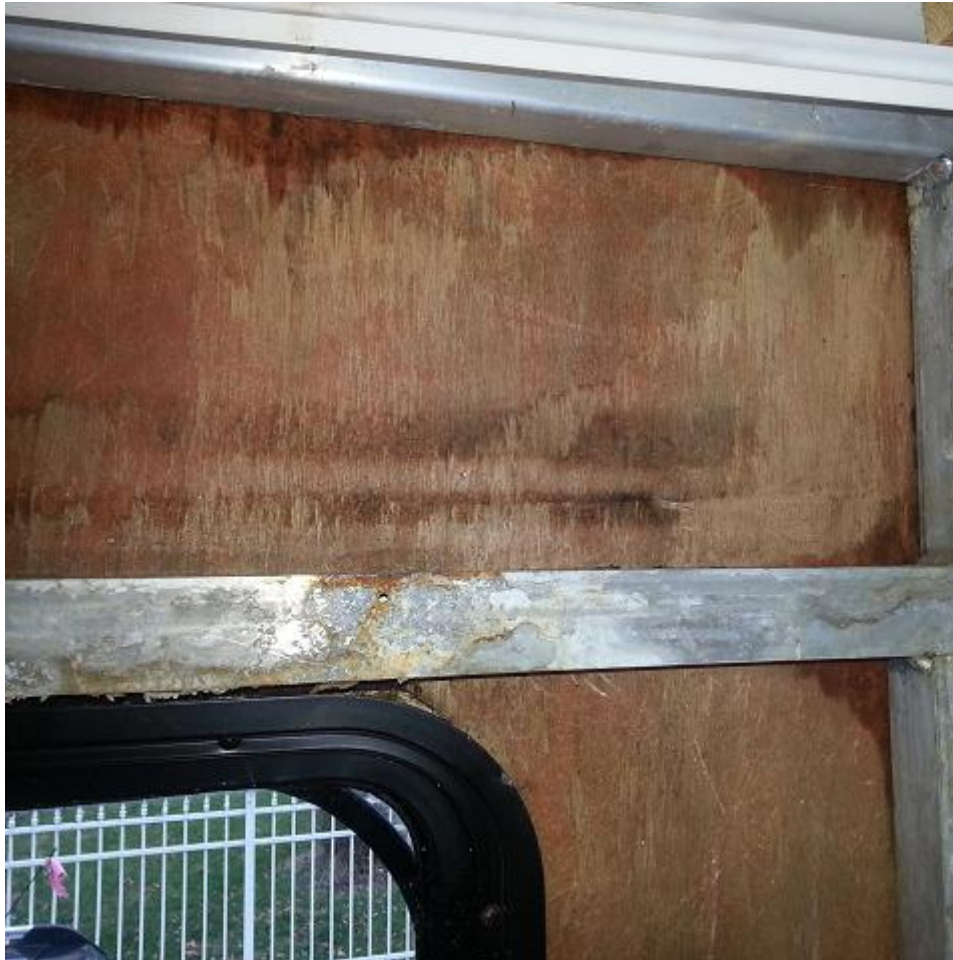
Most of the water stopped, but that's not the only leak, it's still leaking a little; with the original leak, I actually had a small river coming in. This is only a little compared to what it was. (It's not leaking through the tape. I checked it, and it's stuck really well, and it's only been on for a couple of days.) See the below picture:

Behind the upper, horizontal, aluminum frame is the aluminum track that joins the fiberglass roof with the fiberglass side and supports the awning. This track is riveted down with fairly large rivets. They're not pop-rivets and would need a special tool to replace. And removing this--well, the whole fiberglass side would then probably be supported by nothing but the window frames since who knows how much of the wood is rotted.

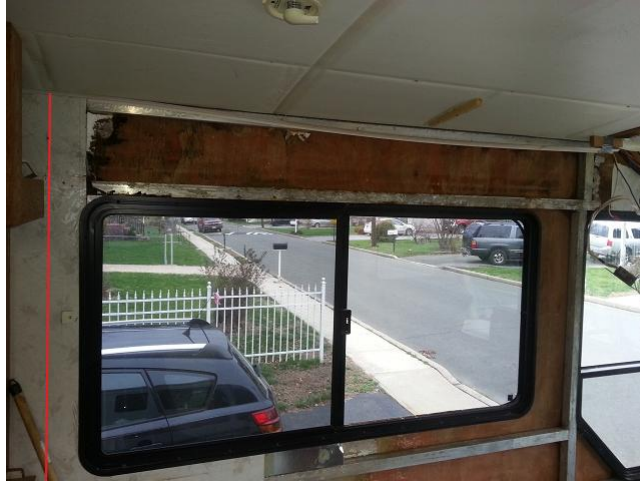
I drew a line on the wall half-way between the kitchen and the back-end of the window, just about where the red line is in the below pic.

The wall at this point was dry and near impossible to peel away from the fiberglass, so it's the right place to stop and will give me a good seam between the old wall and the new.

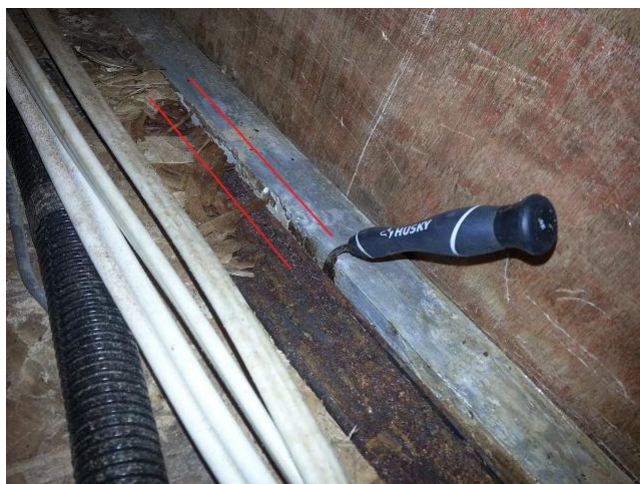
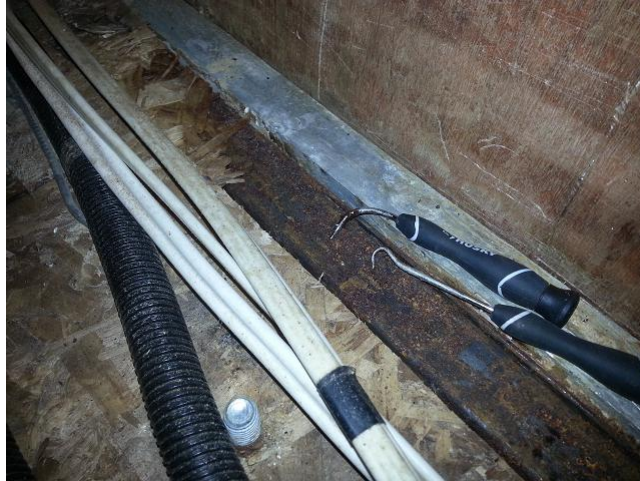
And I just want to point the following out; the below picture shows the way Airstream constructed this motorhome:

What you're looking at between the two red lines is the inner wall plywood (again, probably luan) sandwiched between the steel frame of the chassis and the aluminum frame of the wall. What you see there is a little more dry and more difficult to get out than most of the rest of it (this is very close to the kitchen). The wood between the frames goes down an inch and a half, the thickness of the aluminum frame. A six foot section took me about three hours to clean out with those two wheeny tools.

Why anyone would put thin plywood between two metal frames--well, that's a structural issue. That's bizarre.

I won't put wood between these metal parts again. Probably just shove some kind of hard plastic stripping or aluminum in there as a filler.

Yes, I am replacing all the rotten plywood with wood again. But ... the leaks will be closed off properly, and the plywood will be laminated to the fiberglass skin with epoxy and completely encapsulated with epoxy. The surface area really isn't that big. Lots of windows.

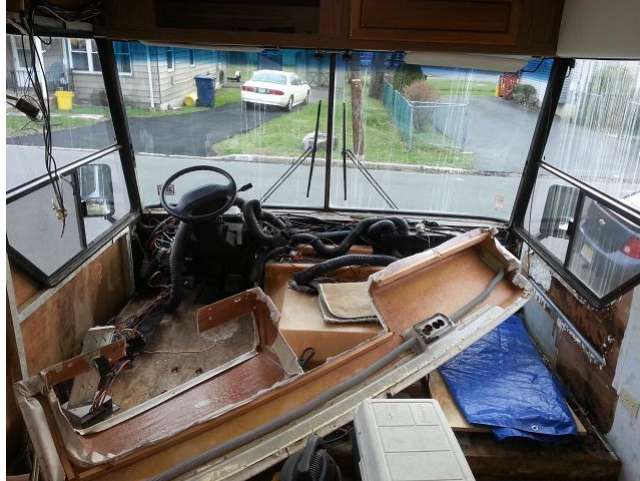
Here' s a picture just after having pulled out the side window. Look at that beautiful, clean cut made by Airstream. It looks like some drunk hacked it apart with a rusted saw. And yes, the window flange barely covered that mess. You can see the line.

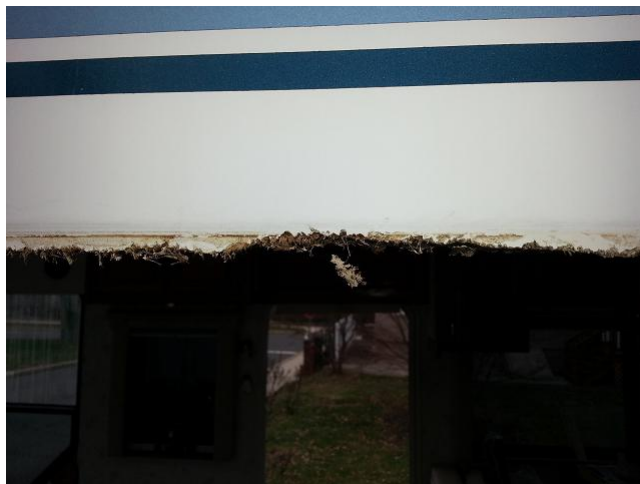
Below is a picture after it' s been somewhat cleaned up.

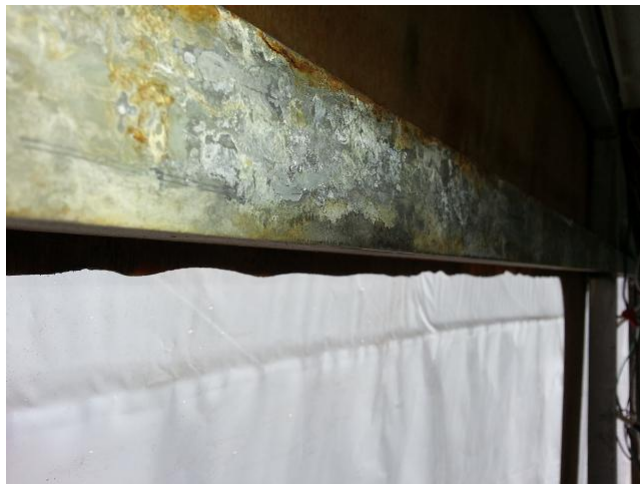
And that jaggedness isn't isolated. Look at the below picture. For some goofy reason, the sides and bottom were cut smoothly and correctly. The mess is just on the top. You know—where it's most important...

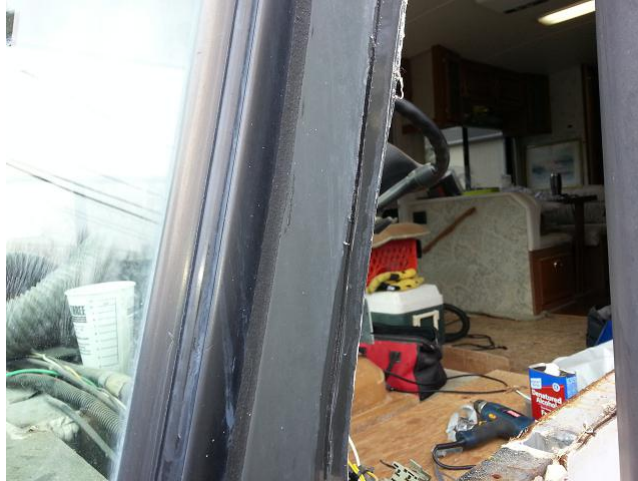
The picture below is the leading edge of the driver-side window. You can see the narrow white line at the top-center where the caulk was. Can't see it below that. This corner was leaking badly, and one morning, I had a puddle of water on the floor.

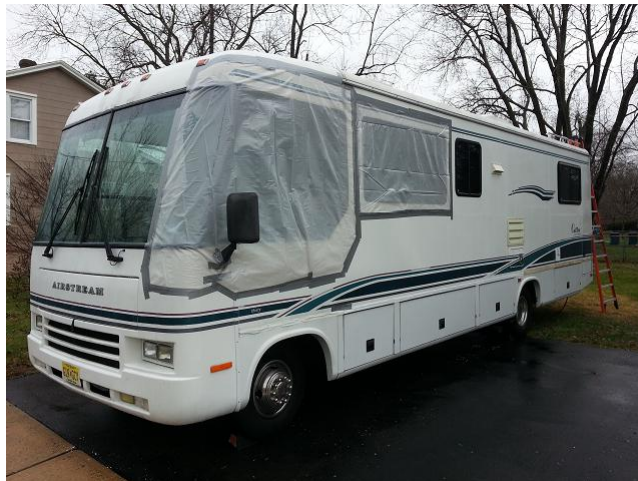
Below is just a picture of how I have it sealed up after taking out the windows. That's six mil plastic; I think it will be fine.

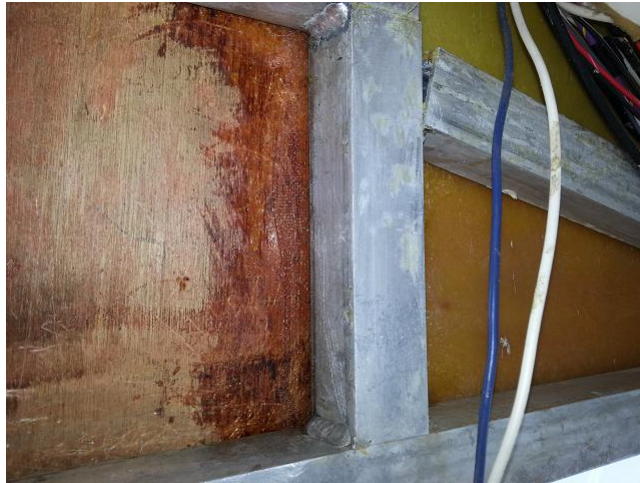
In the picture below, the fiberglass on the left of the picture looks like wood. That's because, I think, during construction, the plywood was laid into the wet polyester resin in order to bond it together. So even though I scraped it plenty, there's fine pieces of wood still stuck on the fiberglass.

Behind the vertical frame is the joint between the main fiberglass side and the fiberglass of the cab (this is above the driver's side window). I epoxied a strip of fiberglass tape over the entire joint. This, along with re-caulking the exterior joint, should stop the leaking.

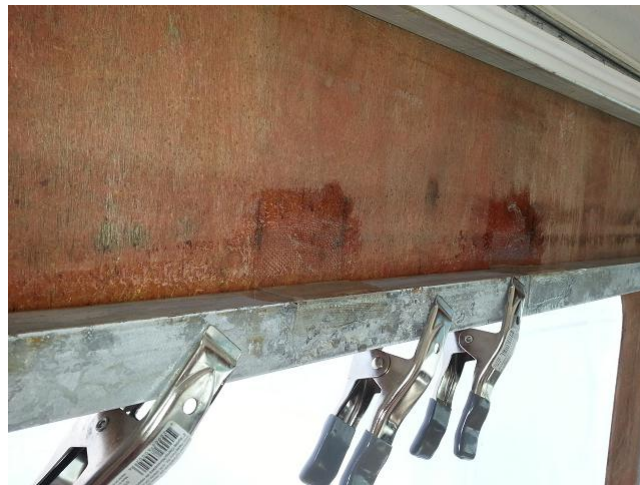
I just wanted to point this out: Look at the amount of paper tape below put on by Airstream. I did not find this unusual; it was everywhere. The inner plywood wall was bonded to the foam and aluminum frames with some kind of glue. But since the glue is holding the plywood to the tape, we can literally say that this motorhome is being held together by tape—direct from the manufacturer (somewhat, anyway).

The wider metal at the top is galvanized steel. That surrounds all the windows, probably a stiffener.

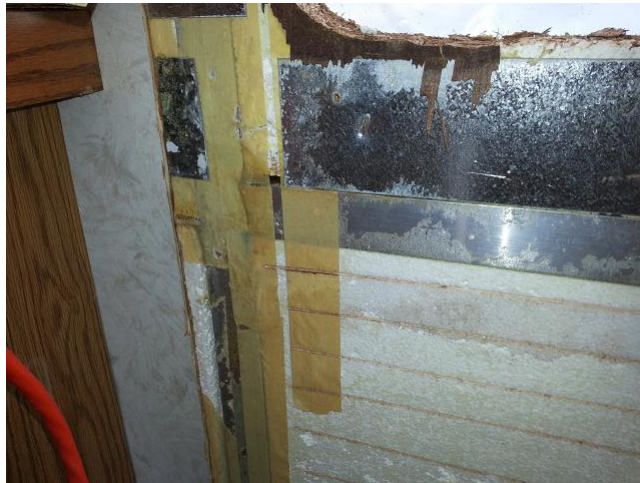
And finally, for now, just a shot of the passenger side. Rot here too, though not as bad. I need to go higher up the wall; I don't know how high yet. But both windows will definitely come out and be resealed.

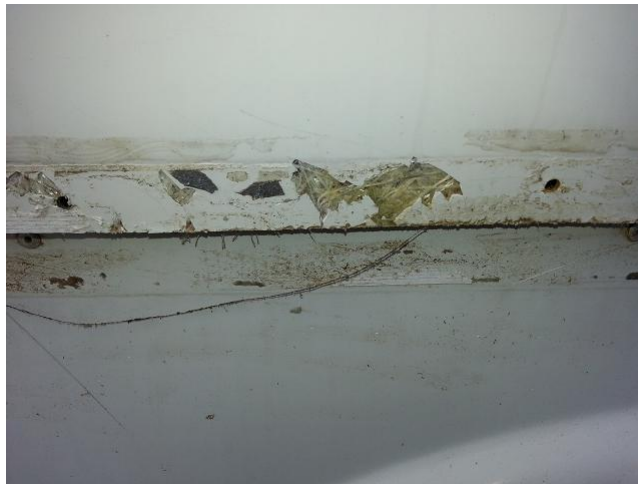
The below picture is the seam between the fiberglass siding and the plastic fender. I removed some temporary duct tape and the gelcoat pulled right off, exposing unsaturated fiberglass threads. Another defect in workmanship. Not enough (or any) polyester resin during manufacture.

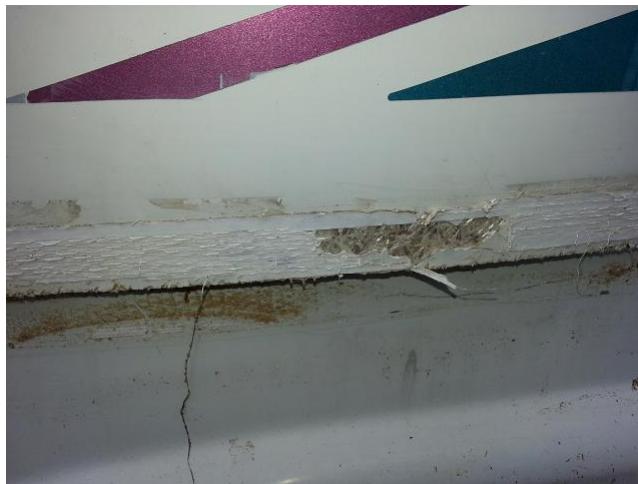
It' s not the only place. The below picture is only a couple of feet away.

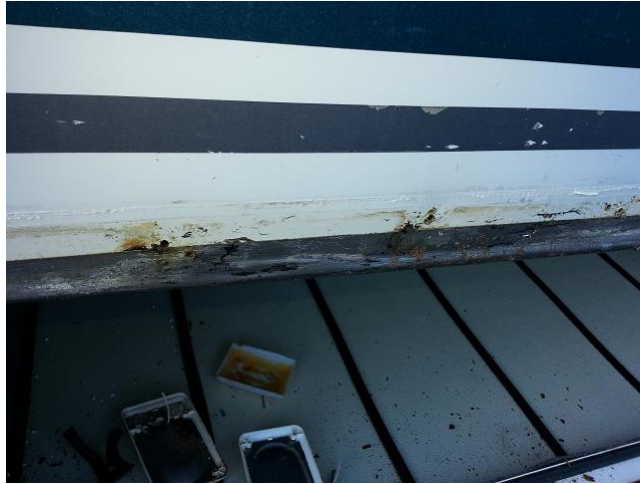
Below you are looking at the bottom of the sidewall. Below that is the inside of a side storage compartment after removing the door. Do you know what that grey stuff is? Duct tape. I have no idea what its purpose was supposed to be, but I know its effect. When water gets

behind it—and it will—it is trapped, which allows it to wick up into the exposed end of the luan and rot the wood.

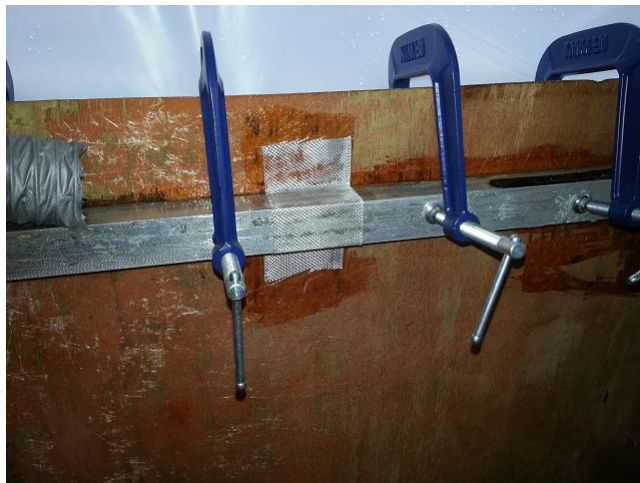
Below is a clearer picture of how I'm reattaching the fiberglass wall to the framework. This is just before I put on more resin. If I don't put on more resin, I wind up with what Airstream did above.

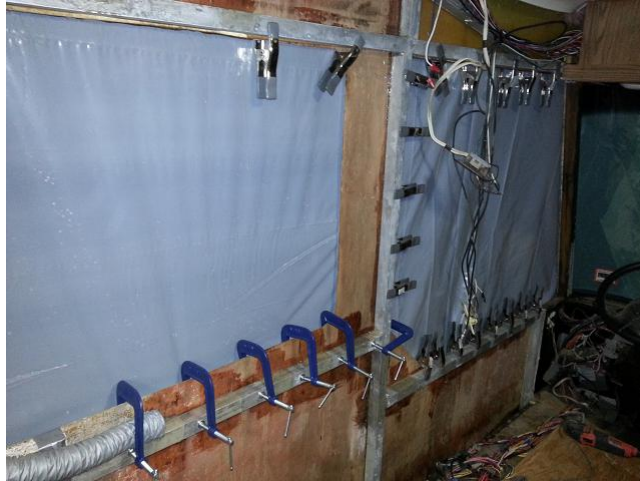
The wall is almost completely reattached now. When done, in goes the foam insulation.

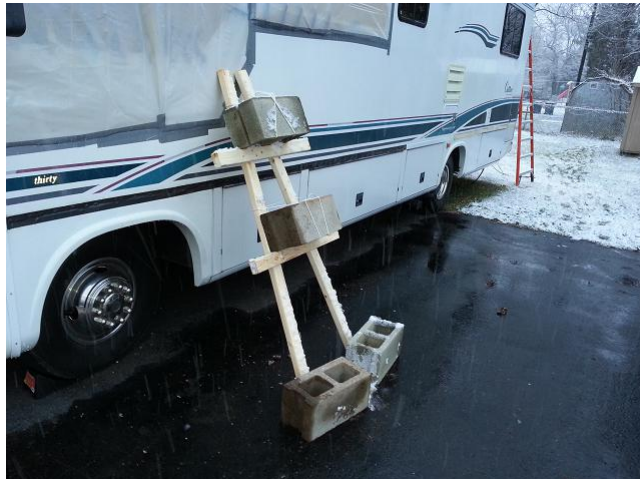
Below shows what I had to do to get some of the siding to lay flat against the aluminum frame before attaching it. This is just pushing against the siding.

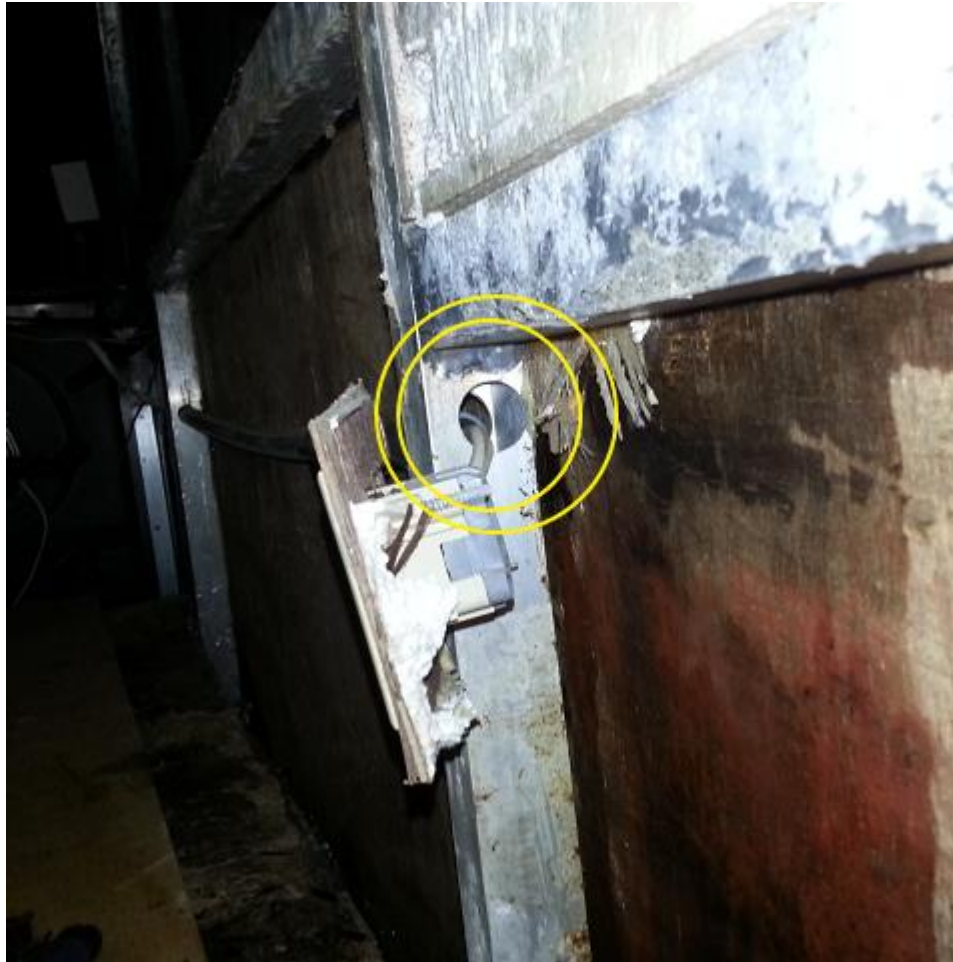
But then Airstream interrupted as I uncovered this. They cut through two-thirds (maybe three fourths?) of a main support in order to push a wire through, crippling its strength. This support, by the way, is right next to the passenger seat.

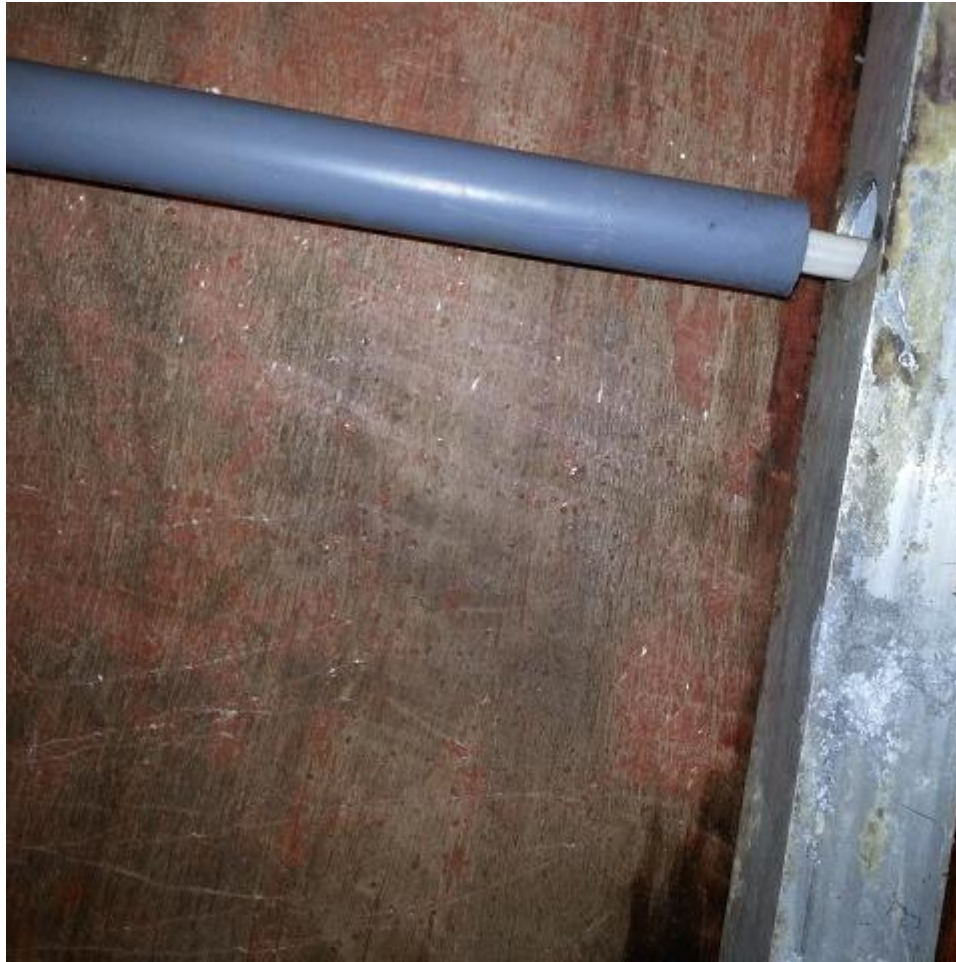
They did this in order to get this plastic pipe through. But there's several easy solutions:

- 1) Get a smaller pipe!
- 2) Find some other way to protect the wire.
- 3) Put the receptacle on the other side of the support so you don't need a hole!

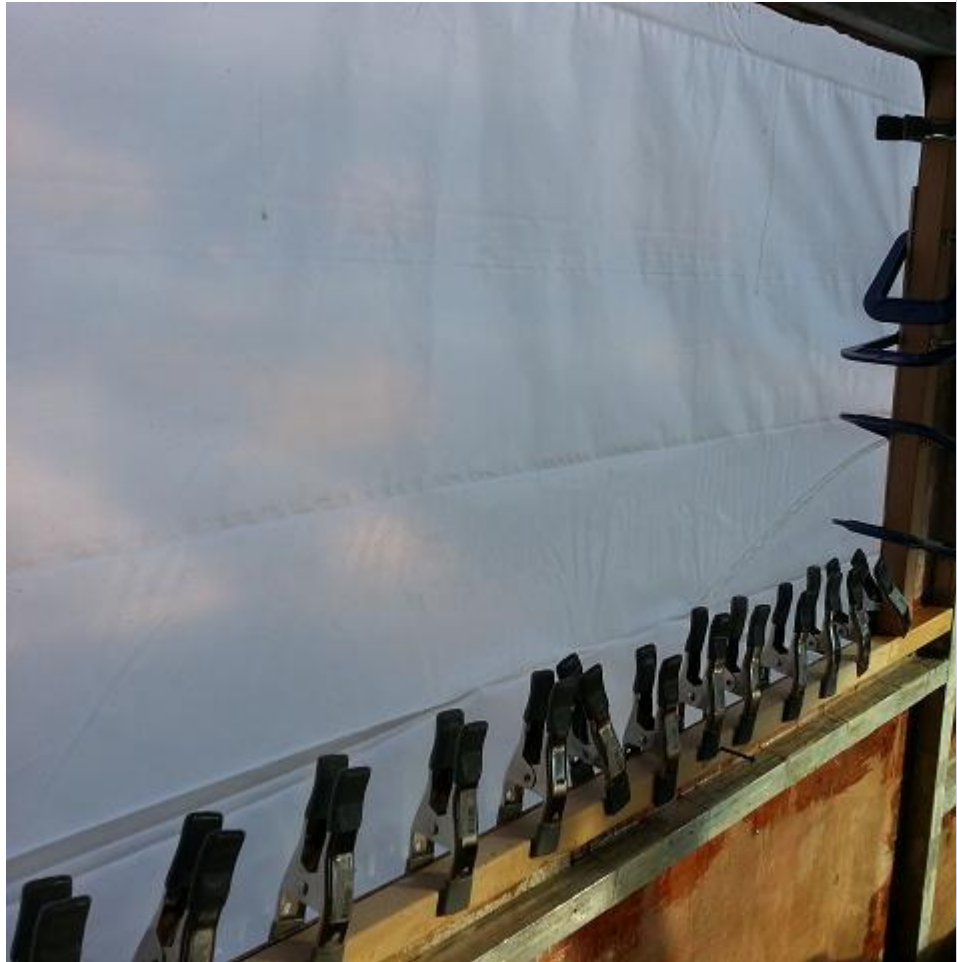
I also decided that the window frame needed more support than merely foam, as Airstream designed it. In the below picture, you can see where I attached 2x2's (they're actually planed to 1.5" x 1.5") to the edge of the fiberglass. The wood is completely encapsulated in epoxy. Then I got to wondering why Airstream couldn't have merely lifted that horizontal aluminum frame that's only a couple of inches below a little higher? With only compressible foam to support the window, any movement in the wall is going to cause leaks. The wood now makes this very solid.

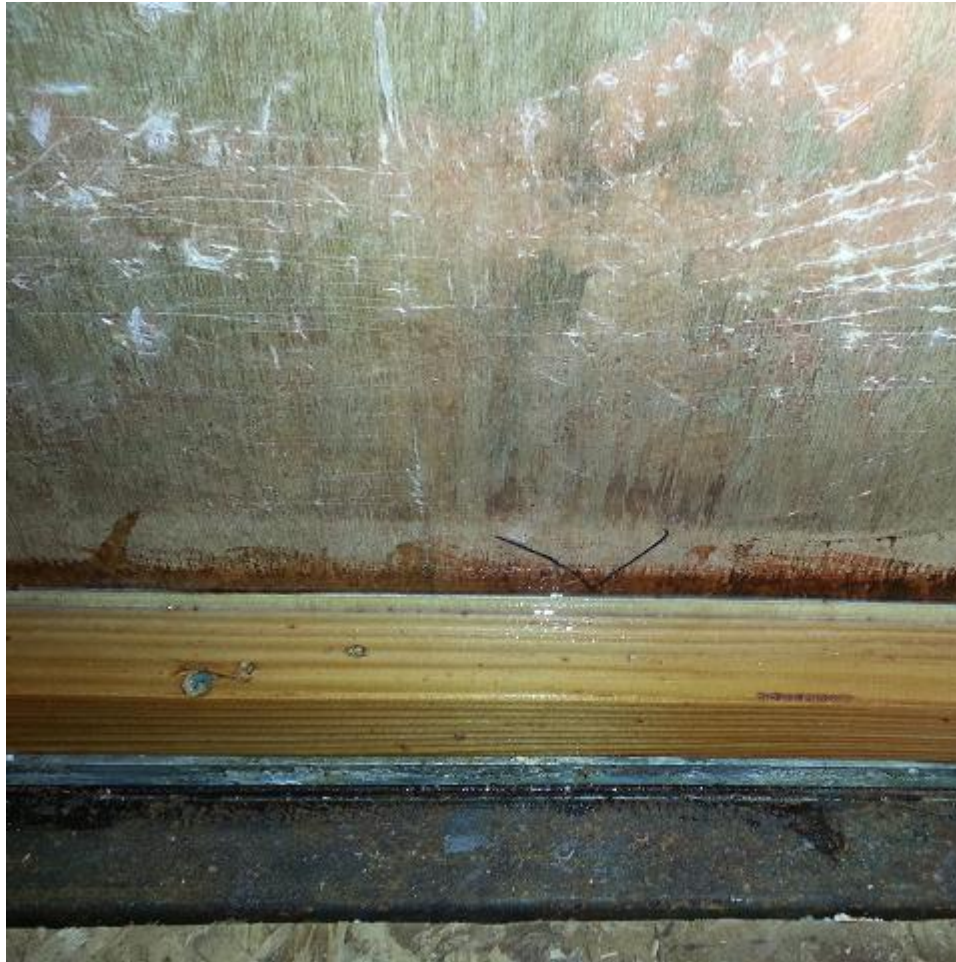
This is the bottom edge along the floor. I epoxied this 2x2 to the aluminum frame below and to the fiberglass wall. Of course it makes the bottom of the fiberglass wall far more solid, but I really put it in in order to have a solid backing to attach the final, interior wall.

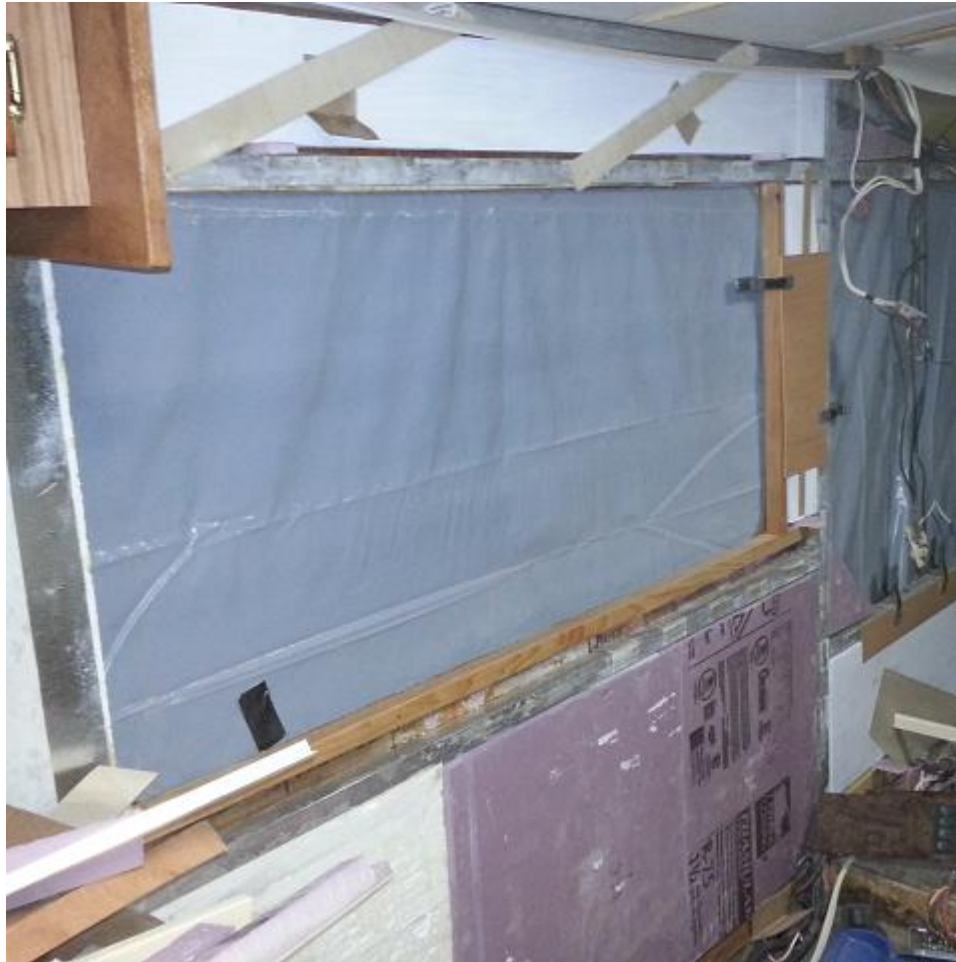
In goes the foam. I used that standard pink foam from Home Depot. In order to get the foam to the proper thickness, I attached 1/8" plywood to the back side. I used Glidden's Gripper paint primer—which has turned out to be an excellent adhesive for foam, and also the least expensive. (You can see a great video on YouTube by a woman who did comparisons amongst many glues, many of them made for foam and much more expensive. Gripper was easily in first place.) I also covered the plywood with the primer to waterproof it.

I decided to attach the foam to the fiberglass by using nothing more than standard construction adhesive. It seemed better than a solid glue because with this adhesive I could use up and down, single lines of adhesive (I hope that's clear. Sorry, I didn't take a picture). That will allow for a slight airspace between the lines of adhesive giving a path for water. Meaning, if water ever gets into the wall again, it will run down straight to the bottom of the wall and exit through small holes I am leaving at the bottom.

Some of the foam below is white. It's supposed to be pink. That's because some of it got inadvertently painted by ...

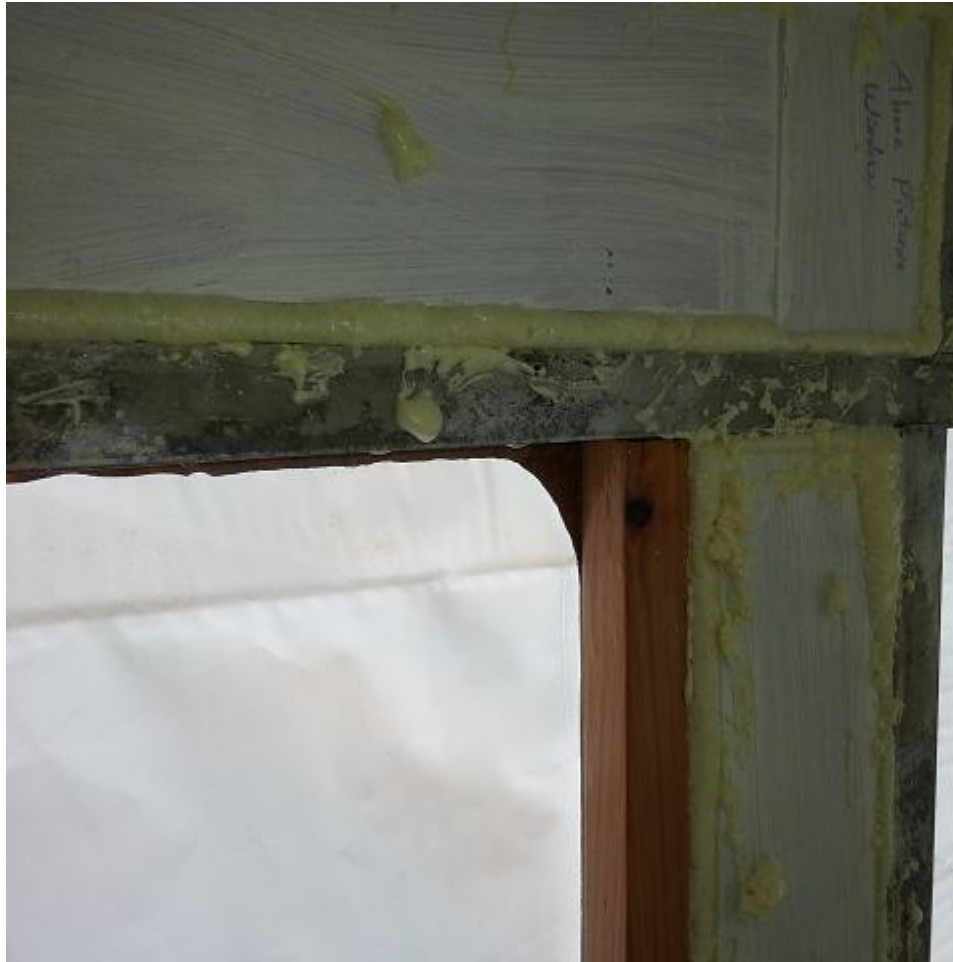
When cutting the foam, I purposefully left a half-inch gap around all the edge so that I could fill them with spray-foam and get a really tight fit.

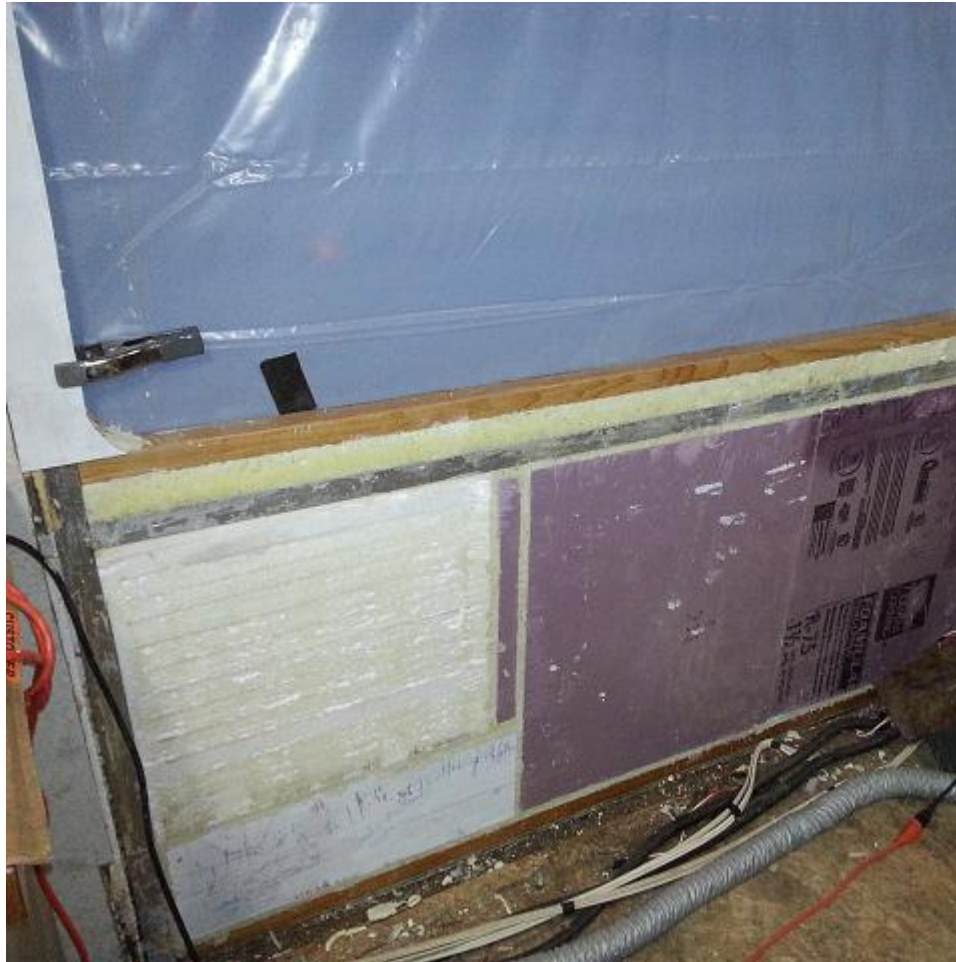
Below shows how well the spray foam sealed everything. The white foam on the left is still the original foam; there was no rot under it, so I left it. The narrow strip of pink is just a filler. It's just how it worked out since the pink foam isn't that wide. Anyway, this has made for a really tight-fitting, sealed wall and I'm pretty pleased with it.

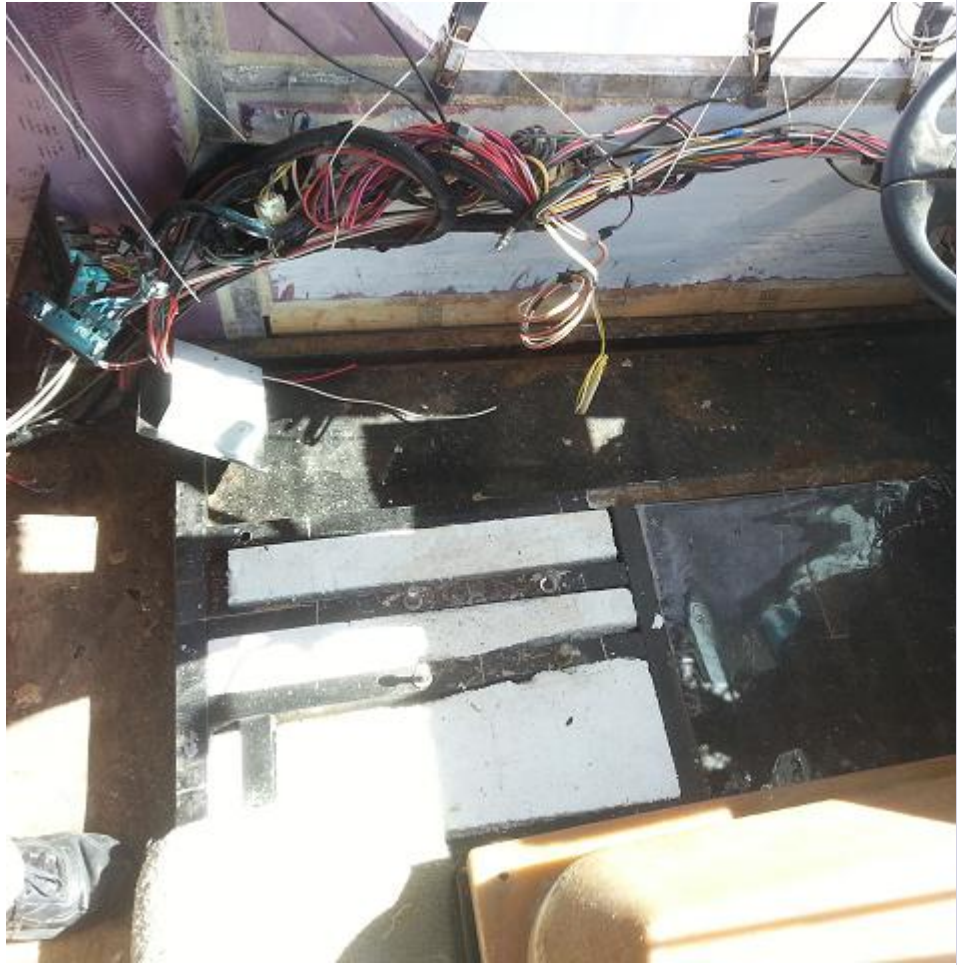
While the masonite' s being painted in the basement (way too cold to paint in the RV), I started the floor under the driver. Just as I expected, the insulation is very sad here. I pulled out the foam next to the wall; you' re looking at steel. Under the driver' s feet there' s some kind of rubber glued over the foam. I' m not touching that.

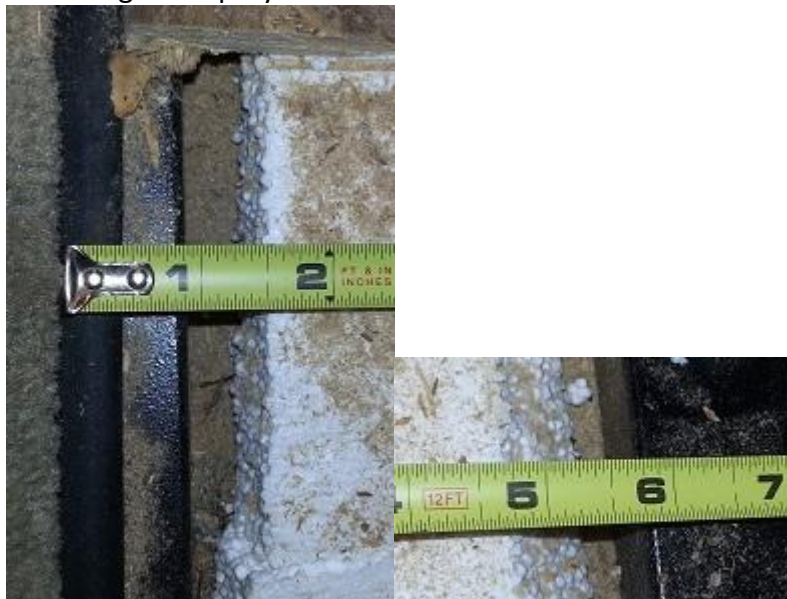
Below you can see huge gaps between the foam and the steel framing. No consideration to actually doing the job right—just in getting the job done. With this much air space, the insulation is doing very little. I will be cutting all this existing foam to a half inch all around as I did the wall and filling with spray foam.

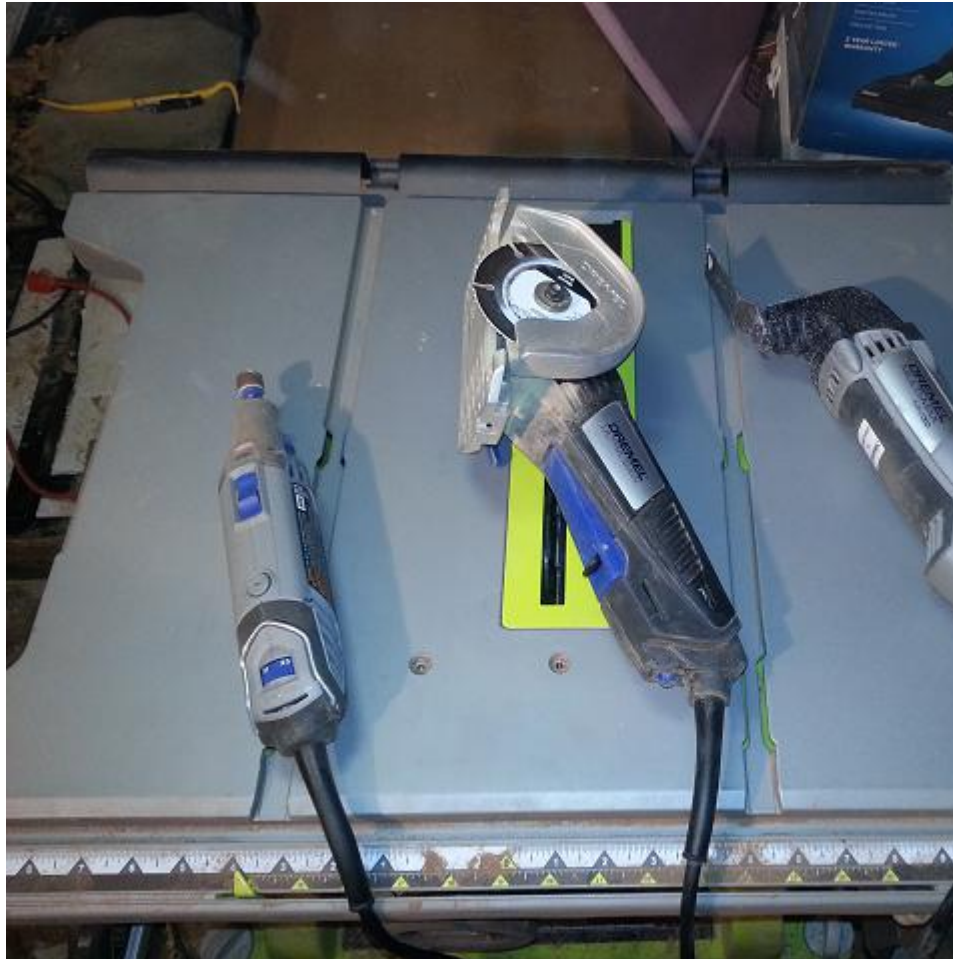
One more thing. Three indispensable tools, all by Dremel: The center saw was used to cut the wall covering in strips to pull it off. It saved lots of time. It's a really easy saw to handle. And the saw on the right has a thousand uses. The two biggest time savers were in, sort of, peeling the wood from the fiberglass siding where it wasn't fully rotten, and it works really well for cutting foam.

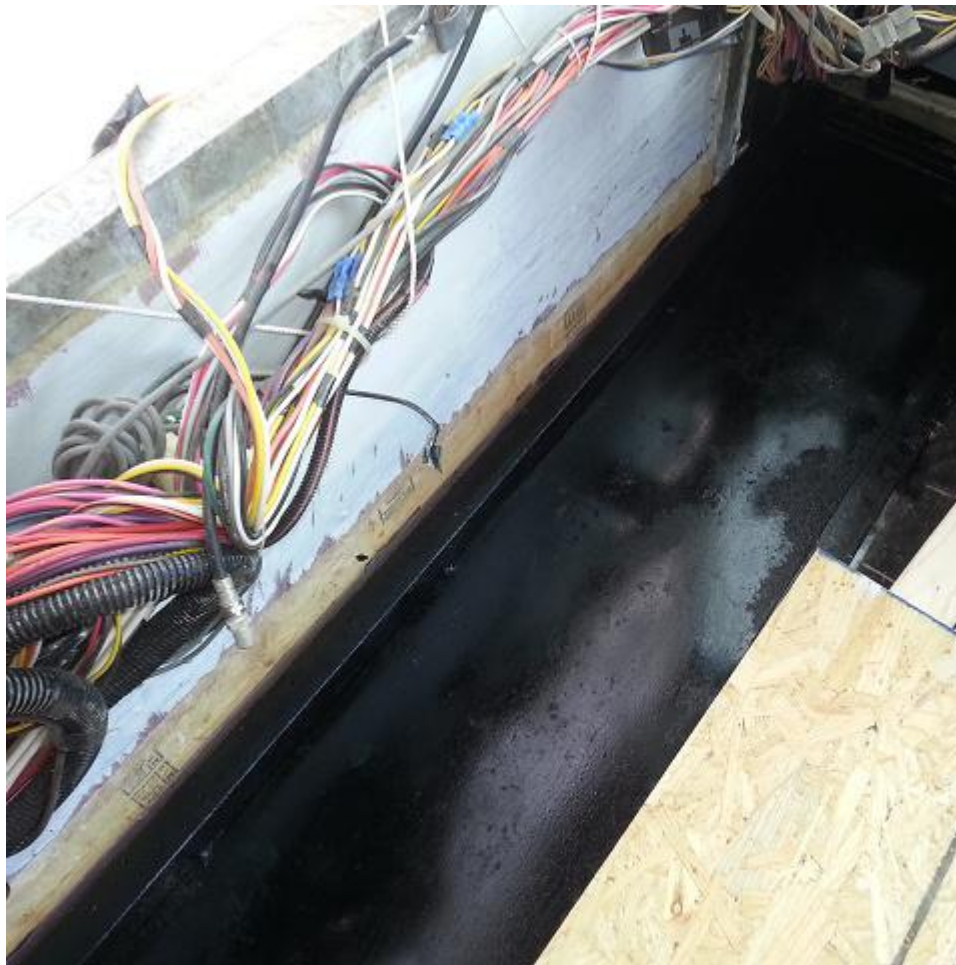
Below is the rusted steel under the driver's seat all cleaned up and painted.

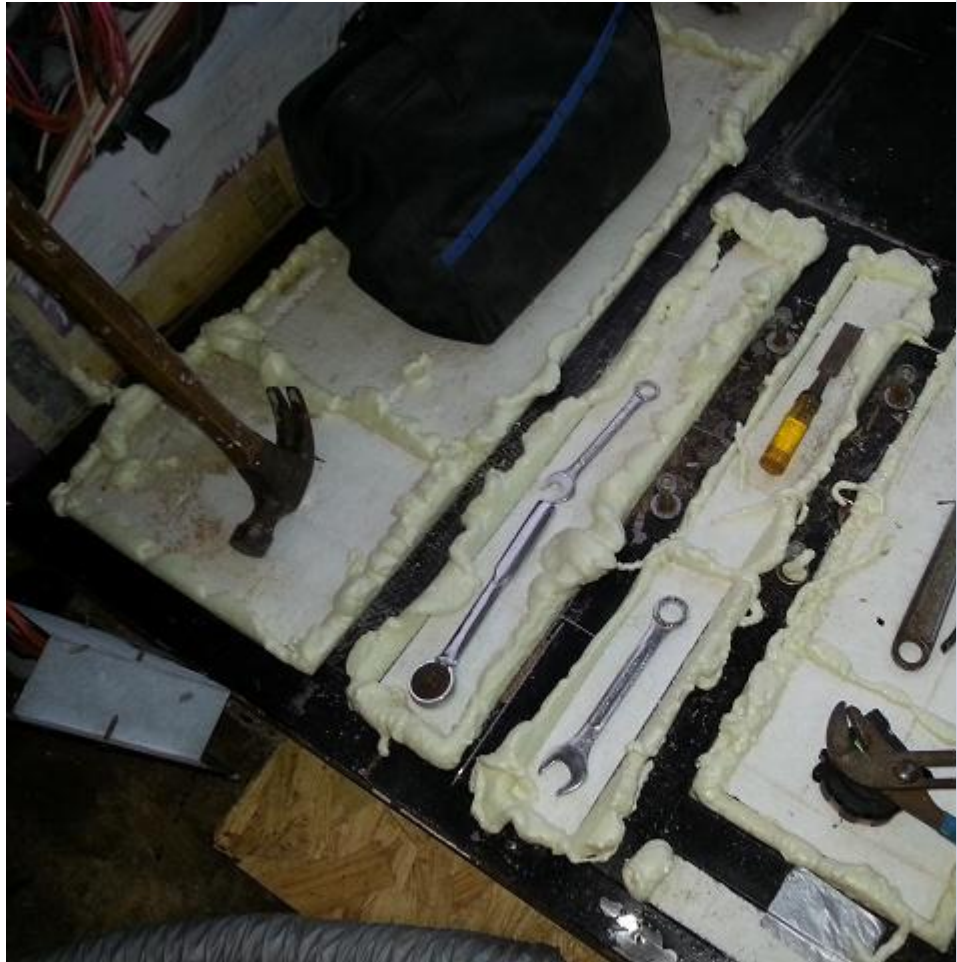
The white foam needed to be weighted down or the spray foam would make if float up.
