## Massive leaks and destruction

About a month ago I acquired a 1996 Airstream Cutter Motorhome. I paid vaguely below the lower end of book value. Before I bought it, I knocked and pounded on all the walls, looking for any soft spots. Everything seemed good. Here'st it looked like when I bought it:

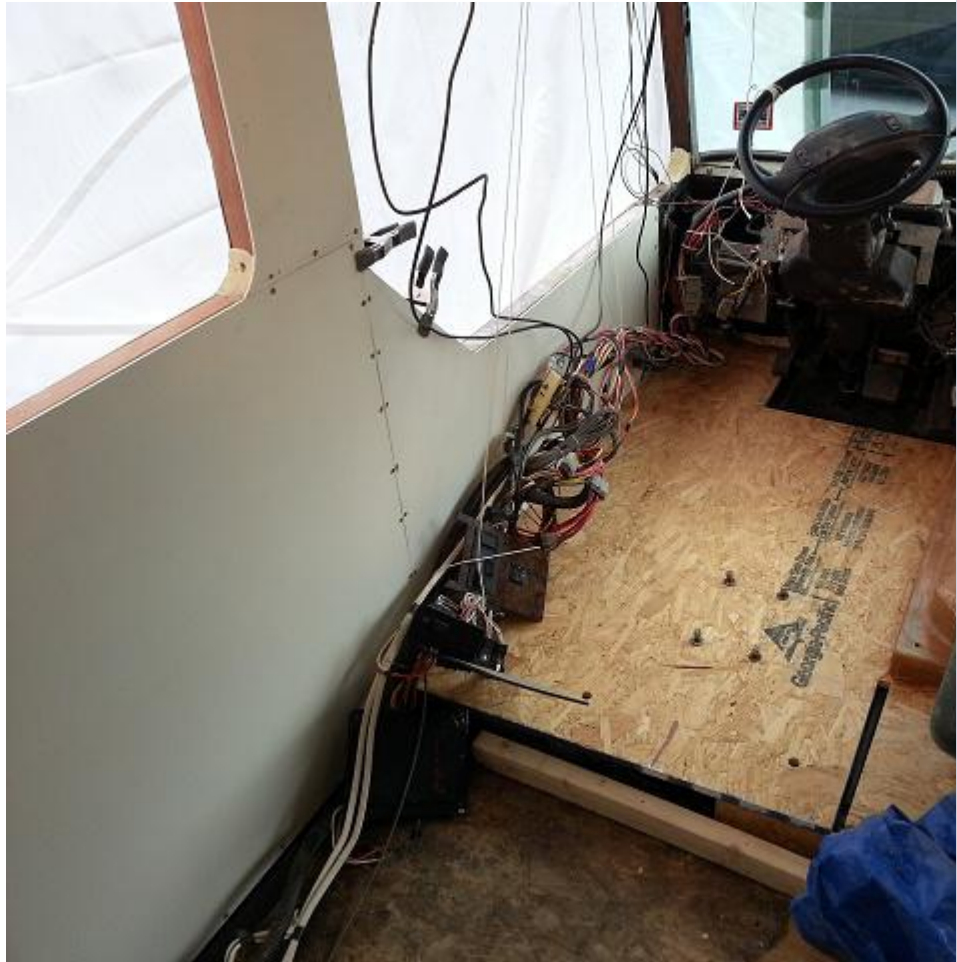
The inner wall is finally in. I used simple, exterior paint on this. I like the simplicity of it. The seams will be capped with molding. Also, the new subfloor. This wood, even with all the holes for the seat and the seat belts, was actually easy to measure and cut since the frame is perfectly square—not like a house.

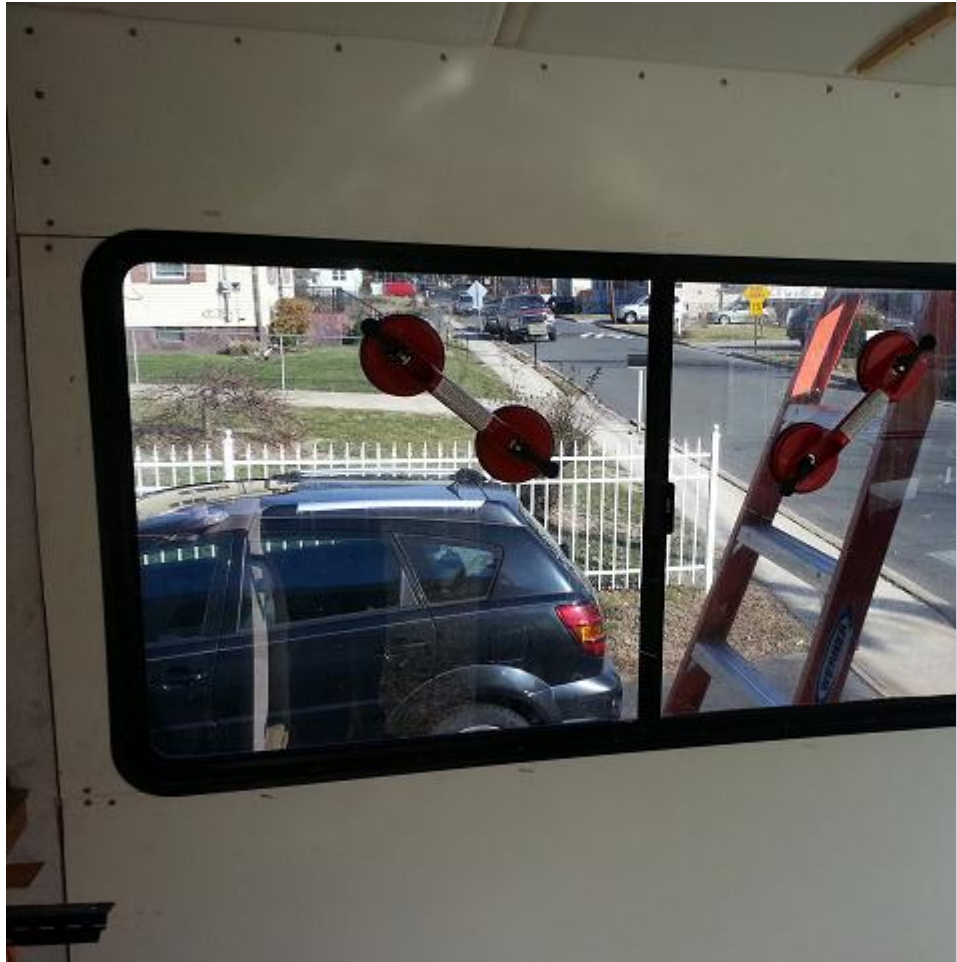
I paid seven US dollars each for the suction cups below. They allowed me to set the window back in place from the inside by myself with very little effort.

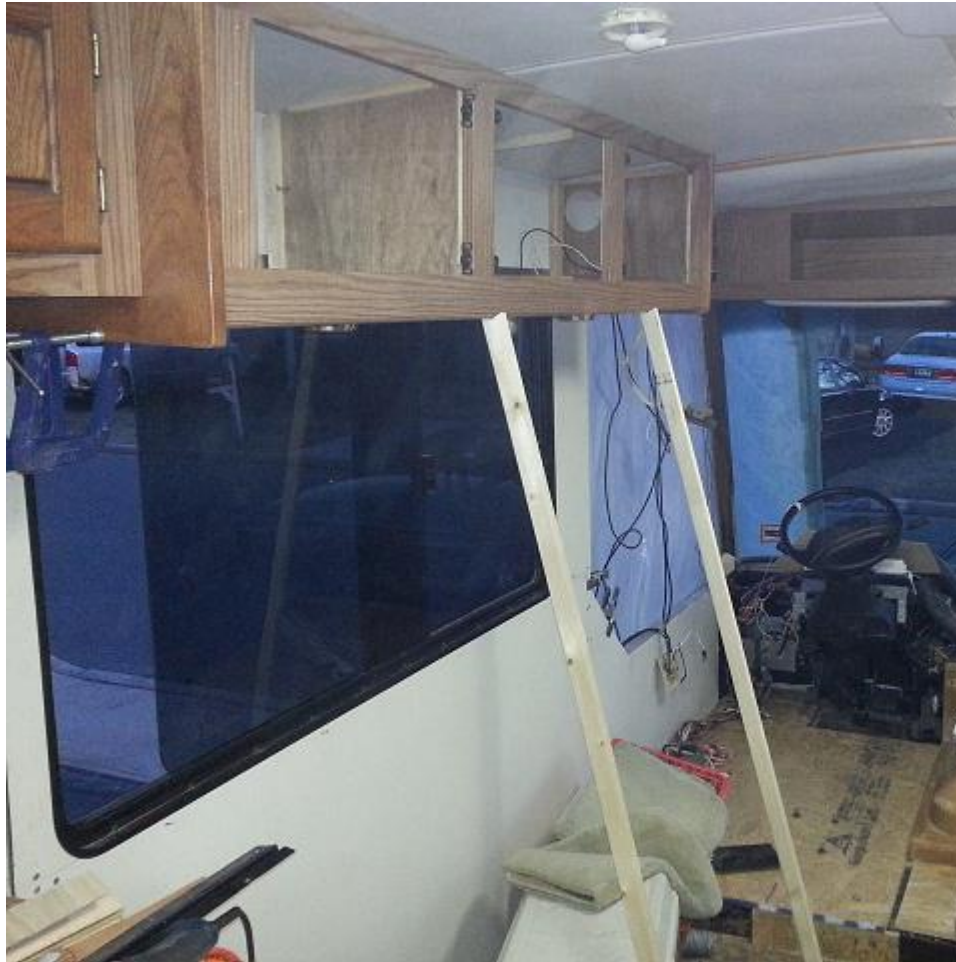
In goes the upper cabinet.

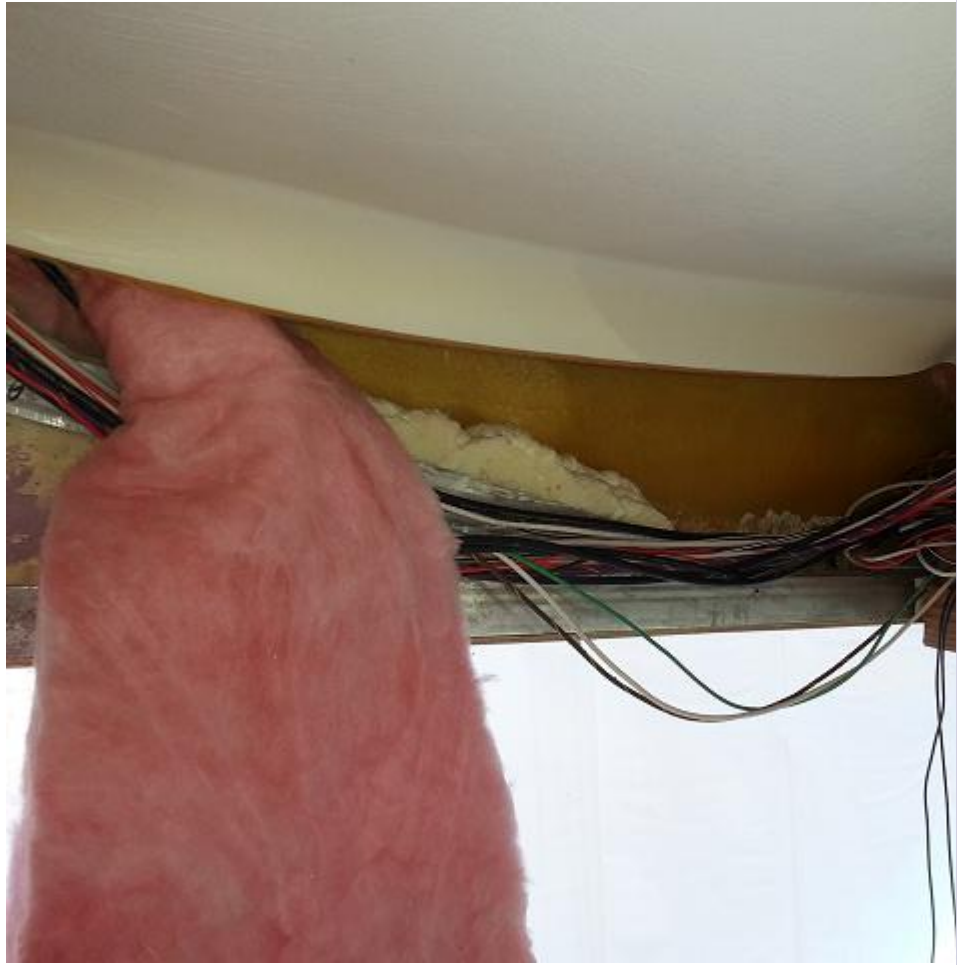
... I found this. I guess Airstream couldn't find any real insulation, so they stuffed the ceiling full of leftover carpeting.

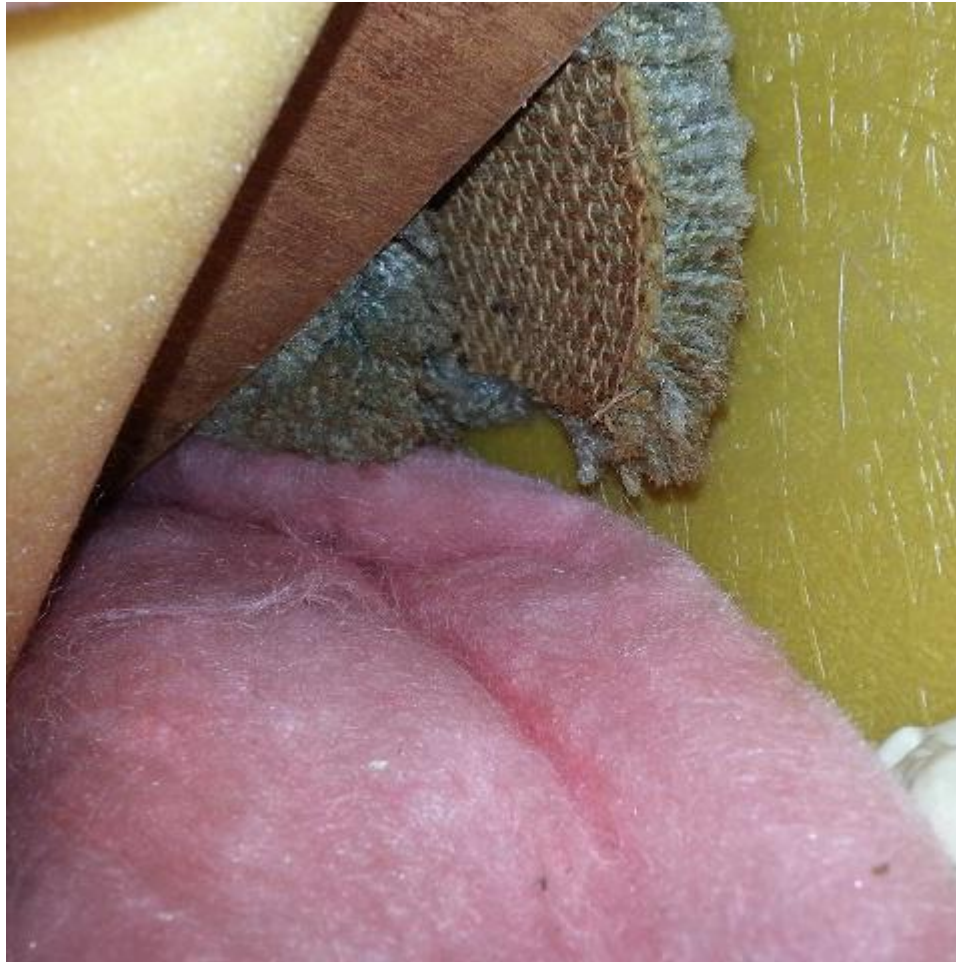
Below is what I spoke about in an earlier post. Anyone who knows anything about RVs knows that this bulging is a sure sign of delamination.

I didn' t know this at the time. The dealer knew this. Again, they waited for someone ignorant like me to take this RV off their hands. By the way, that peeling dark red stripe: I found that that pulled off easily. So now, instead of that mess, it is an all gray stripe.

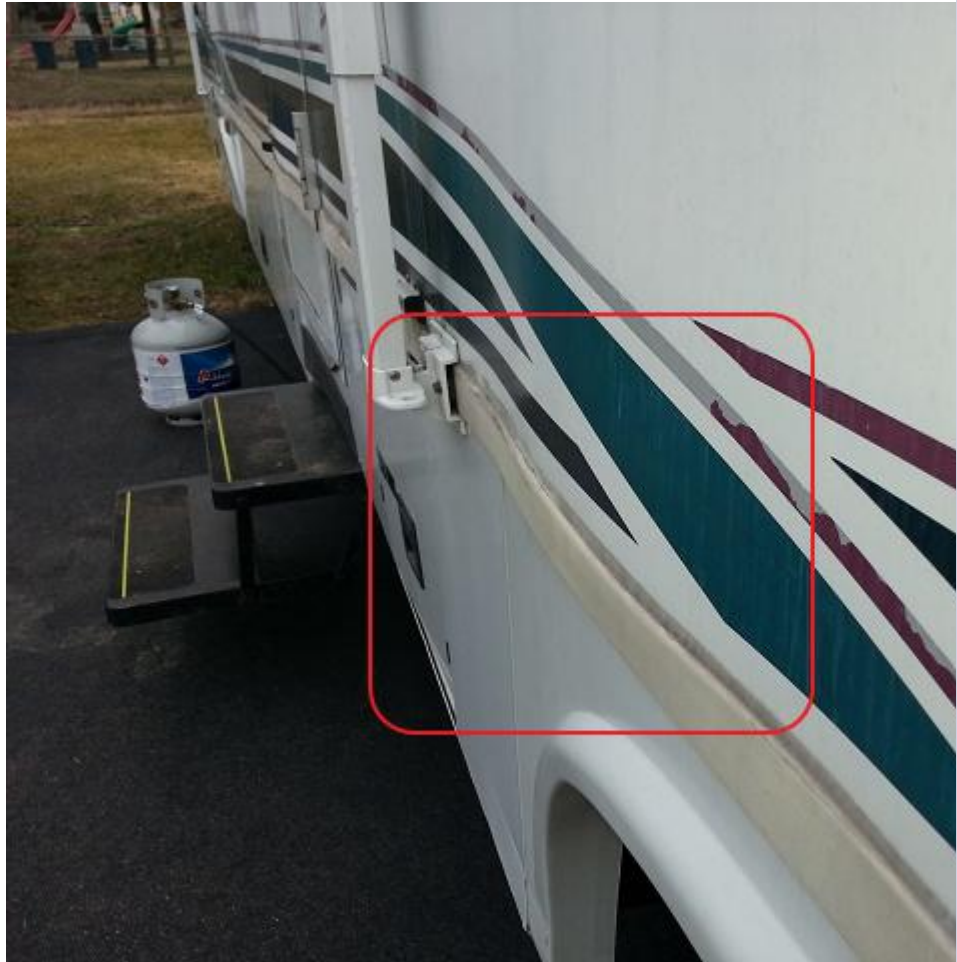
I talked about this before too. This is the outside cap over the driver's seat between the cab and the side of the RV where the most water was coming in on the driver's side. You can see how weeny the caulk is and how it isn't completely sealed.

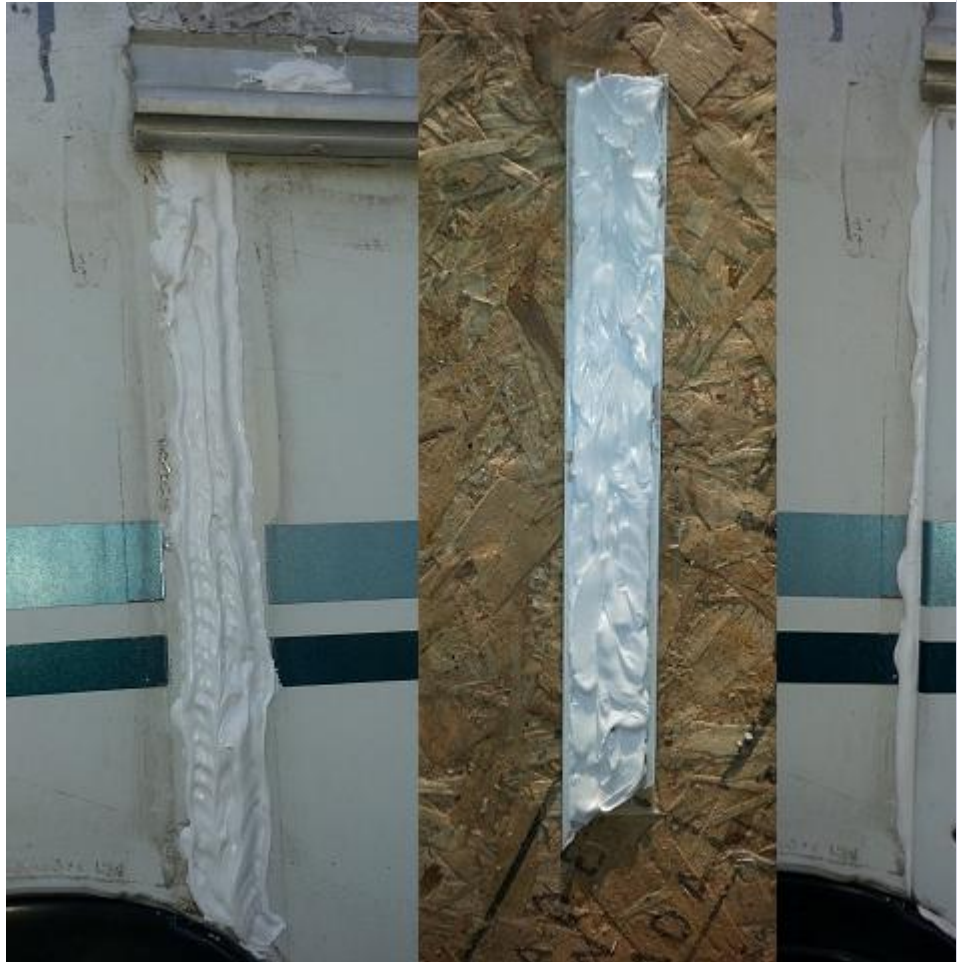
Before I showed the driver' s side window—how little sealant there was. This is now the passenger side. Again, practically nothing.

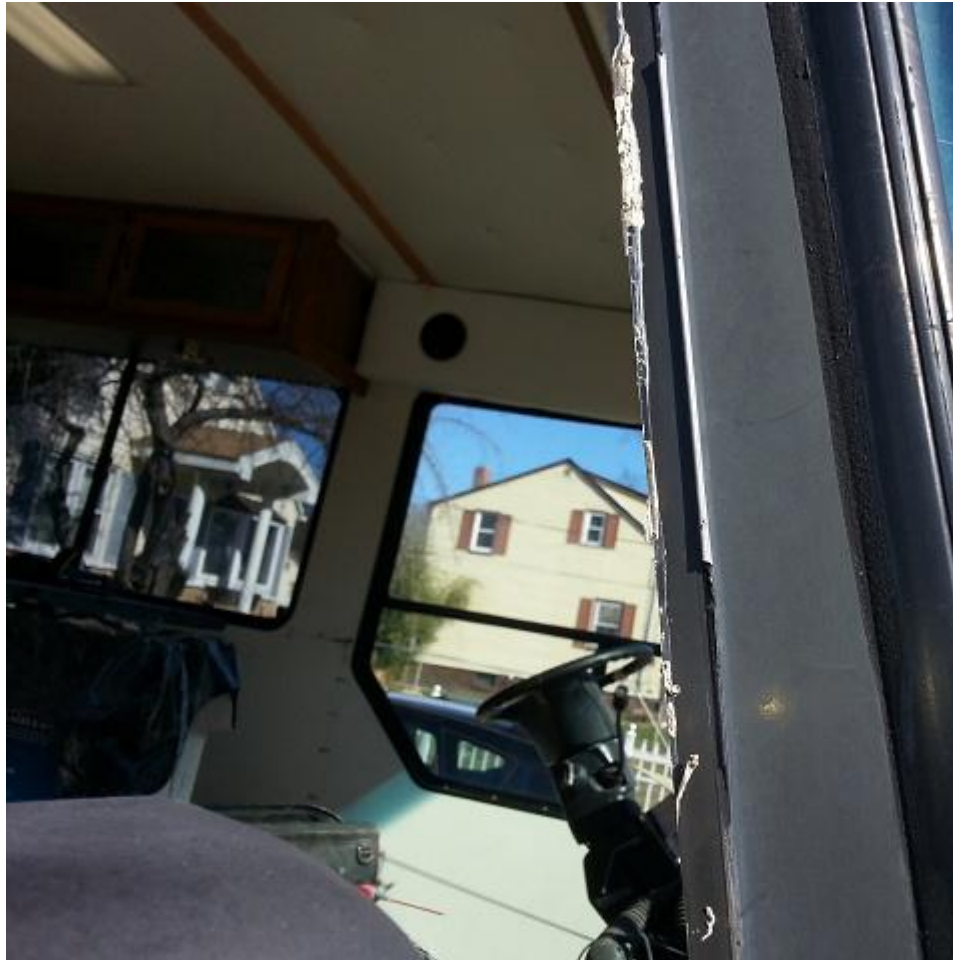
And here it is higher up. The yellow arrow is pointing to the caulk that was put on from the outside. The red arrow points to where the main sealant should be—but isn't. That's a full, two feet that completely bare.

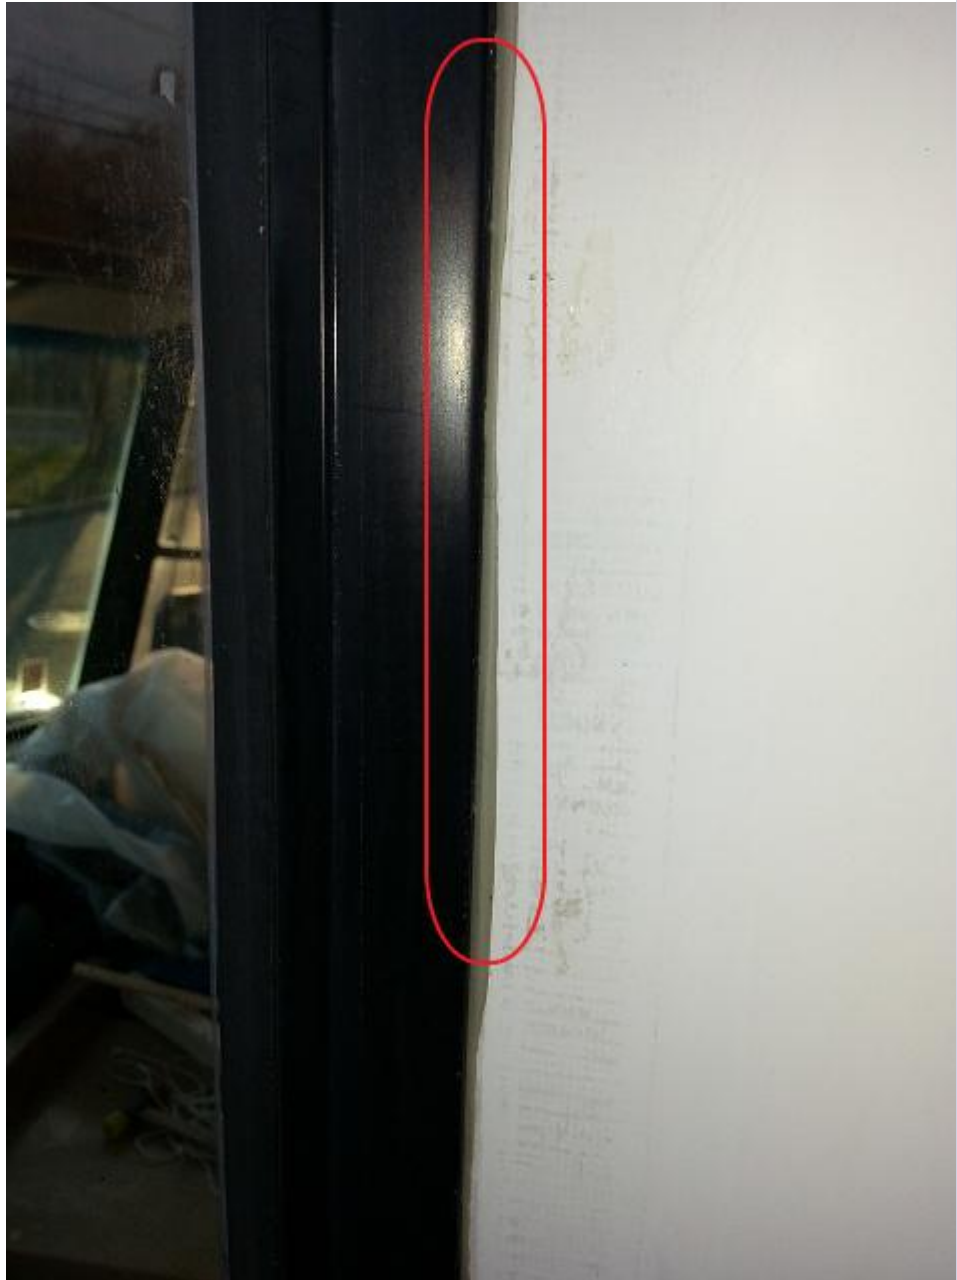
When I put the windows back in and sealed them, I used butyl tape. I didn't think a single strip was enough, so I slit the tape down the middle and put in an additional 50%. And so after tightening down the frame, the butyl oozed out as in the picture below. I am certain that window is not going to leak. Just a few dollars more and very little additional time BY THE MANUFACTURER could have saved this motorhome (yes, owner maintenance is still certainly necessary).

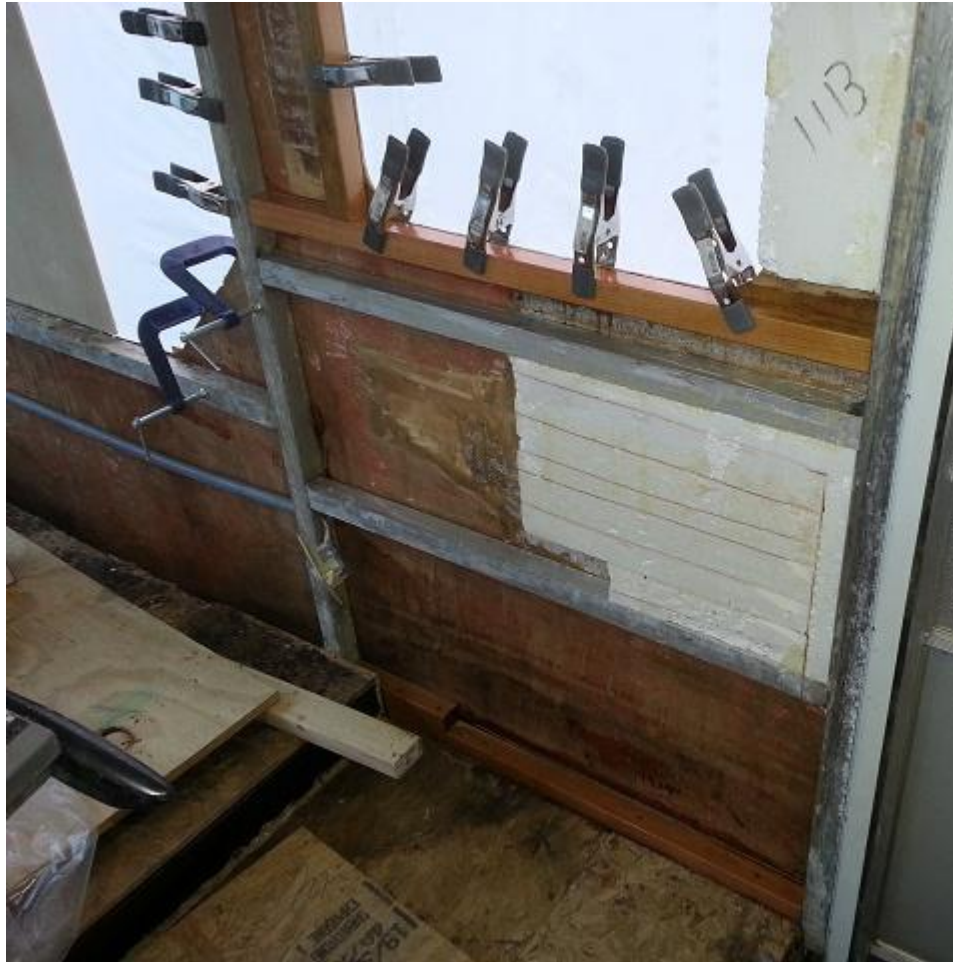
Just a shot of the new window framing as I also did on the driver' s side.

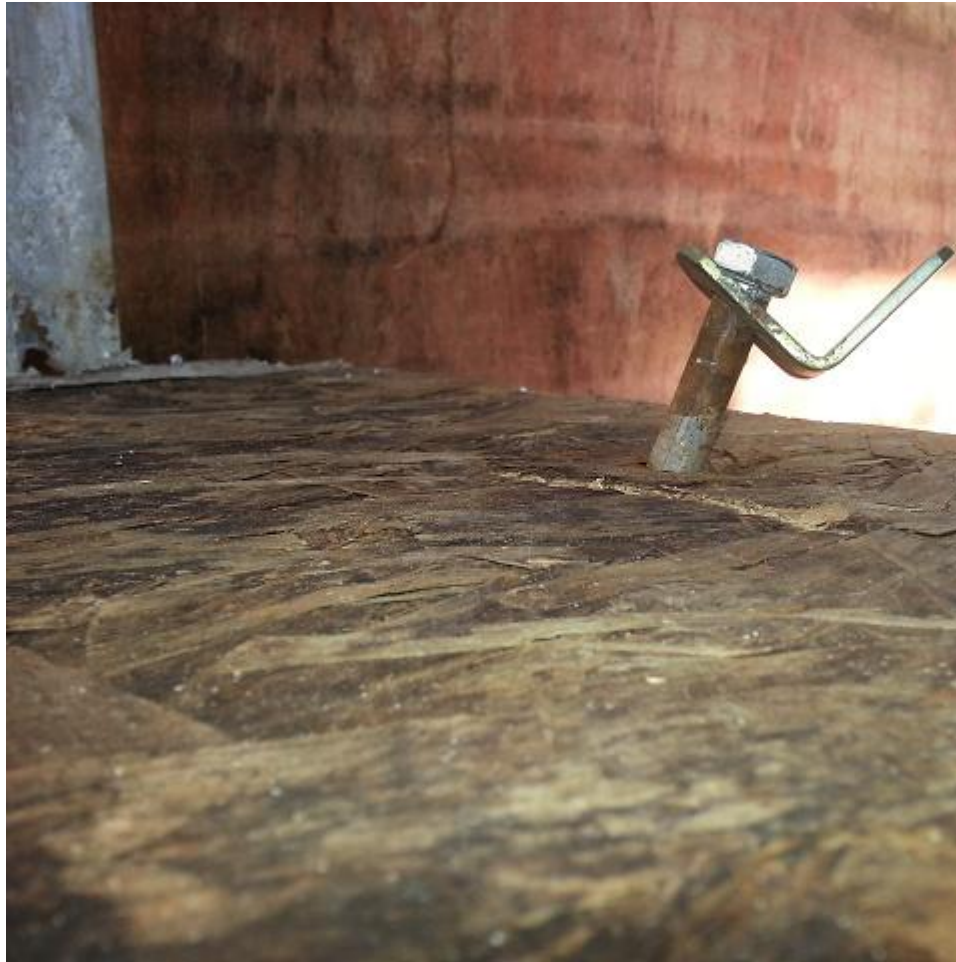
This is inexcusable. This is a bolt that holds the seat belt to the floor. Yes, it's supposed to be straight like the others were.

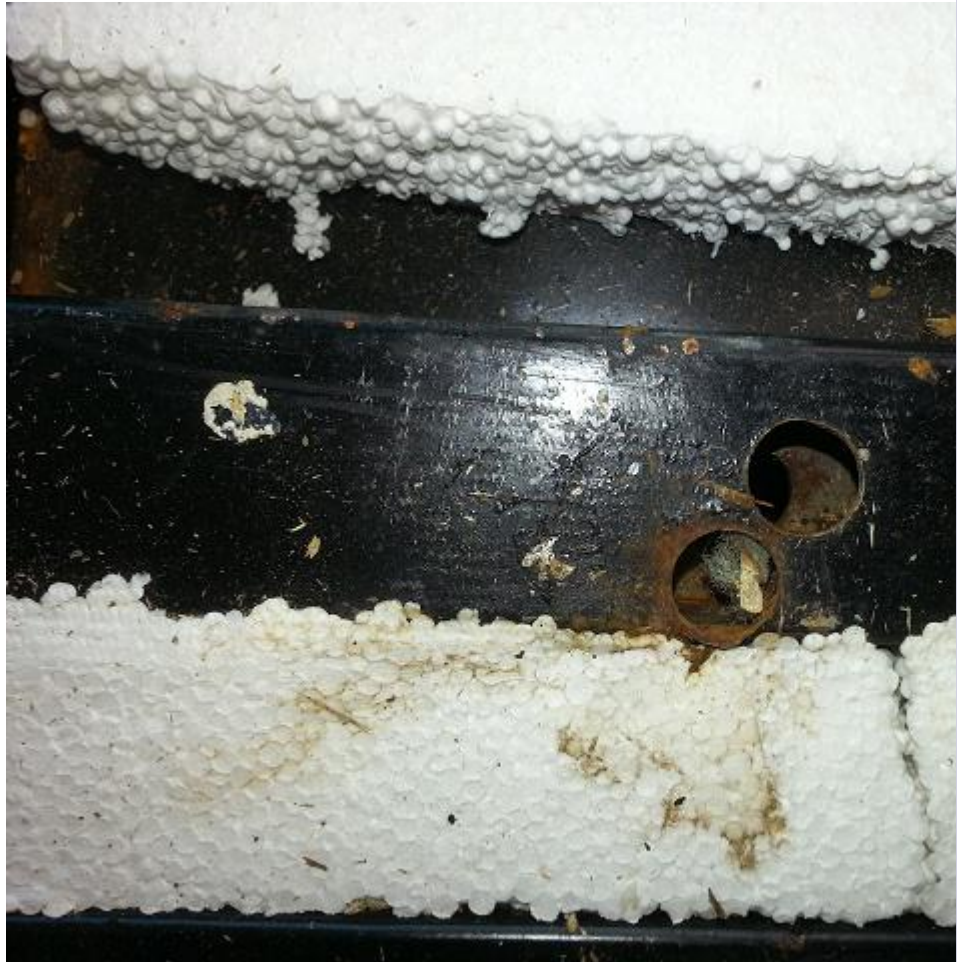
All cleaned up and painted.

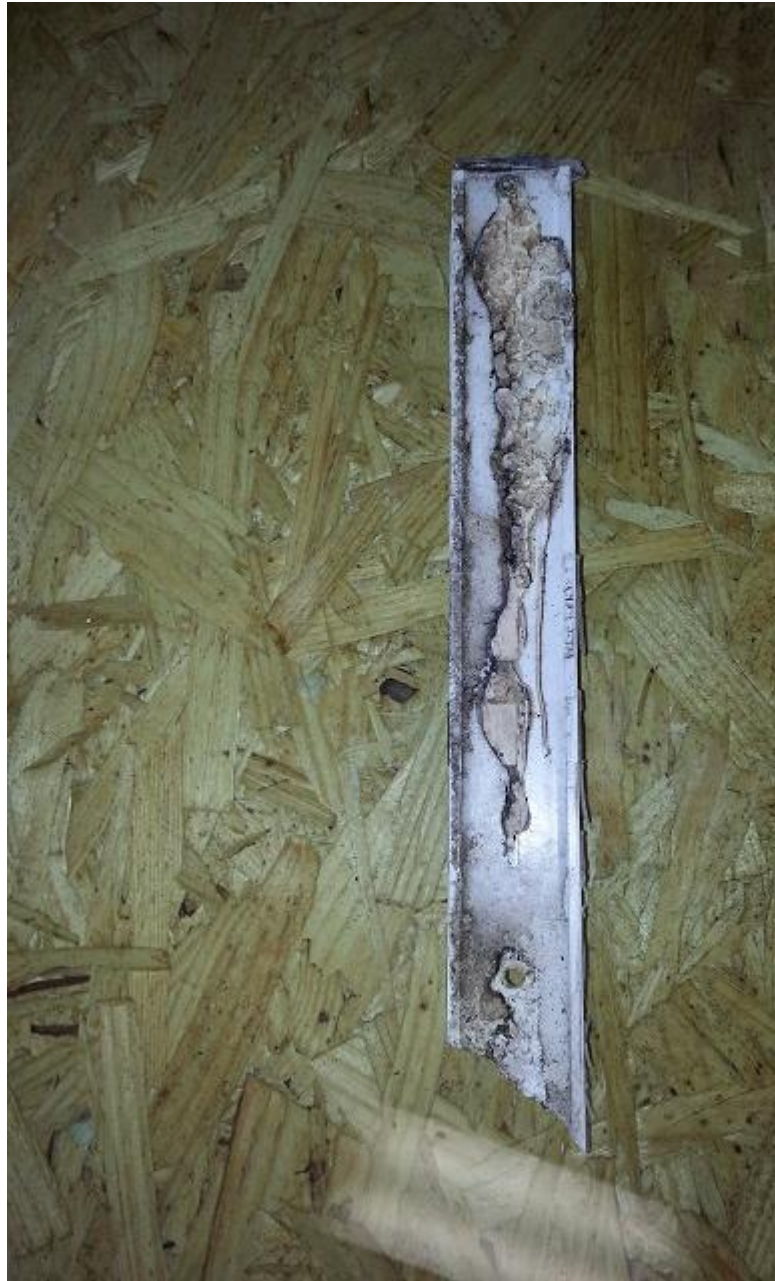
*This is the outside cap over the driver ' s seat between the  
cab and the side of the RV where the most water was  
coming in on the driver ' s side. You can see how weeny the  
caulk is and how it isn ' t completely sealed.*

*This is how I redid it. Lot ' s on the RV itself, lots on the underside of the cap. So we end up with caulk oozing out everywhere after it is screwed on. It ' s not going to leak. Take note Airstream: it ' s not that hard.*

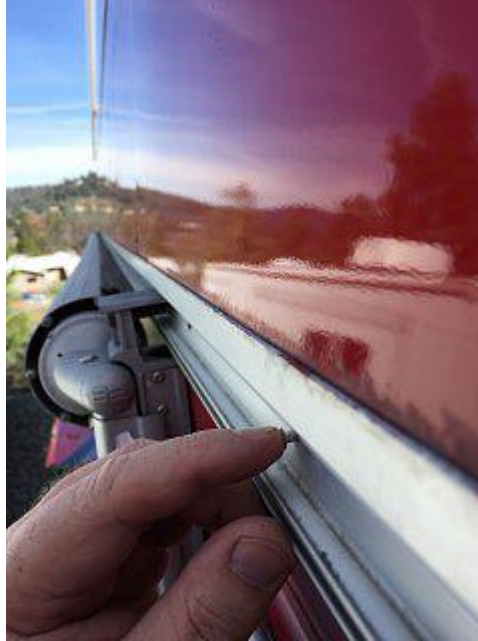
The rivets are original, the whole vehicle is riveted on the outside. The caps that cover the seams both between the front and side, and the back and side panels are then double-sided sticky taped and riveted before the full body paint. Then the outside is silicone caulked. It may be that they thought there was only the caulking needing maintenance everything else would hold. But all 4 caps in the 4 corners of my RV are missing rivets. My SkyDeck furniture is also missing rivets to the patio surround, even the awning rail that the surround is supported by is missing rivets at the front.

That is likely where all the leaking started. The rail got caught by a tree or just blew around in the airstream (pun intended). The leaks got the wood inside wet which swelled and popped the rivets lower down and more leaks. Fun! Can't wait until summer to fix the holes after the wood dries. In the mean time I have taped much of it off to prevent more leaks.

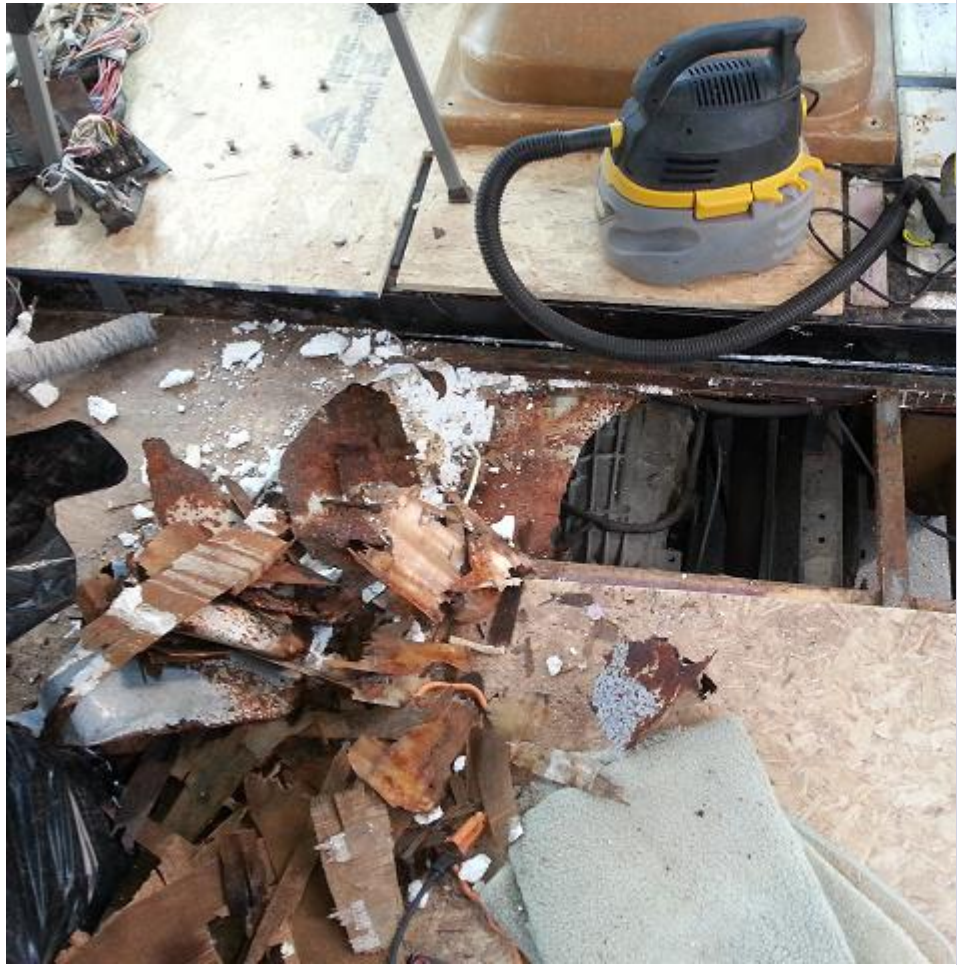
This is the sheet metal below the floor as I get closer to the kitchen. I'm so happy about this! I didn't want to see rust and rot go under the kitchen cabinets. Now, I don't have to remove them.

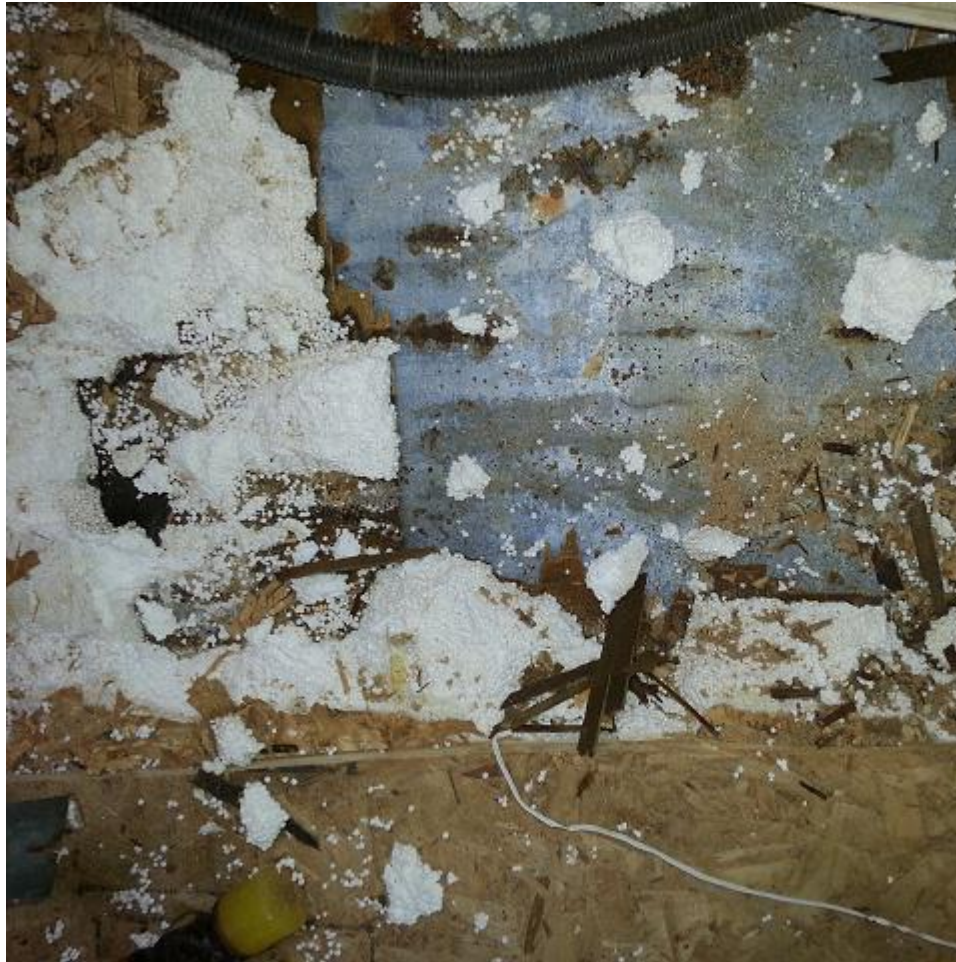
Two sections cleaned up. Notice the bolt being pointed to. This is structural, holding the floor to the chassis.

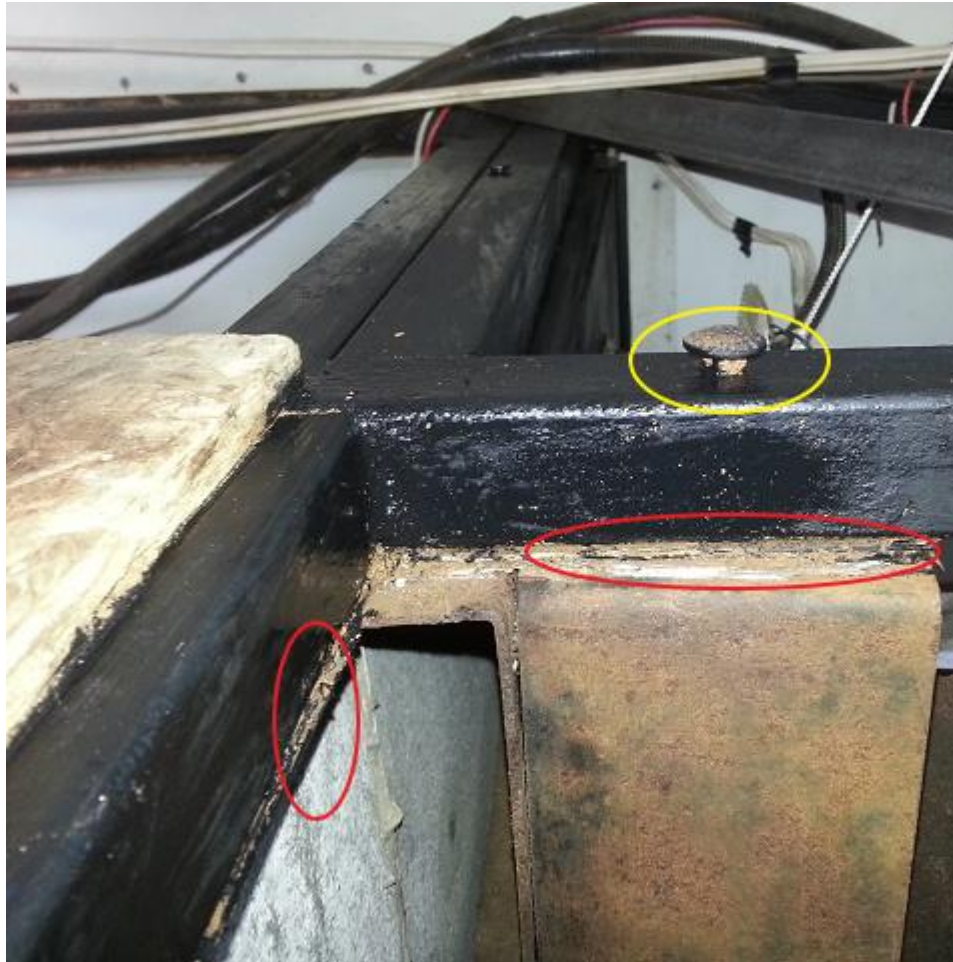
In the yellow circle, the wood floor was between the bolt head and the steel frame. In the red circle, you guessed it: luan. Rotting luan. Again, this is all structural. Not much I can do with the luan, but I did put in a new bolt flat against the frame so that at least the wood of the subfloor is no longer a factor.

I cut those bolts off using an angle grinder. A dremel would work too. Then I replaced them with bolts that were lower profile, which means almost any bolt other than what is in the picture. Then I only had to cut out a small piece of wood to get the wood to seat properly. If I had just notched around the existing bolts, they would still be above floor level, and since I put down tile, it could have been a problem. If you are to put down carpeting or even a finished wood floor (which can also be ground out a little), you should have no problem just keeping the existing bolts and just notching out the wood. But you would need to have a really tight fit, meaning the wood would want to go under the bolt to support it since it is a structural bolt.

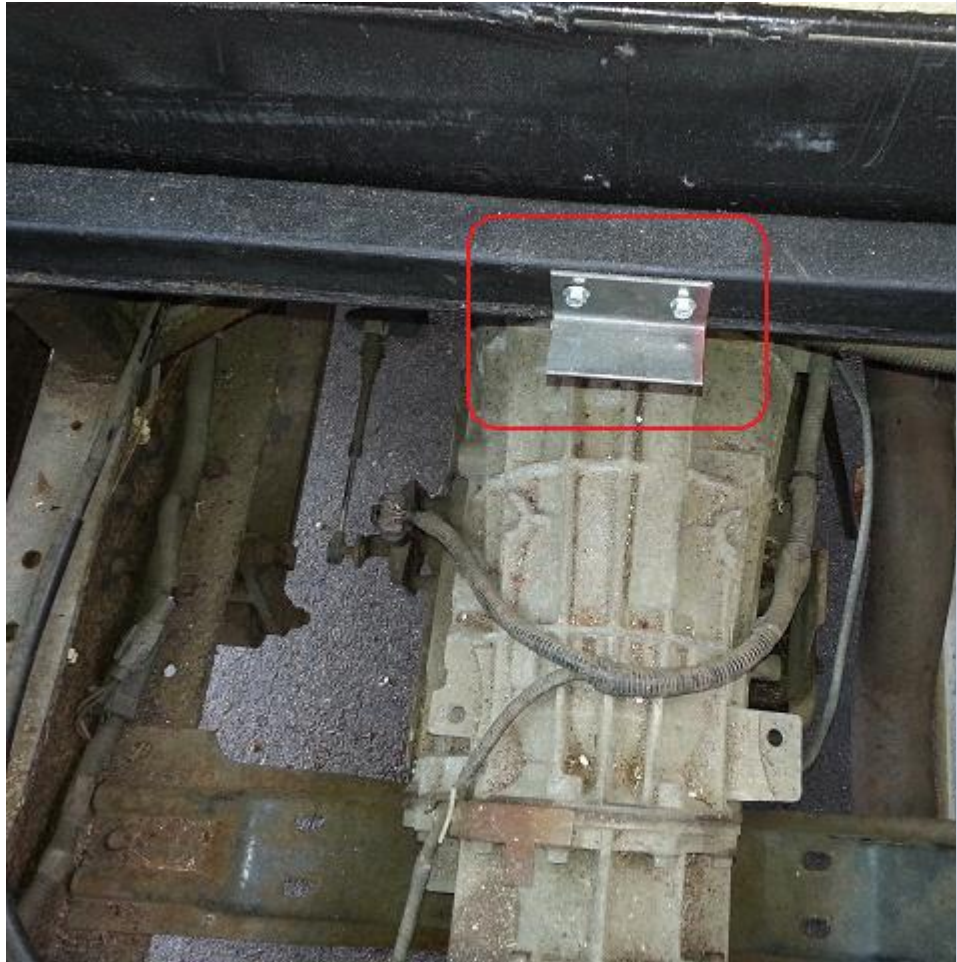
If you look again two pictures up, you can see that these are really big spaces between the frames. The center opening above the transmission is something like 26" x36" . It might have been ok when the RV was new and everything was laminated together, but now that it' s all fallen apart, it needs more support.

So I bolted in these pieces ...

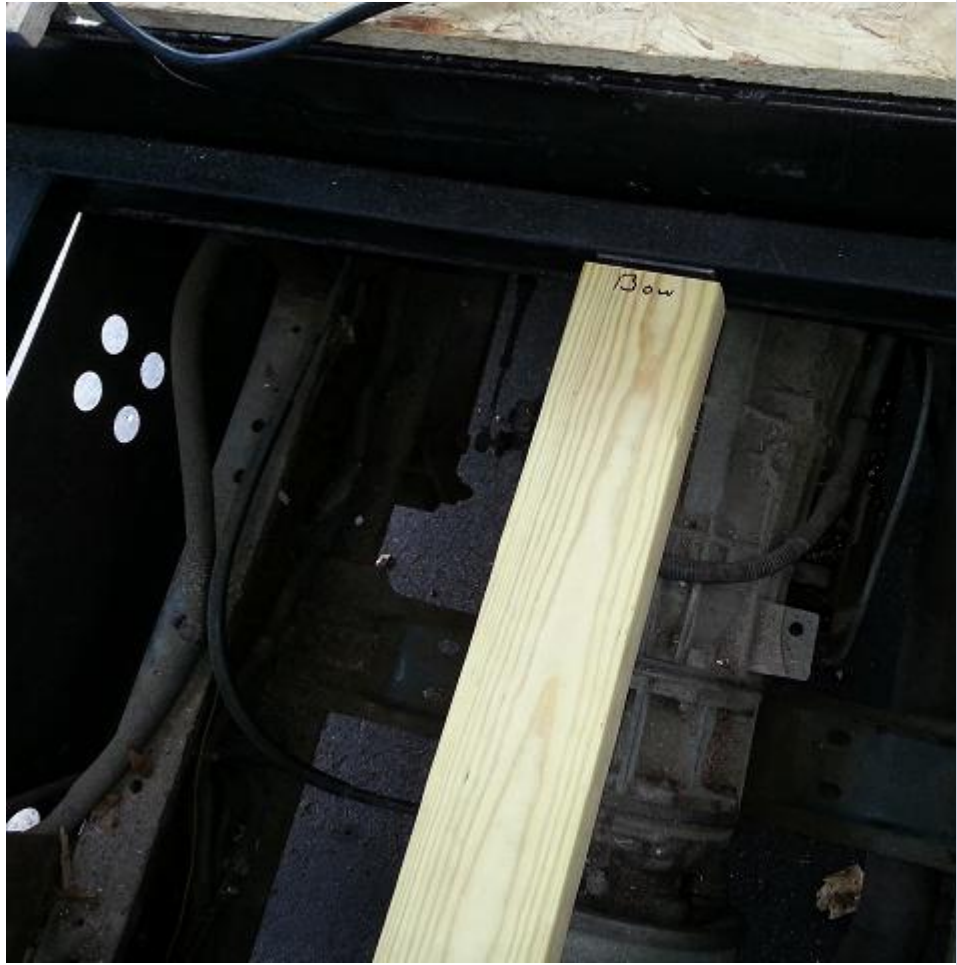
... to support this wood. This is pressure treated. It cuts the size of the hole in half.

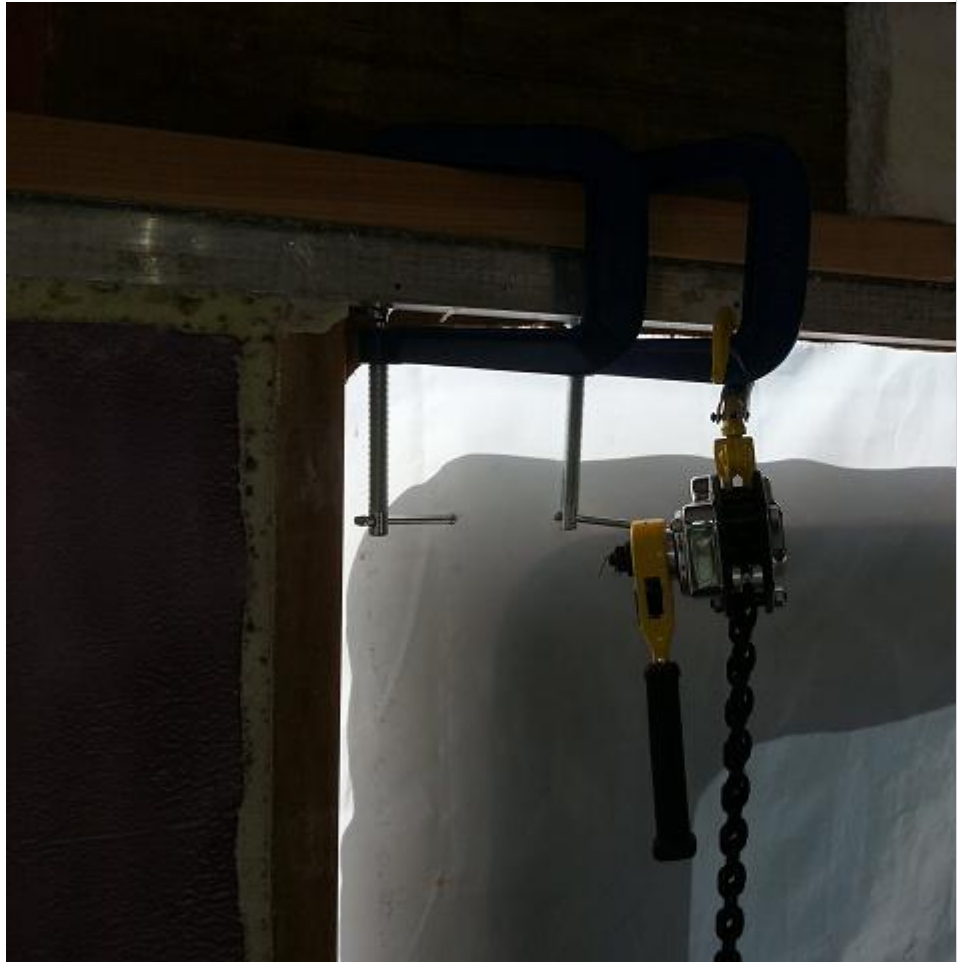
The small hoist I used to lift out the propane tank.

had to remove the floor--because pulling the tank up with a chain hoist was fairly easy. Getting it out any other way would be very hard, I think. My guess is that it weighs somewhere between 100-150 lbs. At least it felt that way given the awkward position. And I also found, at least on my RV, that if I lowered it to the ground (which would have been really hard to do if I didn't have access through the floor given that my bolts were behind the tank), it still wouldn't fit under the edge of the RV without jacking up the RV. So if you can do it in place, that, I think, would save you a lot of headache.

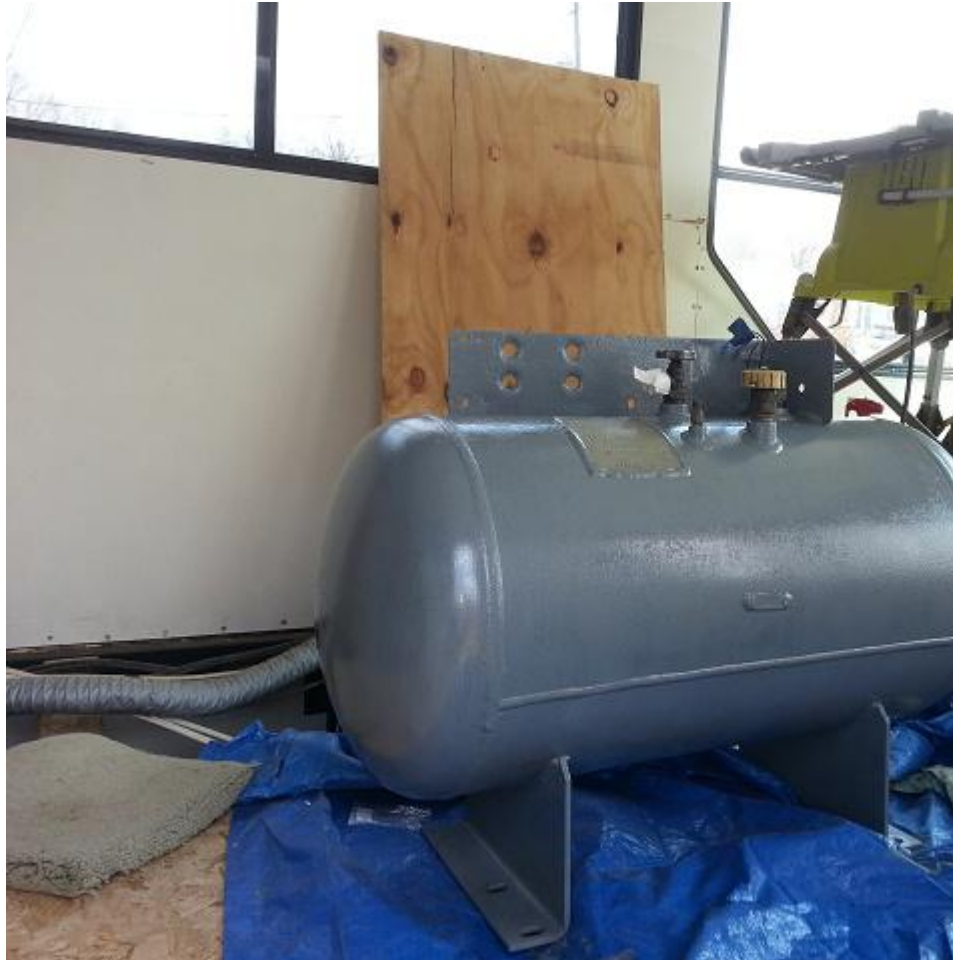
Propane tank de-rusted and rustoleumed. It still needs another coat.

I can't really pin down why the tank rusted. Yes, the floor was leaking, holes right above the tank. But the compartment is also open to the road below, open to tire and road spray. Maybe it wasn't painted well enough to begin with. Just don't know.

So I just used a wire brush. As bad as my tank was rusted, it only took a couple of hours to clean it. But what I found is that a softer, stainless steel brush instead of the normal, hard steel wire bushes with the wood handles works much better. I can brush the rust with the hard brush, and yes, a lot of rust comes off. But when I brush it with the soft brush, it almost all comes off.

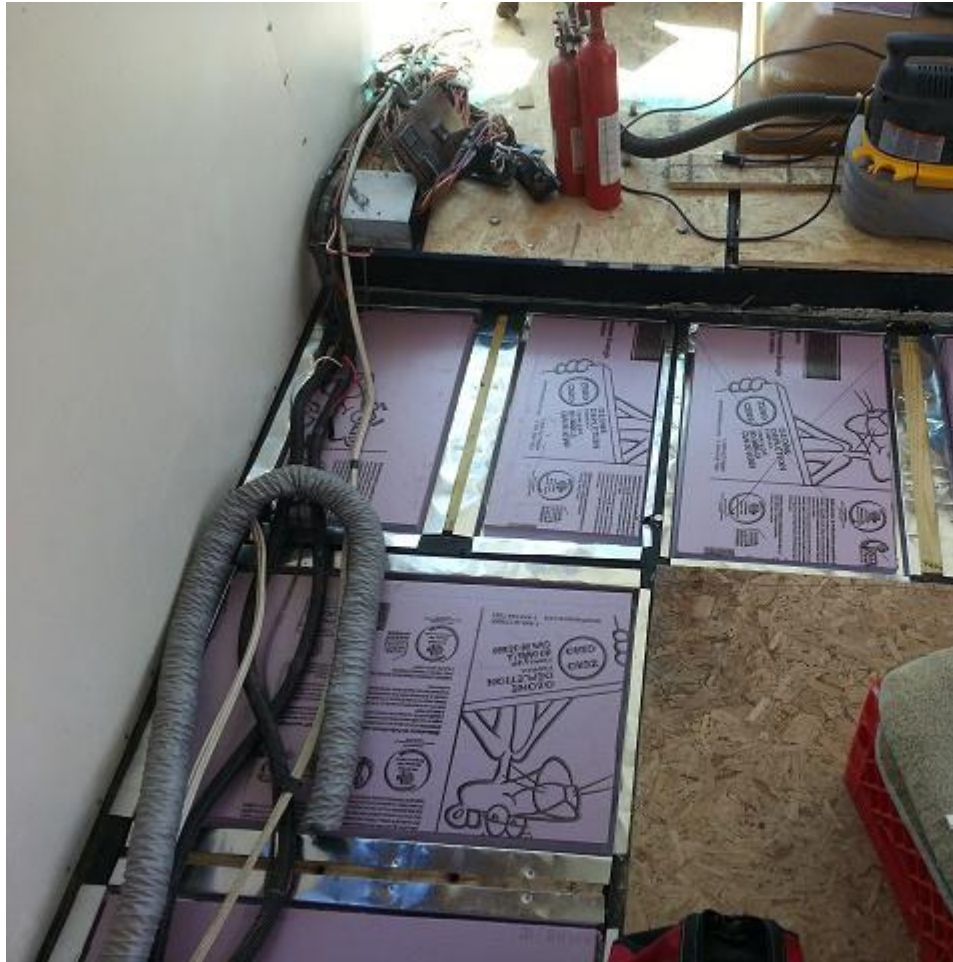
And then the insulation. As in other places, it's cut a half inch shy of all edges which will be filled with spray foam. The sheet metal will also be riveted to the frames. Yes, the wood beams I added are bare, but remember, they're pressure treated and should be fine.

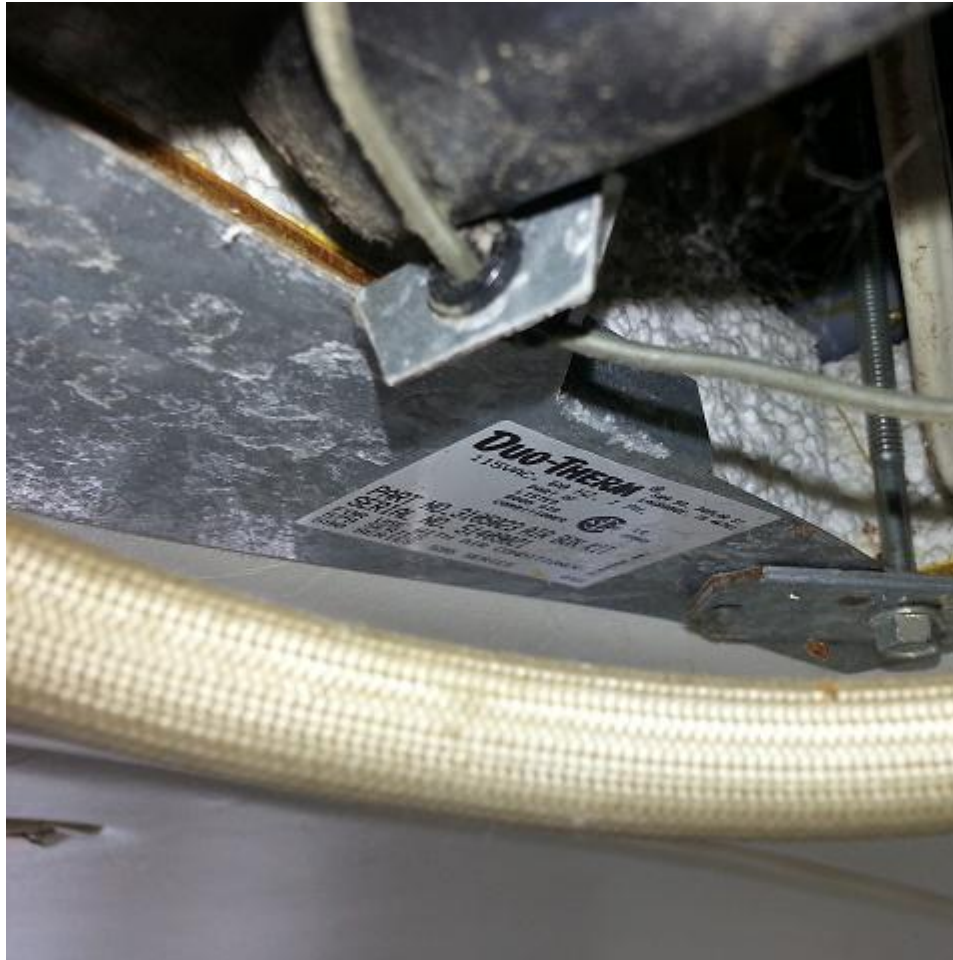
... uh oh. What happened? Run out of long bolts?
