## Massive leaks and destruction

About a month ago I acquired a 1996 Airstream Cutter Motorhome. I paid vaguely below the lower end of book value. Before I bought it, I knocked and pounded on all the walls, looking for any soft spots. Everything seemed good. Here'st it looked like when I bought it:

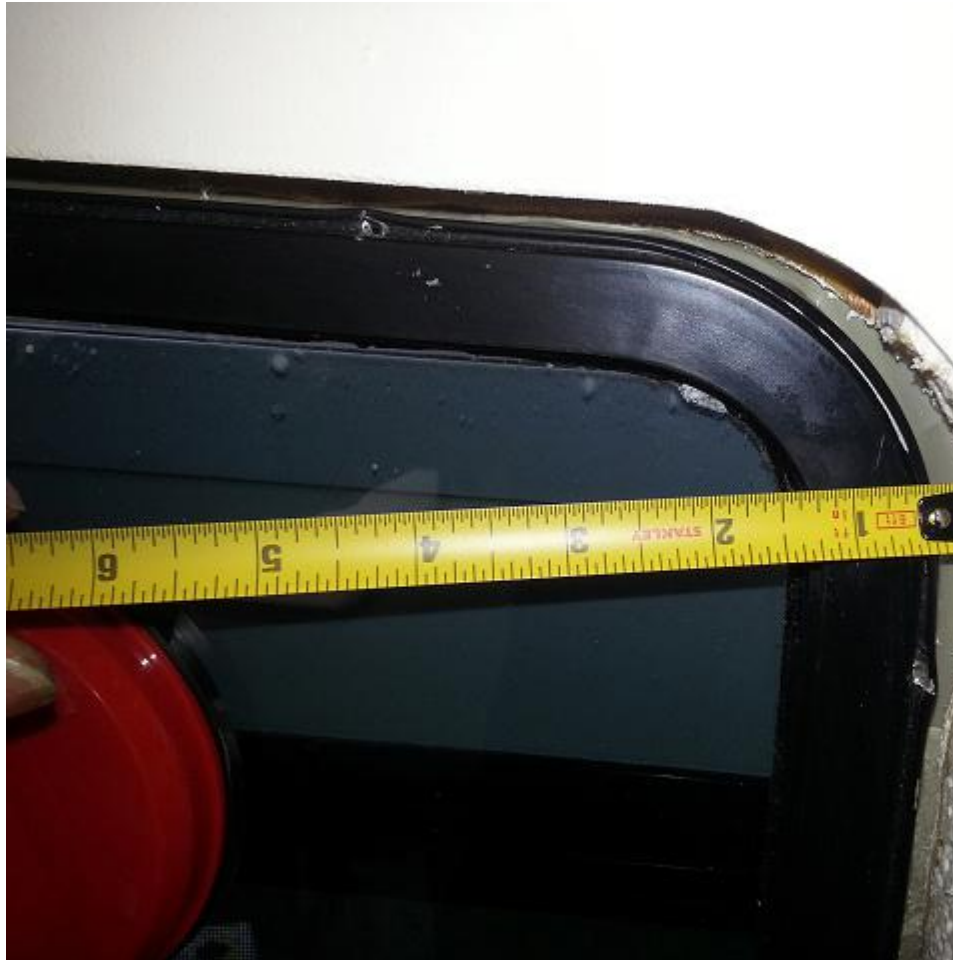
Um, well, that's a lot of space.

A little background: This window was leaking badly. It is right above the propane tank. You know, where the floor was rotted out, where even the sheet metal was rusted through, where the propane tank was all rusted...

And this window is the only repair work attempted by a previous owner that I found. I say "attempted" because, of course, the window was still leaking. But it had been taken out and completely resealed by someone. But it couldn't be done properly because the hole in the wall is JUST TOO BIG.

To put that in greater perspective, that means the window frame will only overlap the fiberglass skin by  $\frac{5}{16}$ " (0.79cm) top and bottom and  $\frac{3}{8}$ " (0.95cm) on both sides. That's not workable. That's why it was leaking.

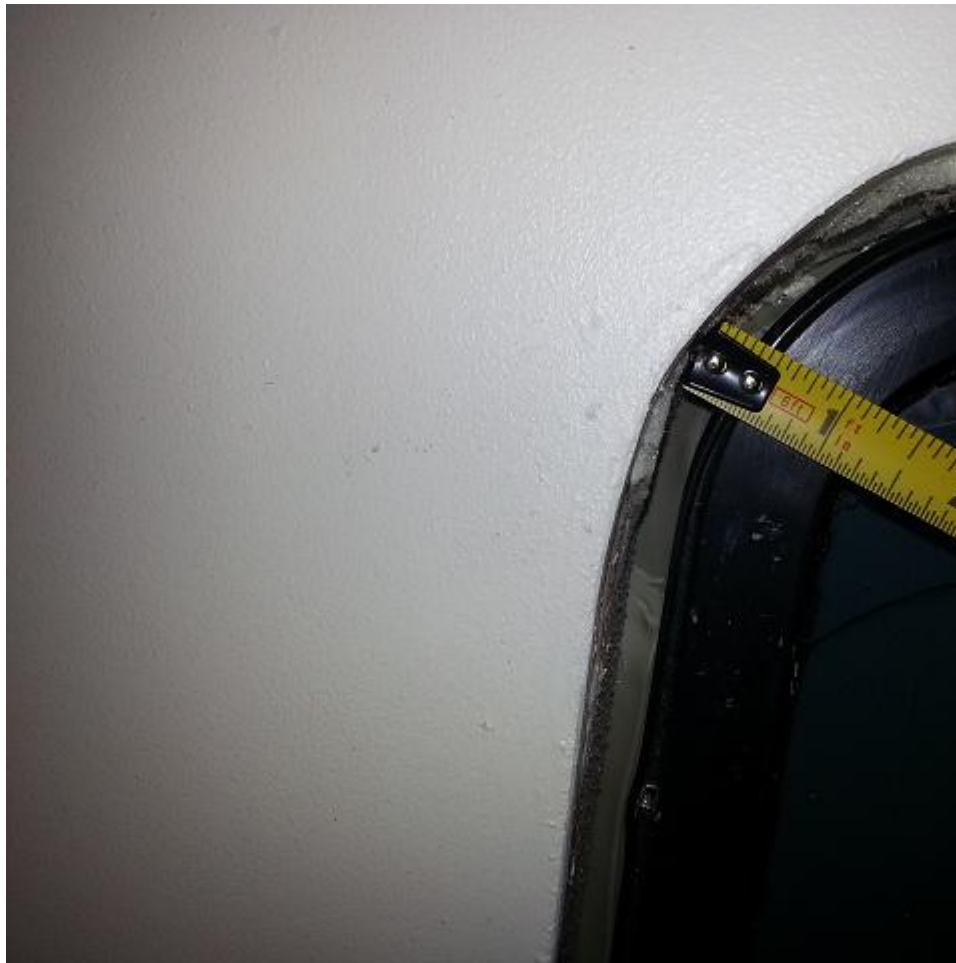
I tried to make it work, but ruined the butyl tape twice. Here's why (see the diagram; the flange is the curved part). There's just such a big gap that there's nothing to hold the butyl tape in. And that's assuming you can get the window perfectly centered in the hole, which is very difficult. I mean if the window is only  $\frac{1}{8}$ " (0.31cm) off, then one edge of the window will have only a  $\frac{3}{16}$ " (0.48cm) overlap. If you try to slide the window while trying to center it, the tape gets all fouled up. And even if you could place it correctly, how can anyone guarantee that this window will never move when the whole RV is rocking and rolling and twisting and shifting on down the road? They can't. It doesn't have to move much to develop a leak. It's

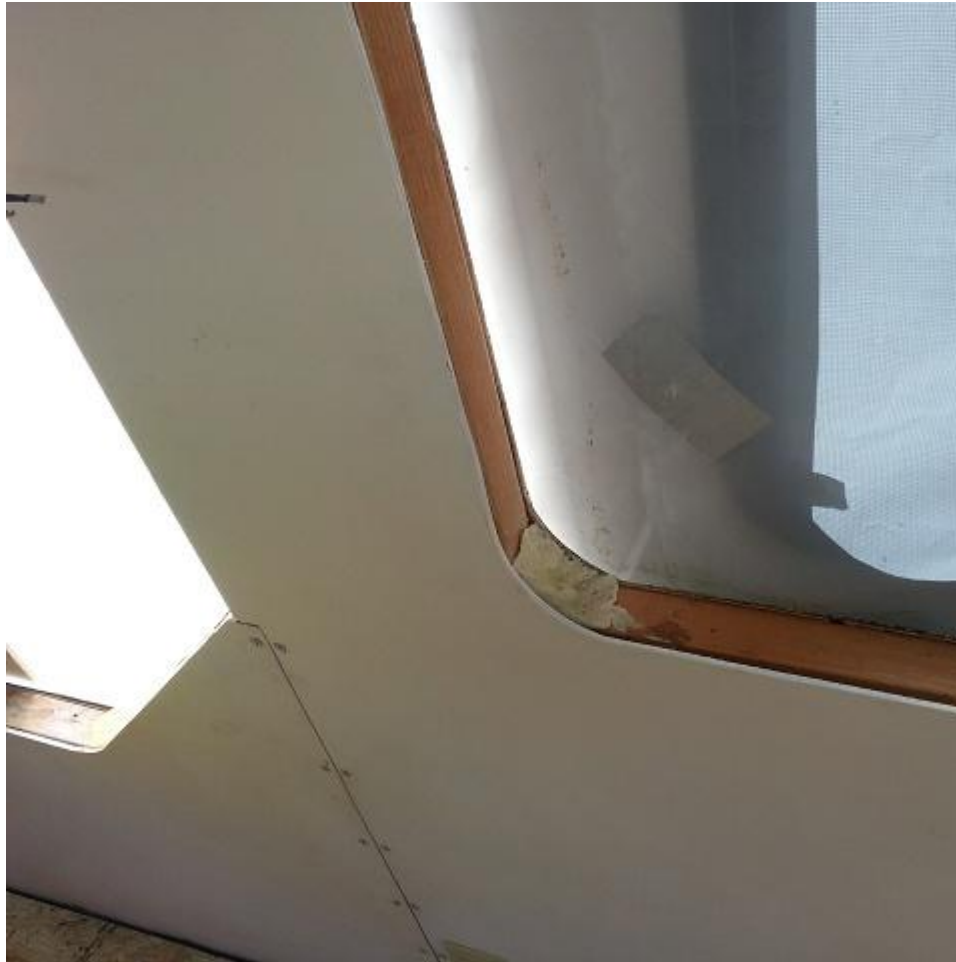
Here's the bottom left of the window opening. The wood you see is wood that I had put in previously to better support the window. That's going to help with trying to fix this.

The below diagram shows what's in my mind at this point. More epoxy coated wood, filling the gap, giving more surface area for the caulk. That, I think, will solve the problem (of course, the 1.5 x 1.5 wood is not to scale). I hope I only need to do this on two of the four window edges—where I have my existing 1.5 x 1.5s.

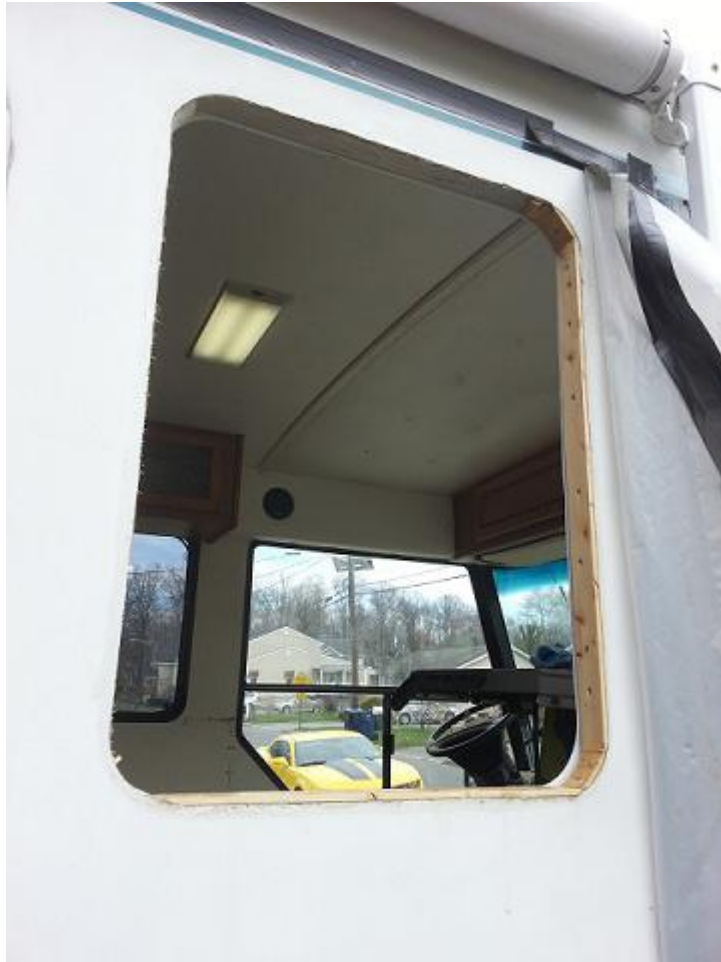
This is what I did to make the window frame smaller. It doesn' t look too pretty, but the wood is encapsulated in epoxy and it does what it was meant to do: made the opening smaller. Now there' s more surface area for the window frame to catch.

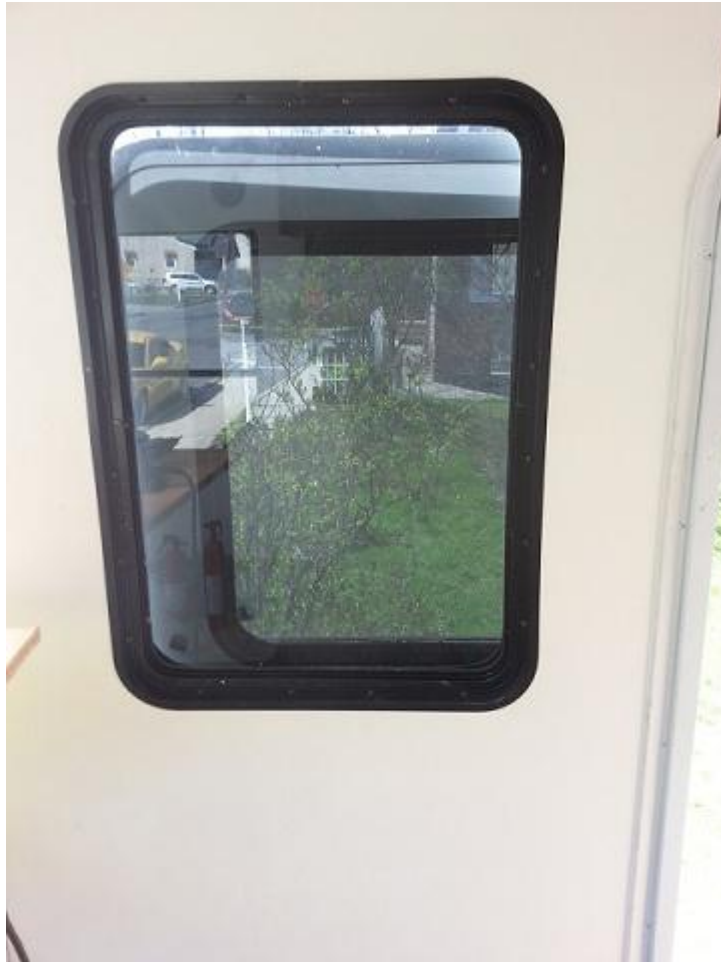
The window is in and fitting tight. I have confidence in it now.

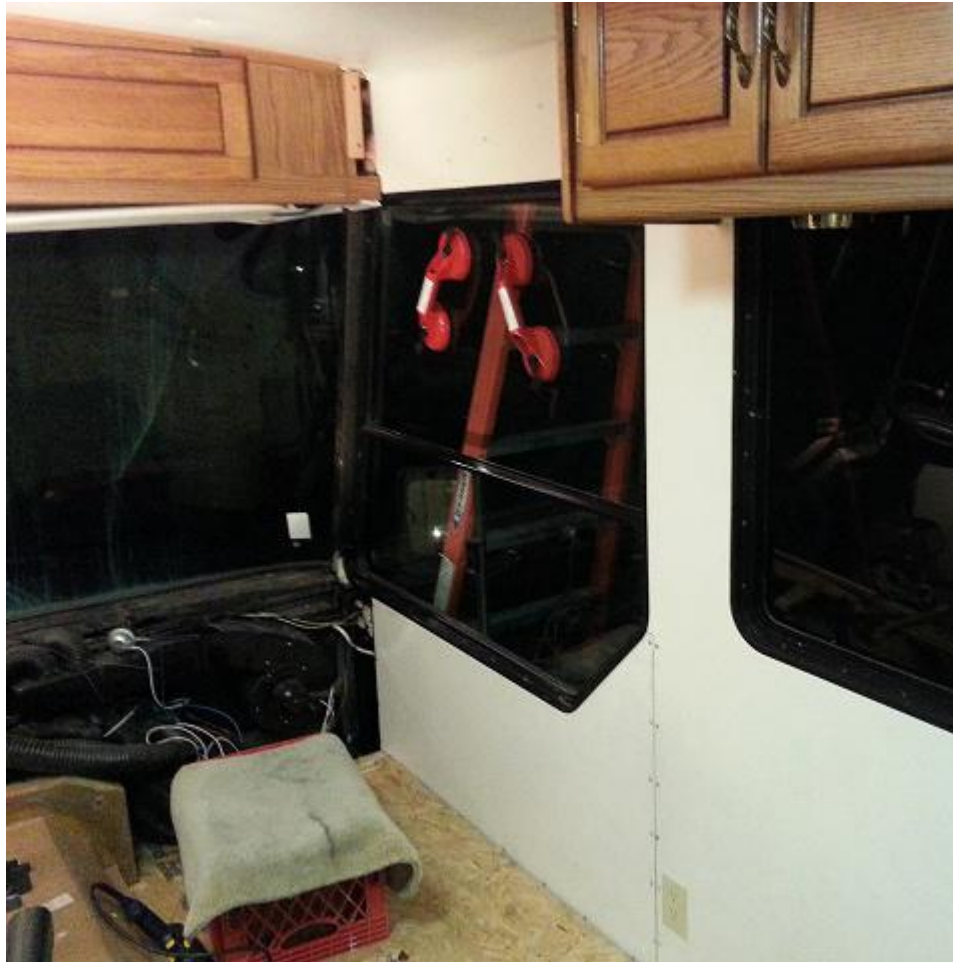
And finally, the front passenger window goes in. Now all the windows are back.

The day after I reinstalled the front window, it rained, and the frame was dripping. It was coming in right in through the joint itself. For now, I just taped it on the outside. I' ll deal with it another day.

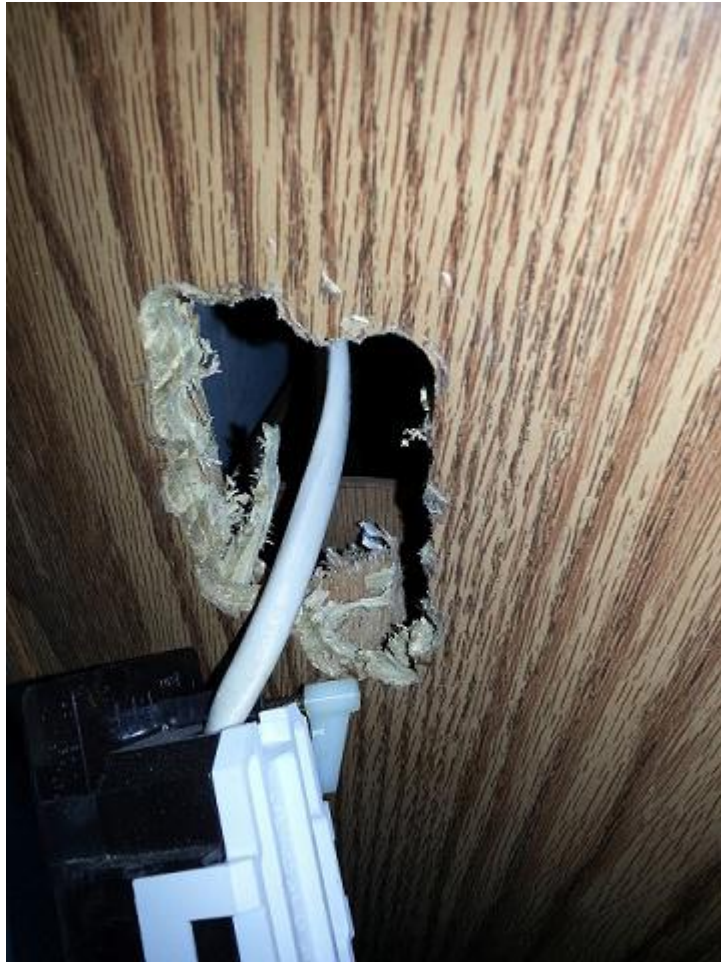
This receptacle was loose. I took it out to find out why. What a way to cut a hole--just hack it out with a drill bit.

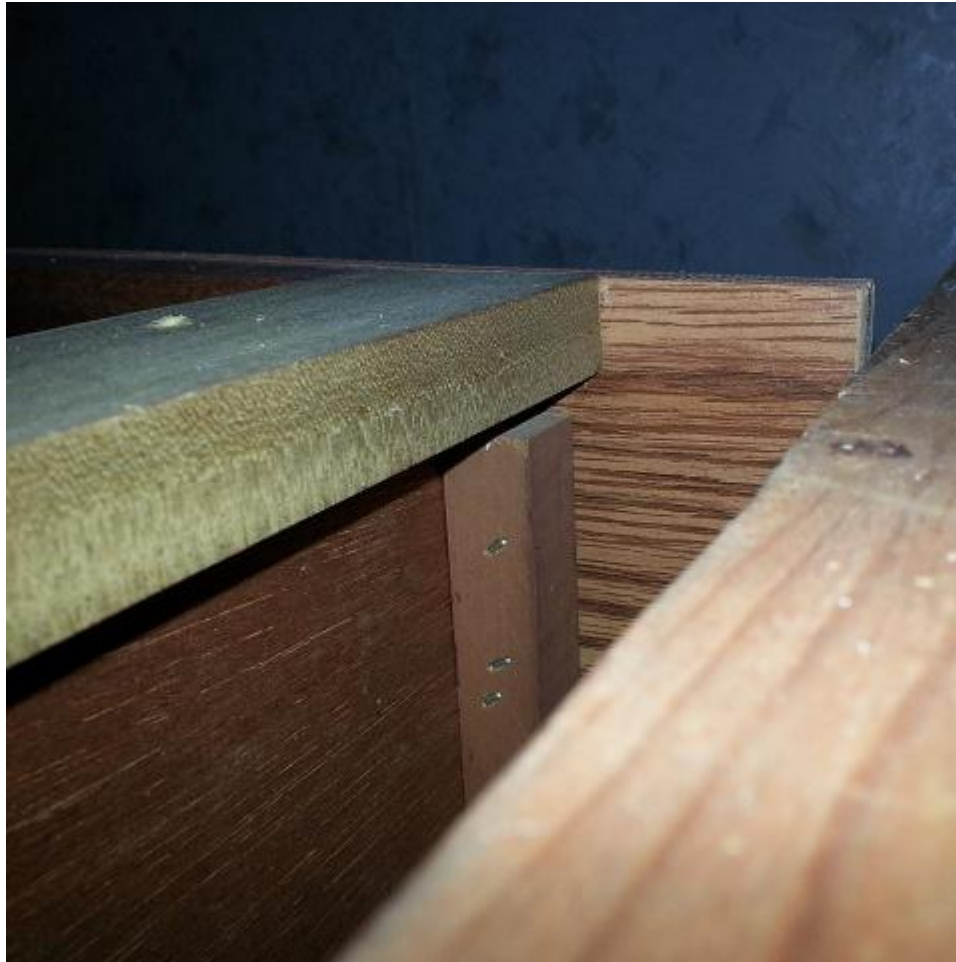
The couple of times I lay down on the bed, it felt strangely uncomfortable, but I couldn't figure out why. Here's why. The bottom half of the bed is  $\frac{3}{4}$  of an inch higher than the top half. It's fixed now.

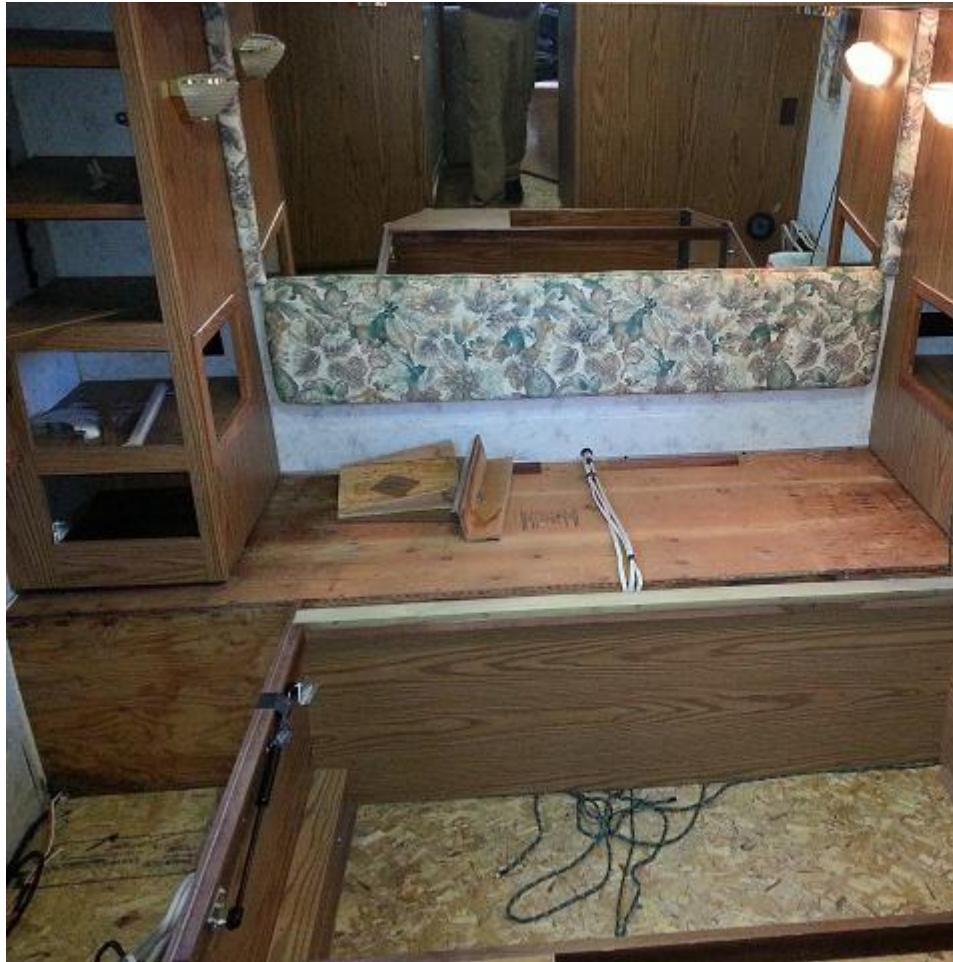
Then, unfortunately, I found more water damage and so tore it apart. There was mold that I killed by spraying pure bleach. But it was actually not that wet. The foam under seemed dry and strong. The line you see under the window is where I'm going to cover it with Masonite.

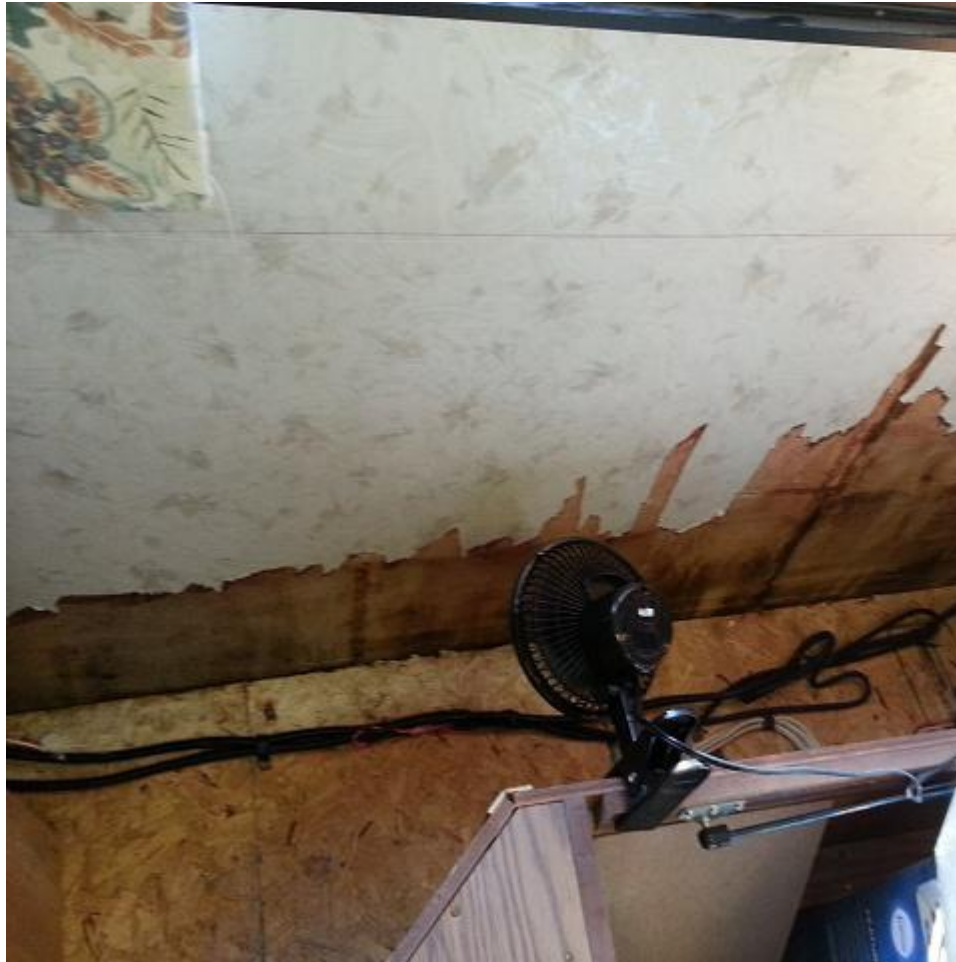
This is inside of the removed corner cabinet. As bad as this looks, it was easy to cut out and not really that wet (This was the same on both sides of the motorhome). This was leaking from the outside molding between the back, fiberglass cap and the fiberglass siding. I had fixed the caulking months ago.

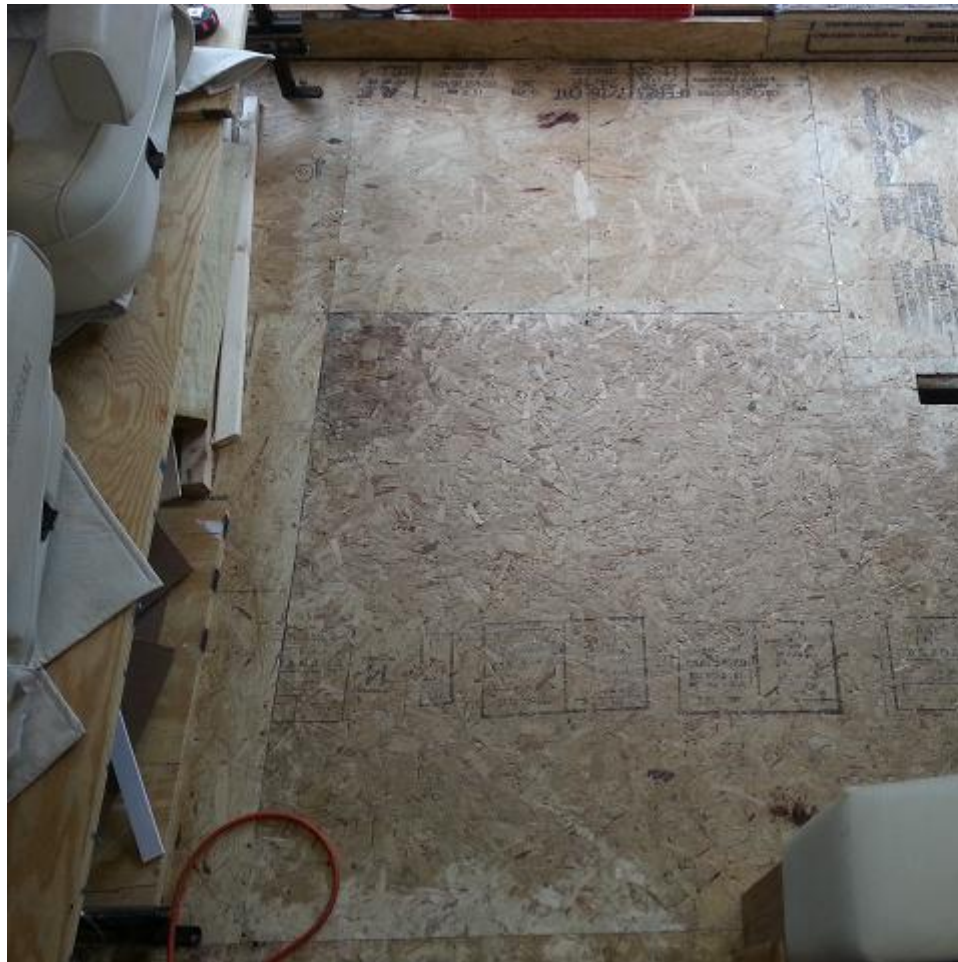
First, I don't think I ever showed the final floor pieced together. Only the center is original. It's now dry, insulated, sealed, and ... done! (You're looking forward. The seats on the left are just being stored.)

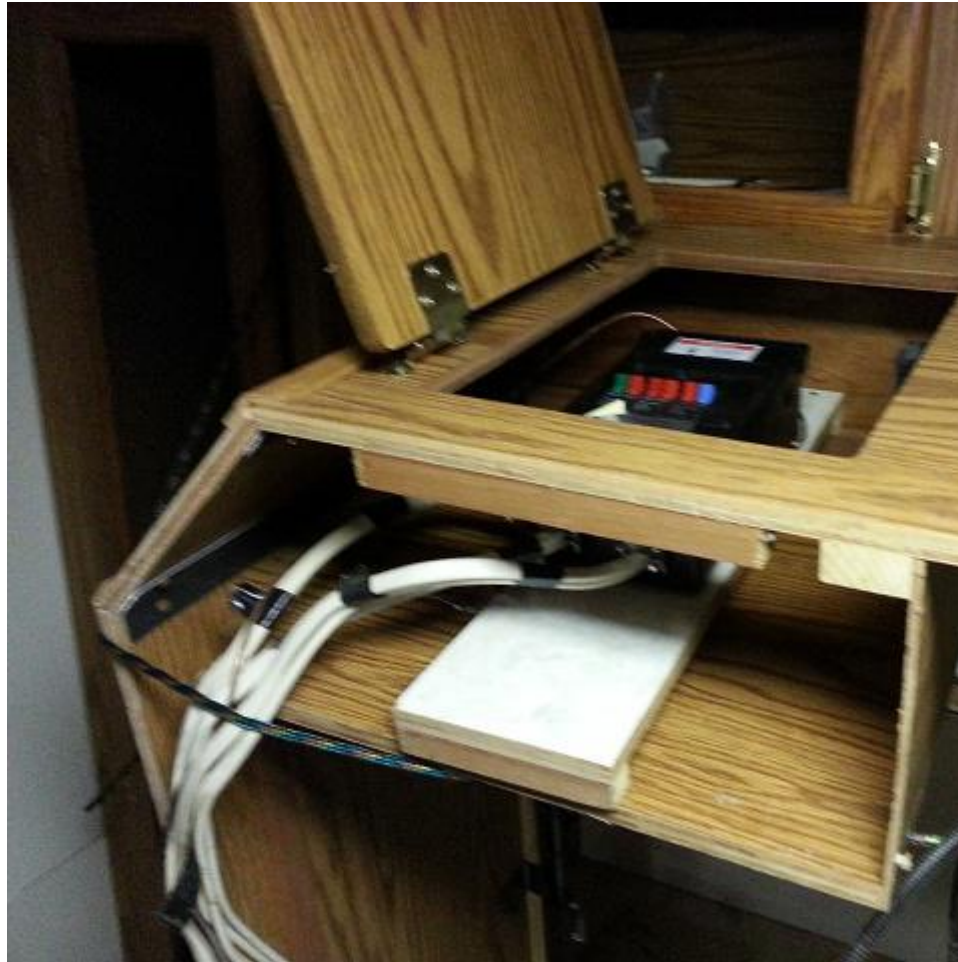
This is the electric panel on the upturned bed frame. This is Airstream's placement: toward the top left and deep inside. When the bed is down, the only way to see anything is by getting on the floor. I moved the box toward the front, down, and to the right. Now it's reasonable to access when sitting.

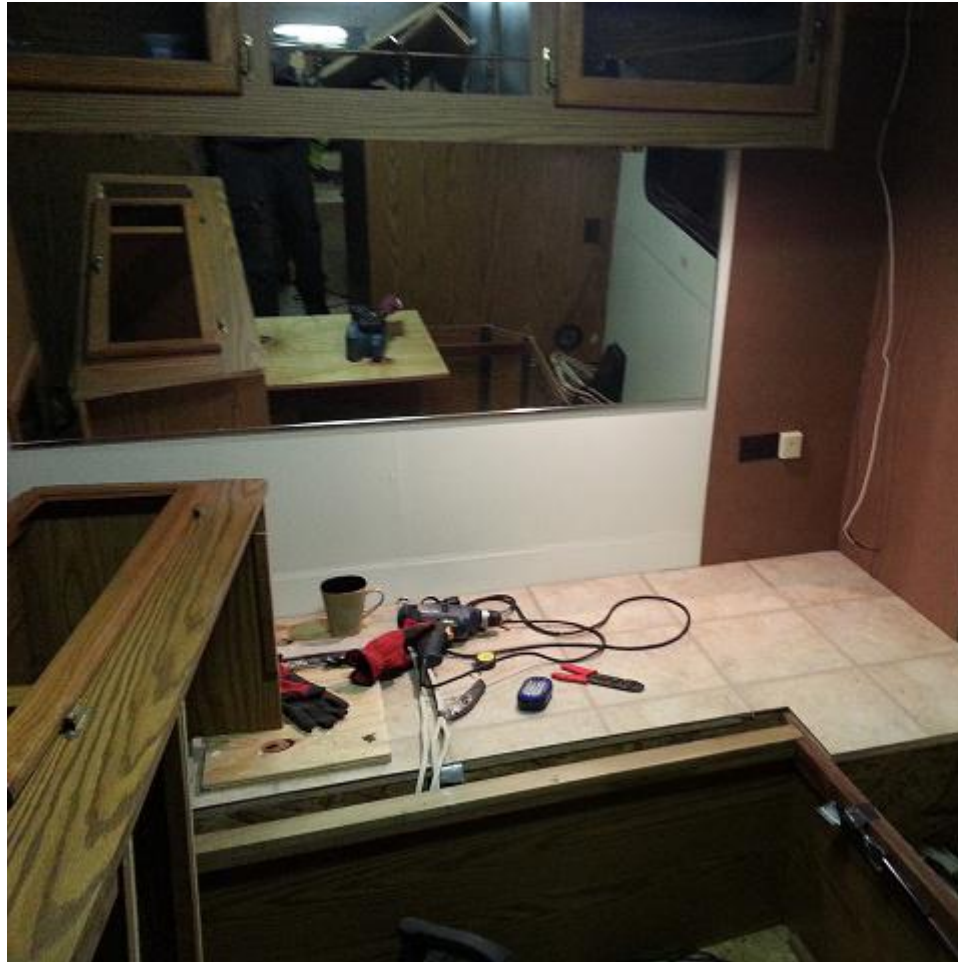
The tile going in (Allure). I put a quarter inch of cork under the floor everywhere for added insulation and to even out the floor seams a bit (even though I did belt sand them all).

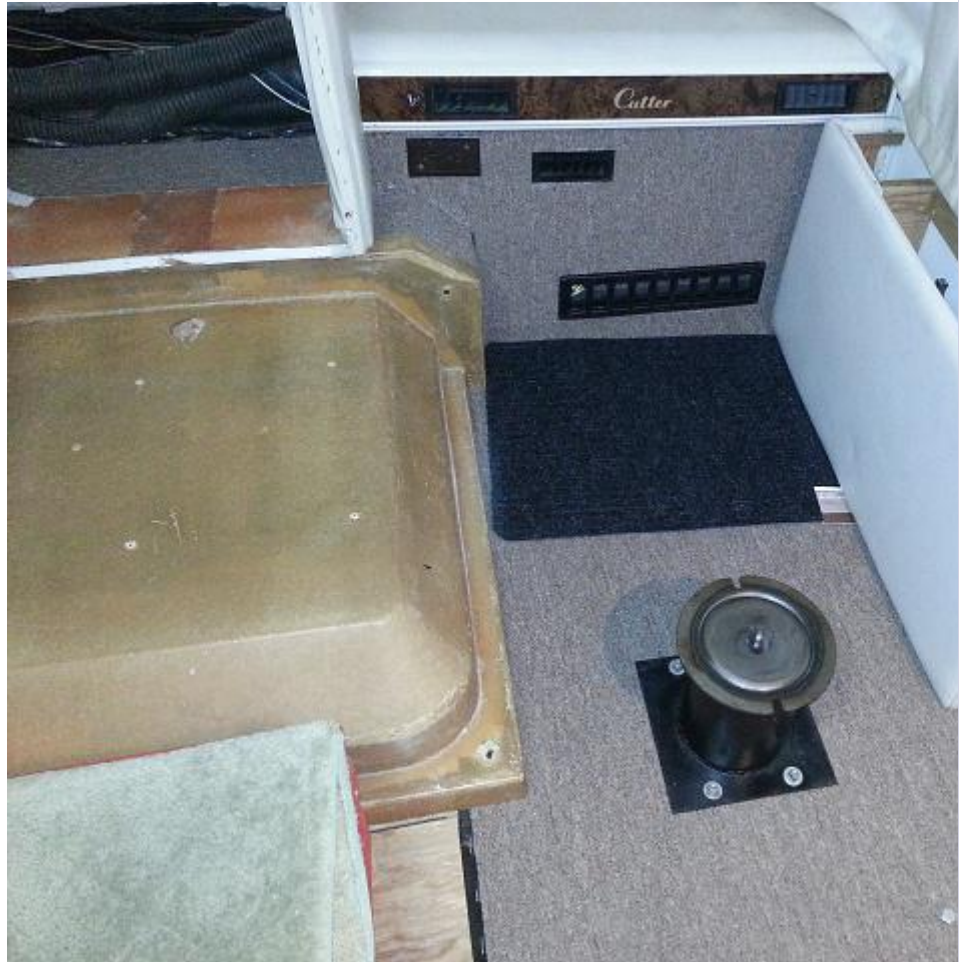
The frame for the television was plastic, cracked beyond repair, and ugly. So I put this together.

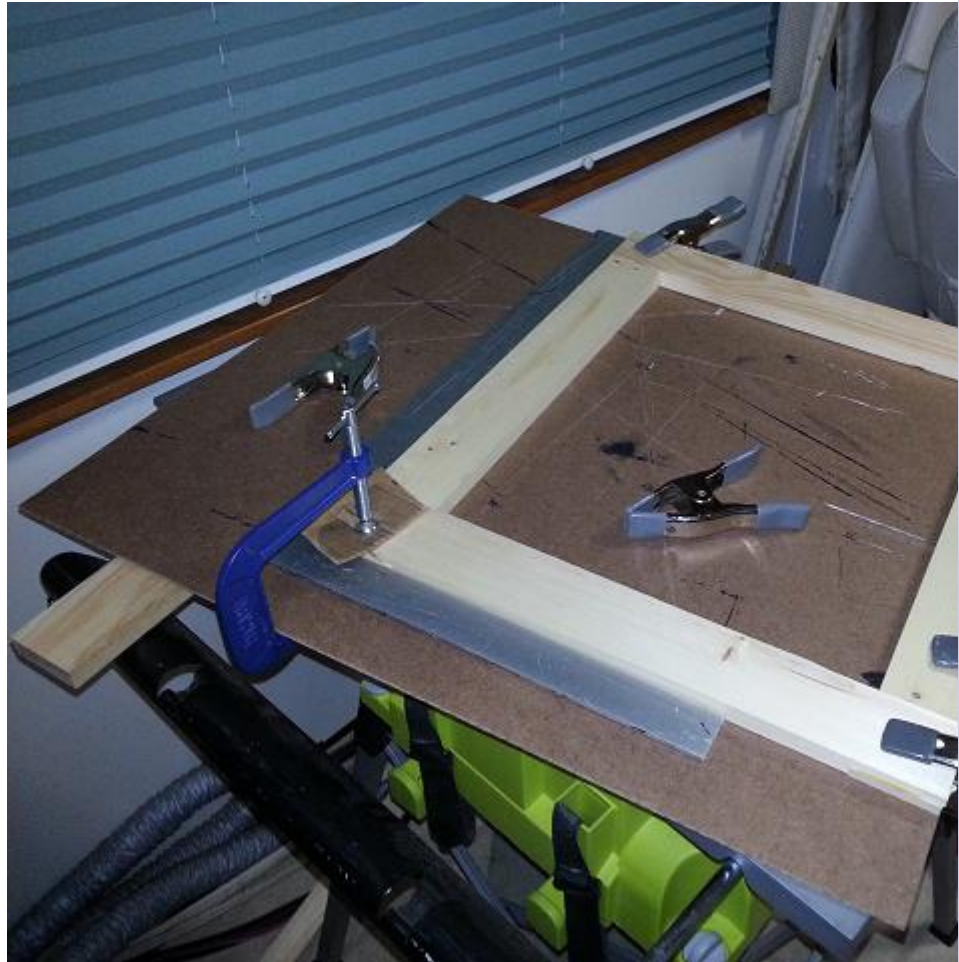
Decent joints, I think.

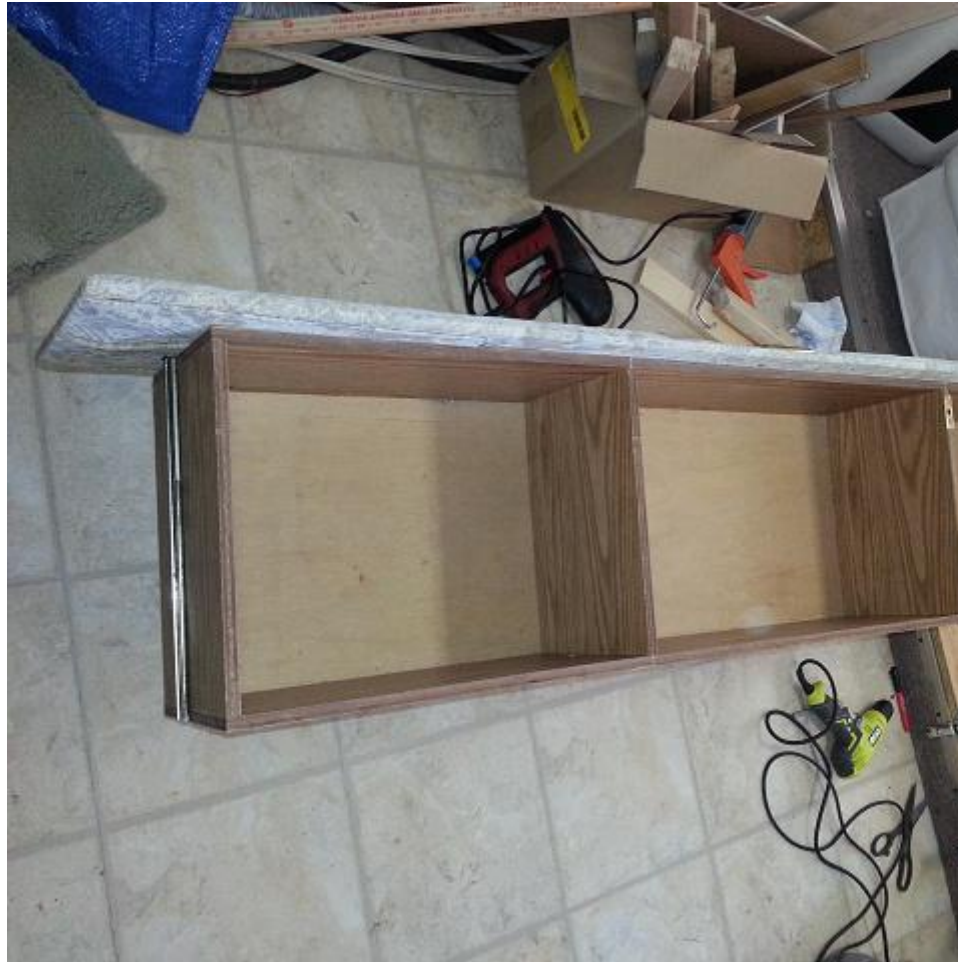
Here's the storage under the new one. That's its biggest asset. Including the chair, it's about 3-4 times as much storage. That small ledge in the back corner of the cabinet is covering electric wires. It's removable.

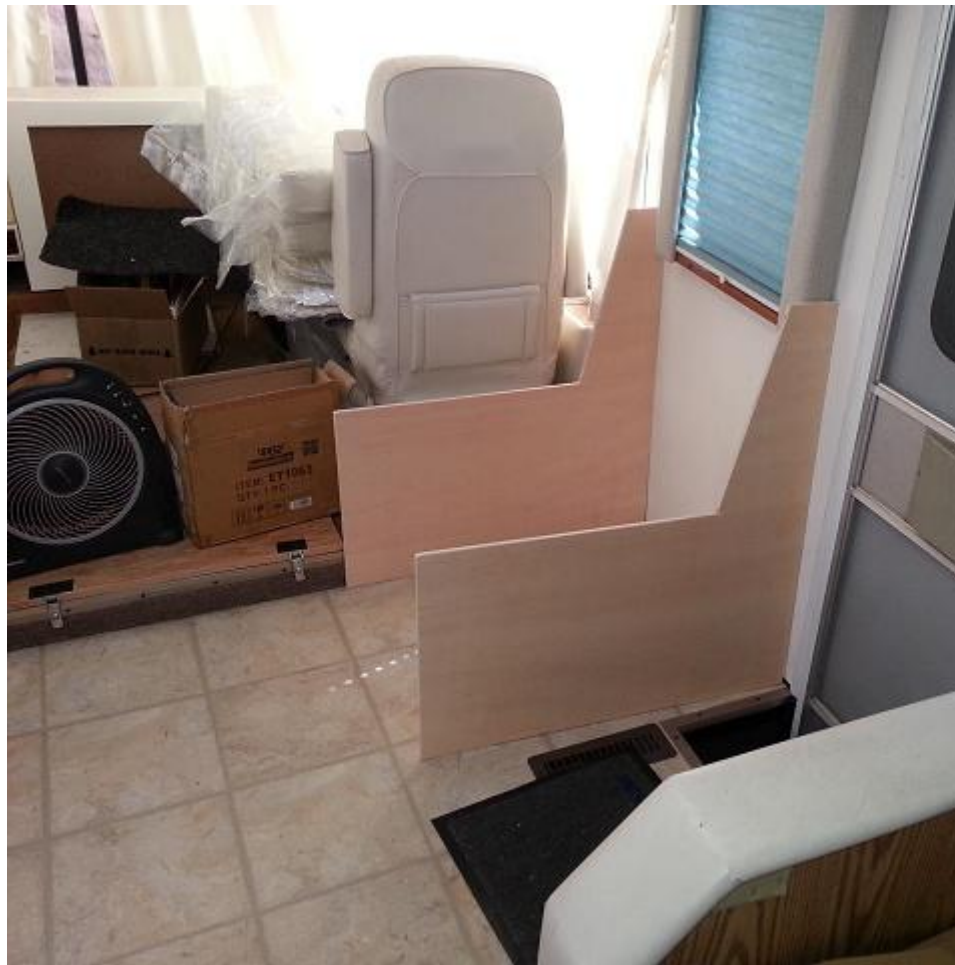
The sofa's skeleton. As I said before, I came from sailboats to RVs, so this design is much closer to what you'd find in a boat. In a boat, it's almost a sin to waste space. This wastes nothing.

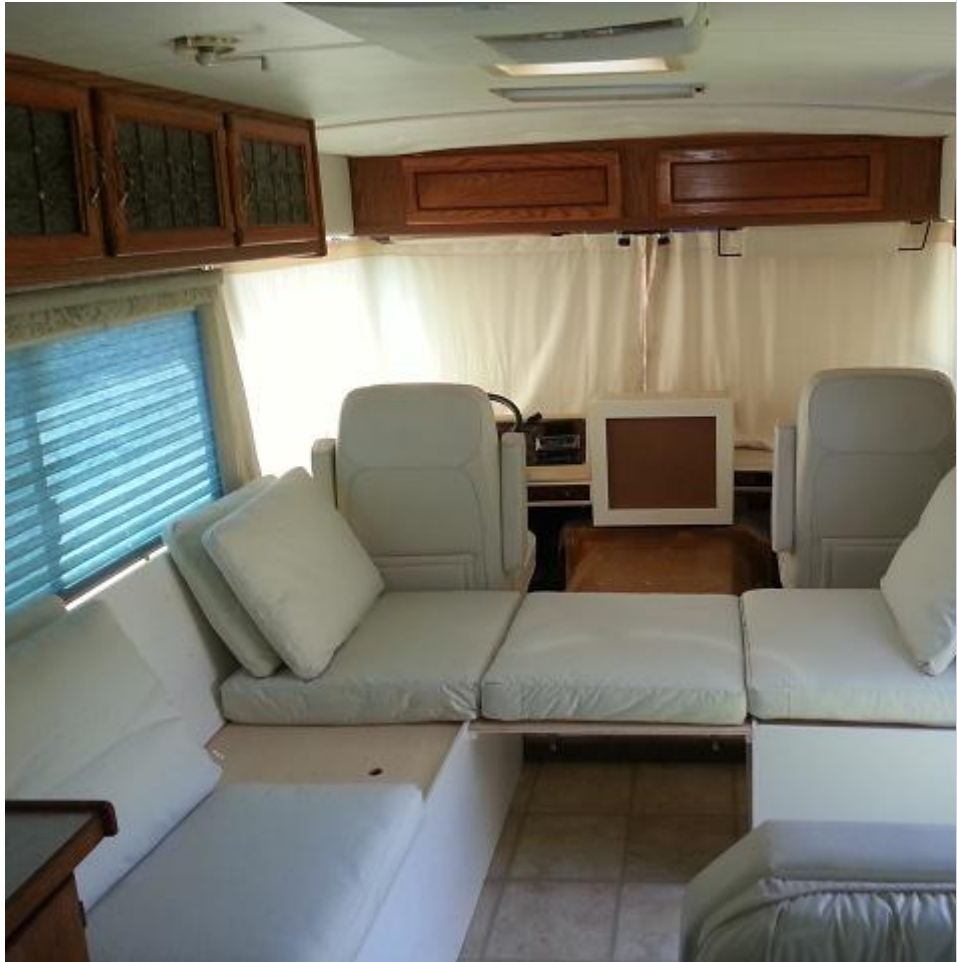
I really built this console just to make it all fit. But it's worked out really well. There's a cubby hole in the front and the back lifts off for storage. Again, this is not the best design, but for an old RV ... I'm pleased. And it's still so much better than what was there.
