Battery Upgrade

I have completed my upgrade to 4 6V Lifeline Batteries. As others have stated, this is a big project. A lot of research has gone into this and I have received help from many forum members. Thank you for the experience. I am posting so that others can improve on the knowledge base. I was dissuaded from going to Lithium due to expense and the lack of data on lithium longevity with the stock charging system and once I priced out the other upgrades, felt that I don't have the time to do this on my own. RV Season is here!

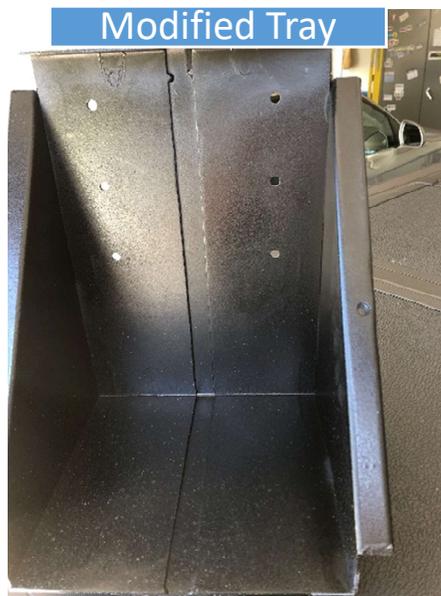
The battery boxes were modified by a hot rod shop that cut the boxes/covers in halves. They lap welded in a 3 inch wide steel sheet of identical gage material to increase the tray widths to accommodate the new 6V bats. This dimension was ~7.2 inches. The trays were painted and then I added seam sealer on all non-welded seams and repainted.

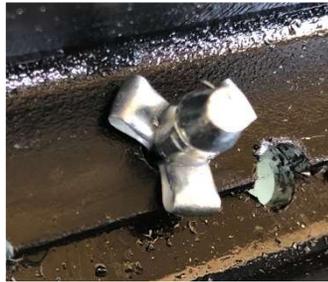
Steel Tri-Fold

Before I installed the trays back in the coach I investigated the rivets and the technique to install them. I have pictures of the TRI-Fold steel rivets used by AS, Stainless steel rivets and the aluminum ones supplied with the inexpensive tool from Harbor Freight. The effort to install the rivets with the tool from HF was acceptable but I did find that the SS rivets were much harder. After inspecting the back side of the rivet (the part that holds the trays in the coach) I decided to stay with the TRI-Fold rivet due to the larger contact with the sheet metal. If this sheet were thicker, I may have made a different choice but with the thinner metal on the coach, I felt that the larger contact area would provide better pull out protection than the SS rivets even though the SS rivets have greater clamping and shear strength. The greater clamping may start to pull the rivet through the hole. I have no way of knowing

this without taking a cross-section. I also decided to add a seventh rivet to hold the trays in.

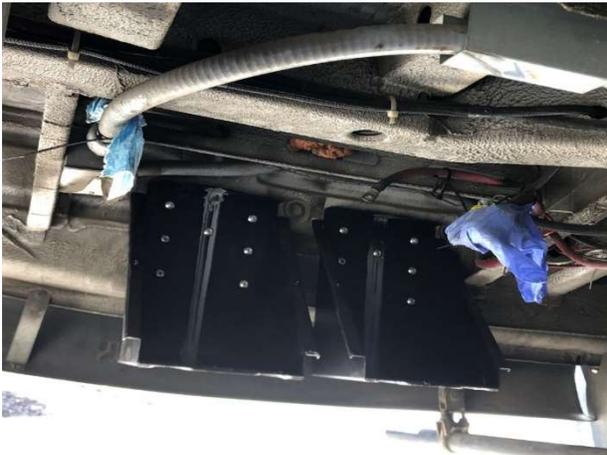
Drivers Side Trays installed, Note 7th rivet in middle of tray. Gray is seam sealer to keep out moisture

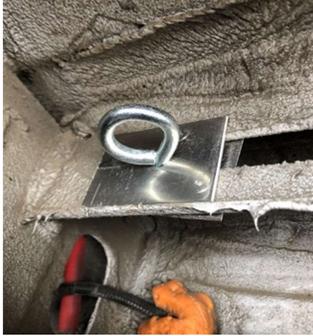
Eye bolt installed on floor rib. Two aluminum backing plates

The eye bolt uses two backing plates that capture the rib. Once the batteries were installed, it was gravely evident that the coach sheet metal would flex a very noticeable amount. It is no wonder that these rivets may pull out under the dynamic load of these heavier batteries. Add compromised holes, lower strength rivets or poor riveting techniques and “battery detaches on the highway”.

I do not think this was needed but why not. I knew that I would add a secondary support to this install and finally settled on an approach that would counter the added weight and increased moment imparted to the tray attachment rivets. I used an aluminum angle (spanning both batteries on each side) to catch the front edge of the batteries and supported this through a turnbuckle that terminates to an eye bolt that is bolted to a stiffener rib on the underside of the floor. A second eye bolt is attached to the

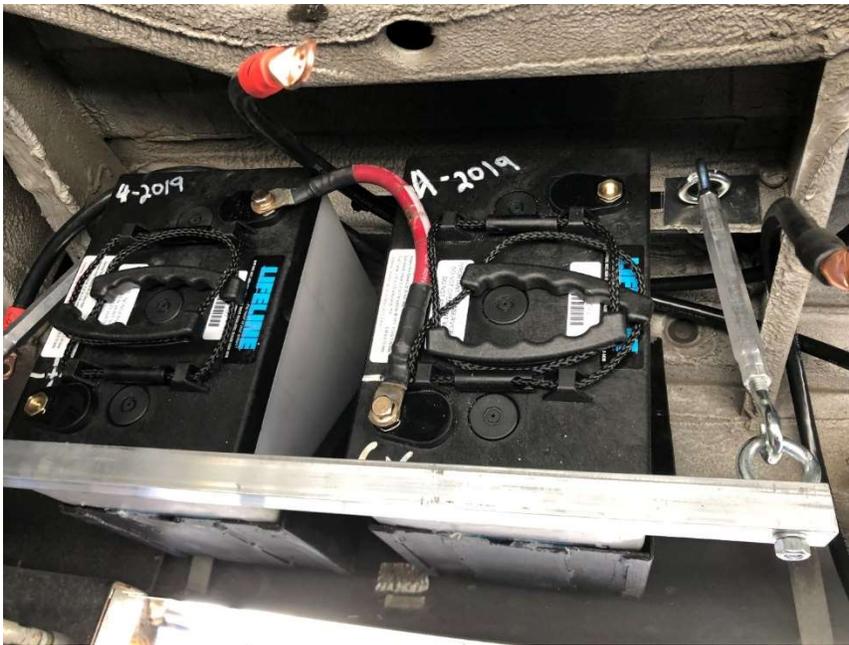
As I adjusted the turnbuckles to support the front edge of the batteries, it was clearly evident that the panel flexing was eliminated. You really do not need to carry the whole weight of the battery, just enough to reduce the load on the fasteners to an “acceptable” amount. The turnbuckle is secured with a jam nut at the top of the assembly to prevent it from turning.

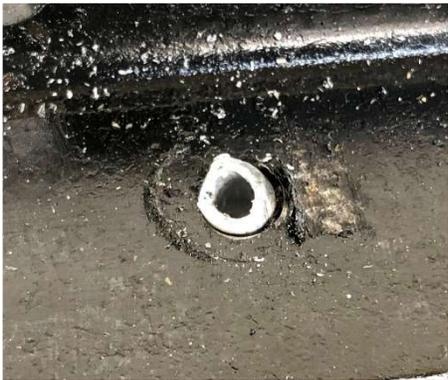
Trial to Shear off Rivet

Blind side of rivet, SS, Tri-fold and AL from left to right
