March 10 2008

As most of you are aware, it all started with "Quest for SS Frame". Back in Sept 2006 we have purchased a well used 1973 26' Argosy. After bringing it home to Pennsylvania, close inspection revealed that the frame needed serious repairs. At first, we have considered sandblasting and replacing sections of rotted frame [shown in the picture under the new one]. After some quick calculations we decided that it would be cheaper for us to build a new SS frame. This would eliminate cost of sandblasting priming and painting for ever. Having most of needed SS material in stock, we first tore down and scrapped the interior which was to be replaced anyway. We removed the empty shell and left it on blocks in the storage yard. In the end of December 2006 old frame was brought into the shop and work begun on new Stainless Steel frame. All work in the winter of 2006 was done on after business hours basis. We could only afford to tie up one 12'X35" bay because our business had to remain operational.

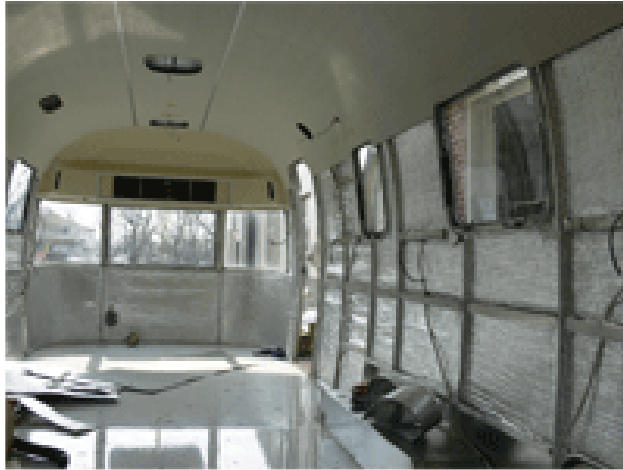
Most of the original fiberglass insulation was compacted down where over 50% of the total wall area was not insulated at all. Stripped out clean shell was then lowered onto the installed floor and fastened with ¼" SS lag bolts to the outrigger plates and the frame at each end of the shell.
