AIRSTREAM SERVICE BULLETIN # 146

SHELL TO CHASSIS SEPERATION

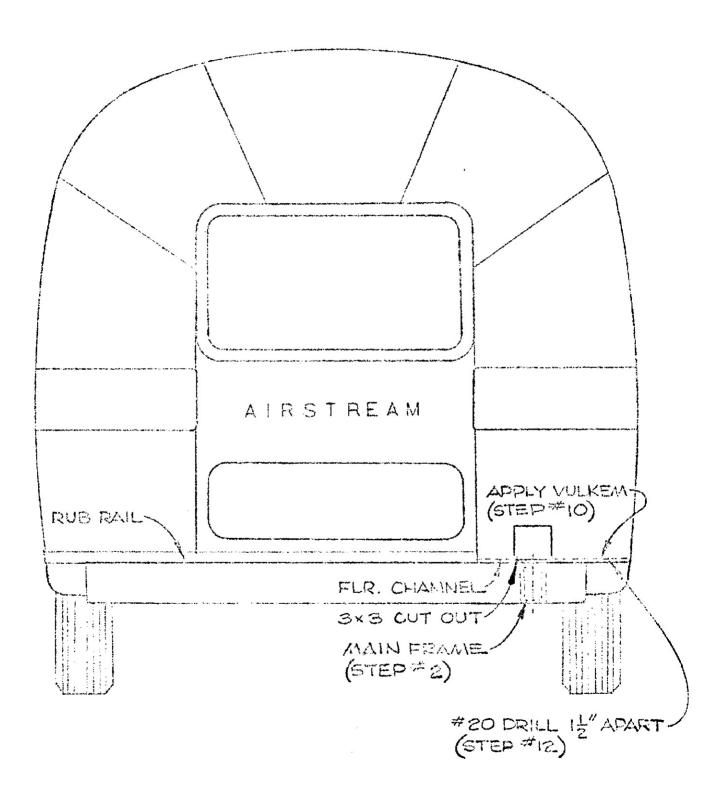
Frame separation at the rear of the trailer is indicated by the chassis of the trailer dropping away from the shell or body.

- To correct 1969 1970 1971 1972 Models -
- (1) Remove rub rail from rear of trailer.
- (2) Cut 3" square hole directly above main frame, starting at bottom of rear sheet. (See figure # 1B) <u>Be sure not to cut floor channel.</u>
